LIONS GATE BRIDGE NORTH VIADUCT 2021 ORTHOTROPIC STEEL PLATE DECK INSPECTION REPORT

A234840

A234840-Lions-Gate-North-Viaduct-OSPD-Inspection-Report

2023 Mar 24

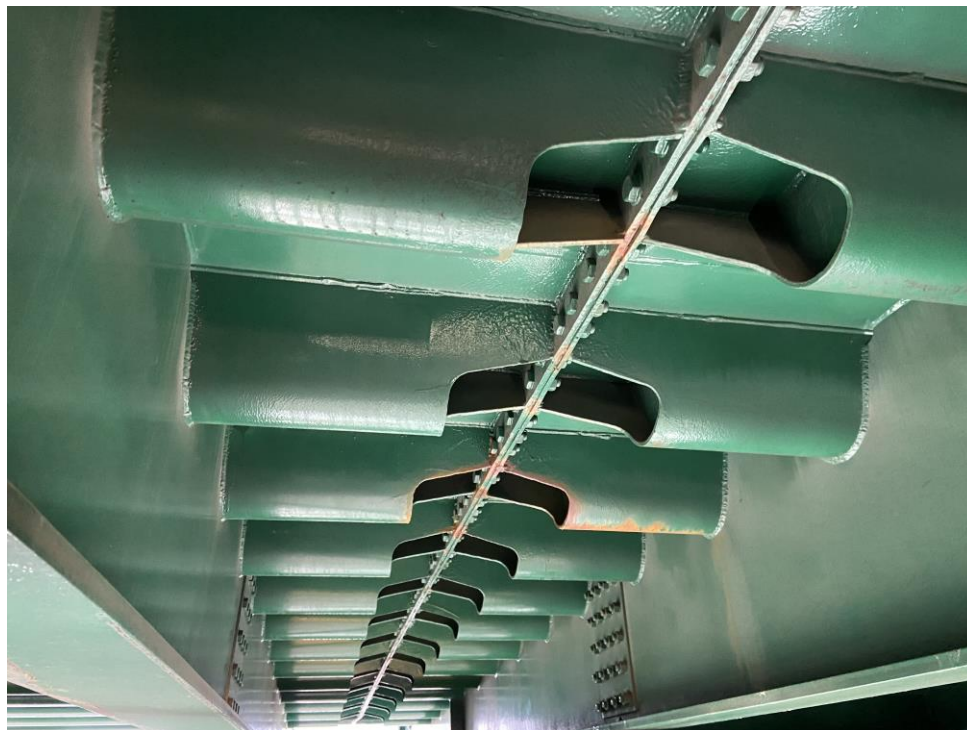
Figure 3: Typical OSPD Bolted Transverse Splice

- > The bolted OSPD splices, generally located in the middle of each approach span, typically showed signs of water ingress and corrosion particularly in areas where the bolt spacing was larger, with rust jacking noted at several locations.

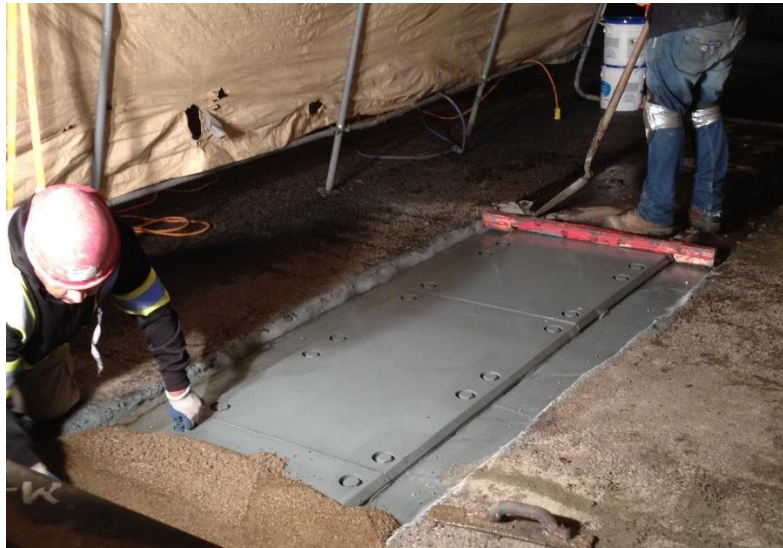
Figure 4: Link Plate Installed at Breather Joints in 2014 (BC MoTI)

Similar to the typical wearing surface, the PPC wearing surface above the link plates was observed from the sidewalks. In general, the PPC wearing surface was observed to be in fair condition, with cracking observed in the transverse direction of the deck, as shown in Figure 6. This cracking is occurring along the edge of the link plates shown in Figure 4 that were installed in 2014.

Based on the condition of the underside of the deck at the link plate locations, COWI is concerned that the link plate detailing represents a long-term risk to the structure. Furthermore, inspection of the interface between the link plate and the OSPD is only possible by completely removing the link plate and the paving, which is not practical. Therefore, the extent of the corrosion is not something that can be monitored. COWI recommends the Ministry initiate a study to determine if any modifications to the link plates can be made to mitigate as much of this risk as possible before the paving is replaced during the 2022 repaving program.
