**BC Ministry of Transportation and Infrastructure
South Coast Region**

**PAVEMENT STRENGTH TESTING AND EVALUATION
HIGHWAY 7 & 7B - LKI SEGMENTS 2730 AND 2715
PITT MEADOWS / PORT COQUITLAM, BC**

V13101493.002

February 2010

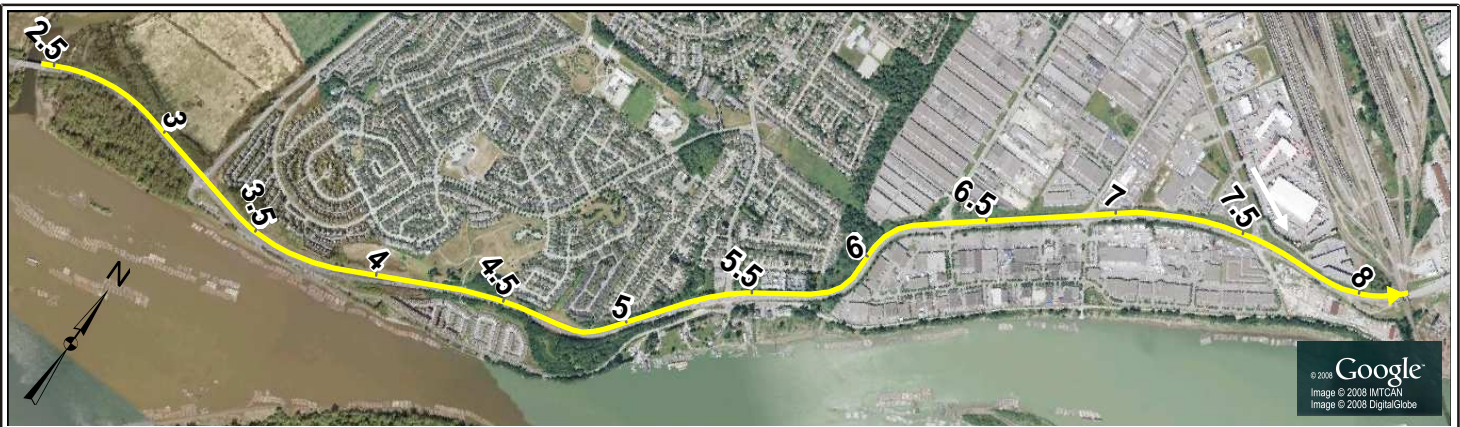
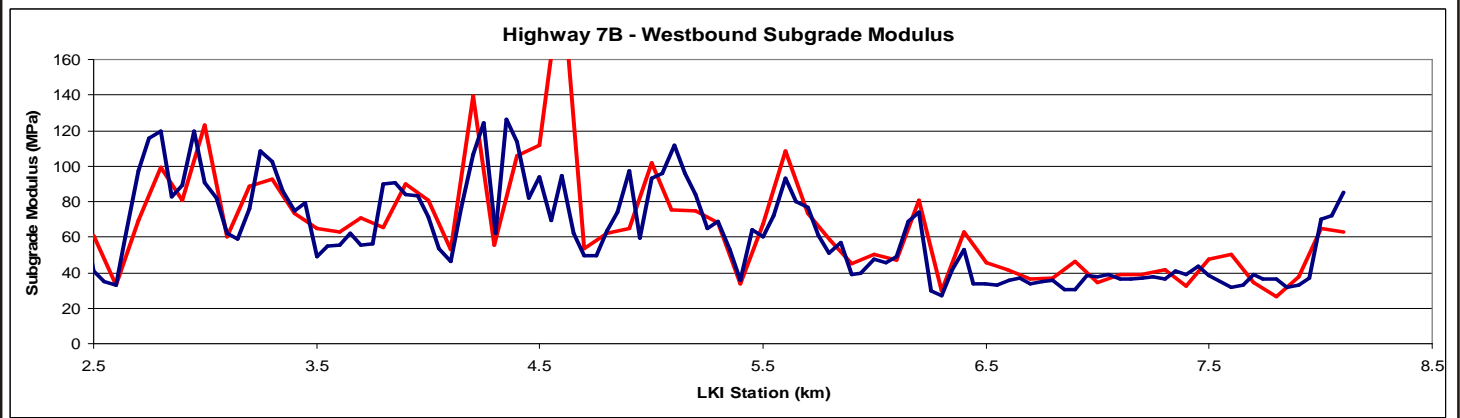
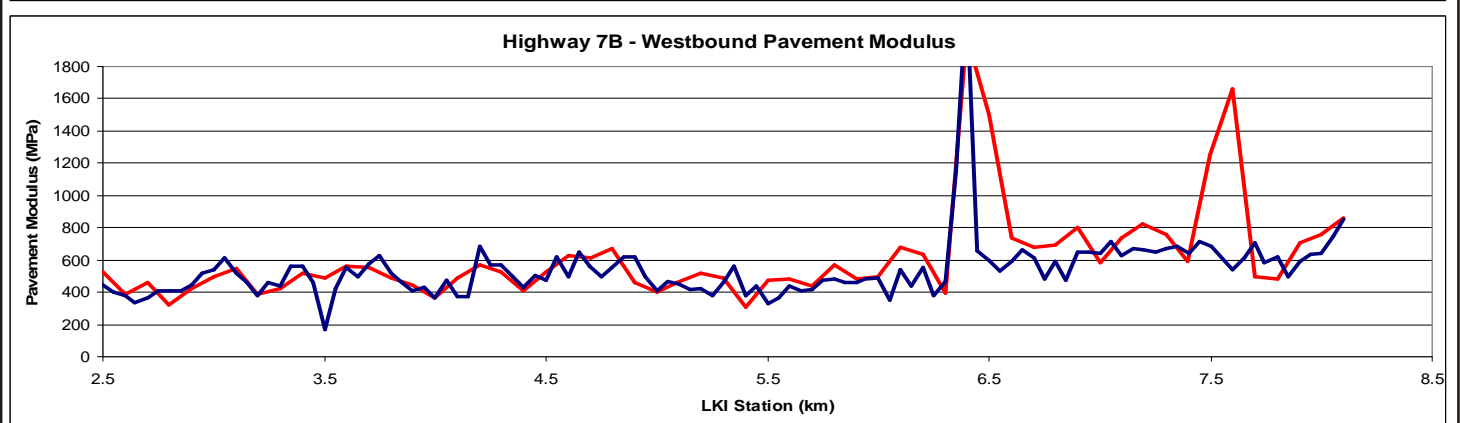
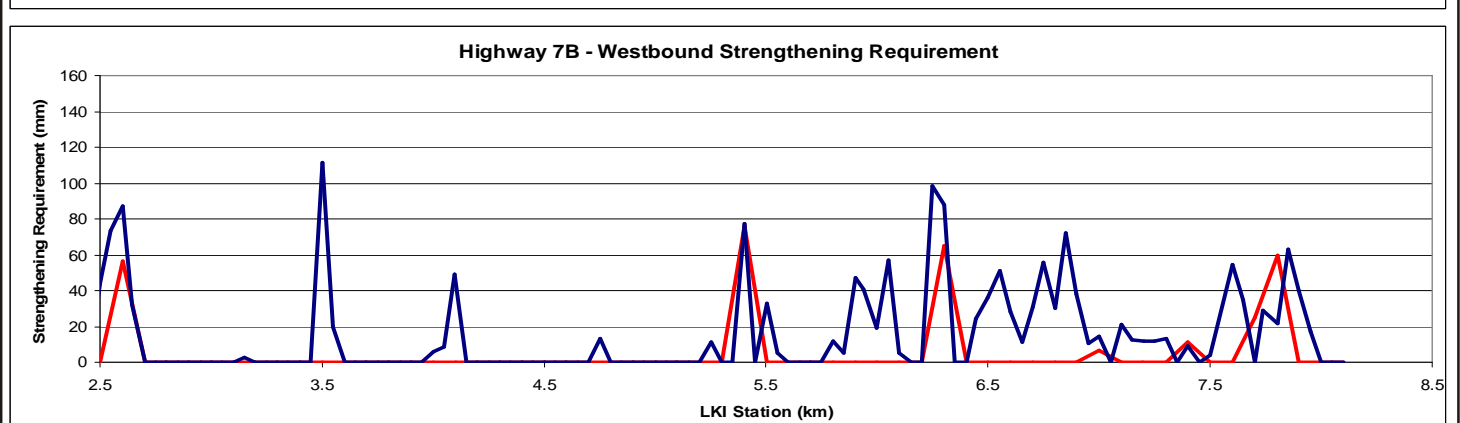
PROJECT NO. V13101493.002	DWN AMF	CKD BP	REV 0	Figure 6
OFFICE EBA-VANC	DATE February 3, 2010

Pavement Modulus (E_p), Subgrade Modulus (M_r), and Effective Pavement Structural Number (SN_{EFF}) were also determined in the analysis are included in Appendix C. Graphical representation of E_p , M_r , and AASHTO strengthening requirements are presented in Figures 6 and 7.

Analysis of the FWD data identified areas within the above roadway sections requiring large localized strengthening requirements. Typically these areas include strengthening requirements greater than 100 mm. These large “spikes” suggest a failed pavement structure, and should be inspected prior to rehabilitation. Base on the FWD analysis, specific test locations that are potential candidates for deep patch repair are summarized in Table 14.
