# Geotechnical Investigation for Fulford-Ganges Road from Cranberry Road to Seaview Avenue, Salt Spring Island, BC

#### PRESENTED TO Ministry of Transportation and Infrastructure

NOVEMBER 23, 2021 ISSUED FOR USE FILE: 704-TRN.PAVE03225-05

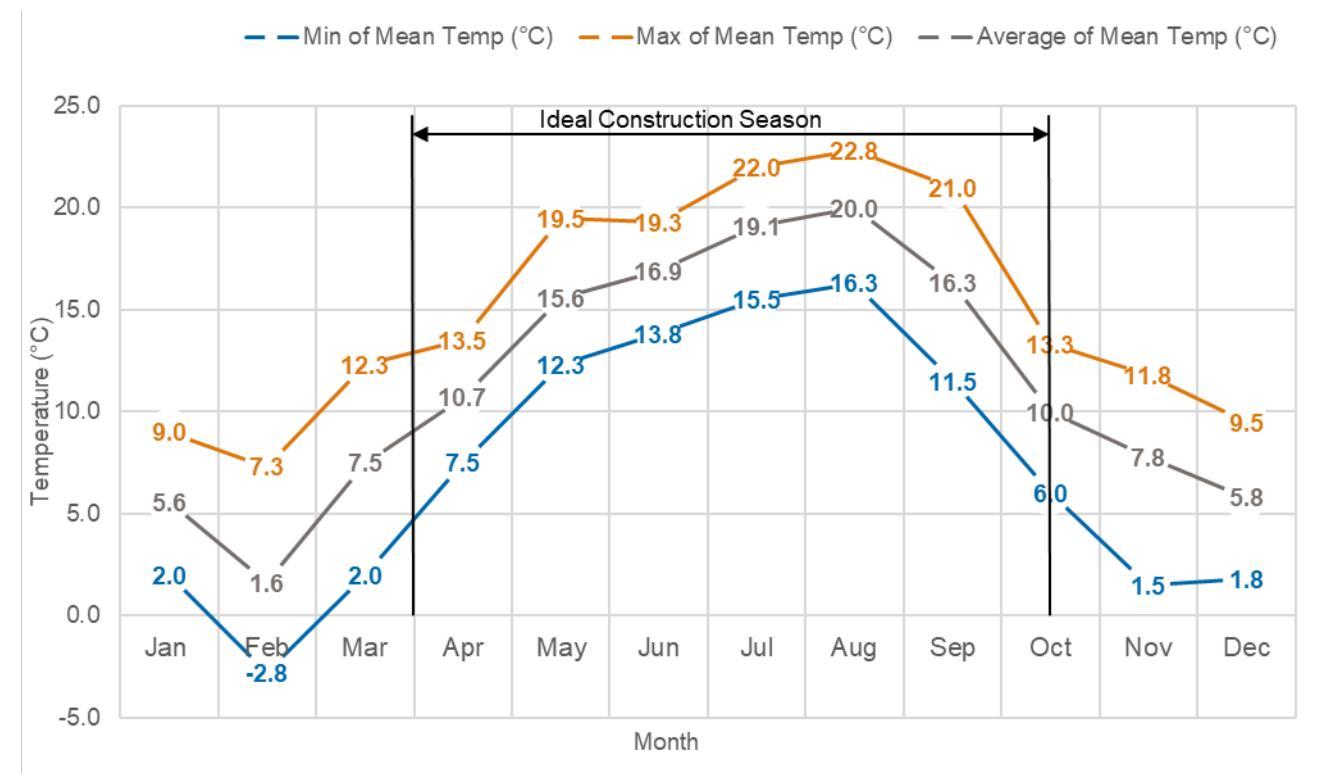
Figure 6-1: Weather Data and Historically Preferable Construction Season

The historical climate data for the weather station (Salt Spring St. Mary's L) is shown in Figure 6-1. Based on the Standard Specifications for Highway Construction, asphalt mix should only be placed when the ambient air temperature is above 5°C. Therefore, as shown in Figure 6-1, the ideal weather for construction has historically occurred between April and mid-October.

Construction during the early spring and late fall seasons have an increased risk of adverse weather conditions that could make achieving the specified in-place compaction difficult and adversely affect the integrity of the finished product. Additionally, early-season construction may have conditions where frost is still present in the road prism.
