BC MINISTRY OF TRANSPORTATION AND INFRASTRUCTURE

BRIARWOOD BRIDGE GEOTECHNICAL SITE CHARACTERIZATION

MARCH 2023

Subject: Briarwood Bridge No. 10427 - Geotechnical Site Characterization
Client ref.: 18003-2023

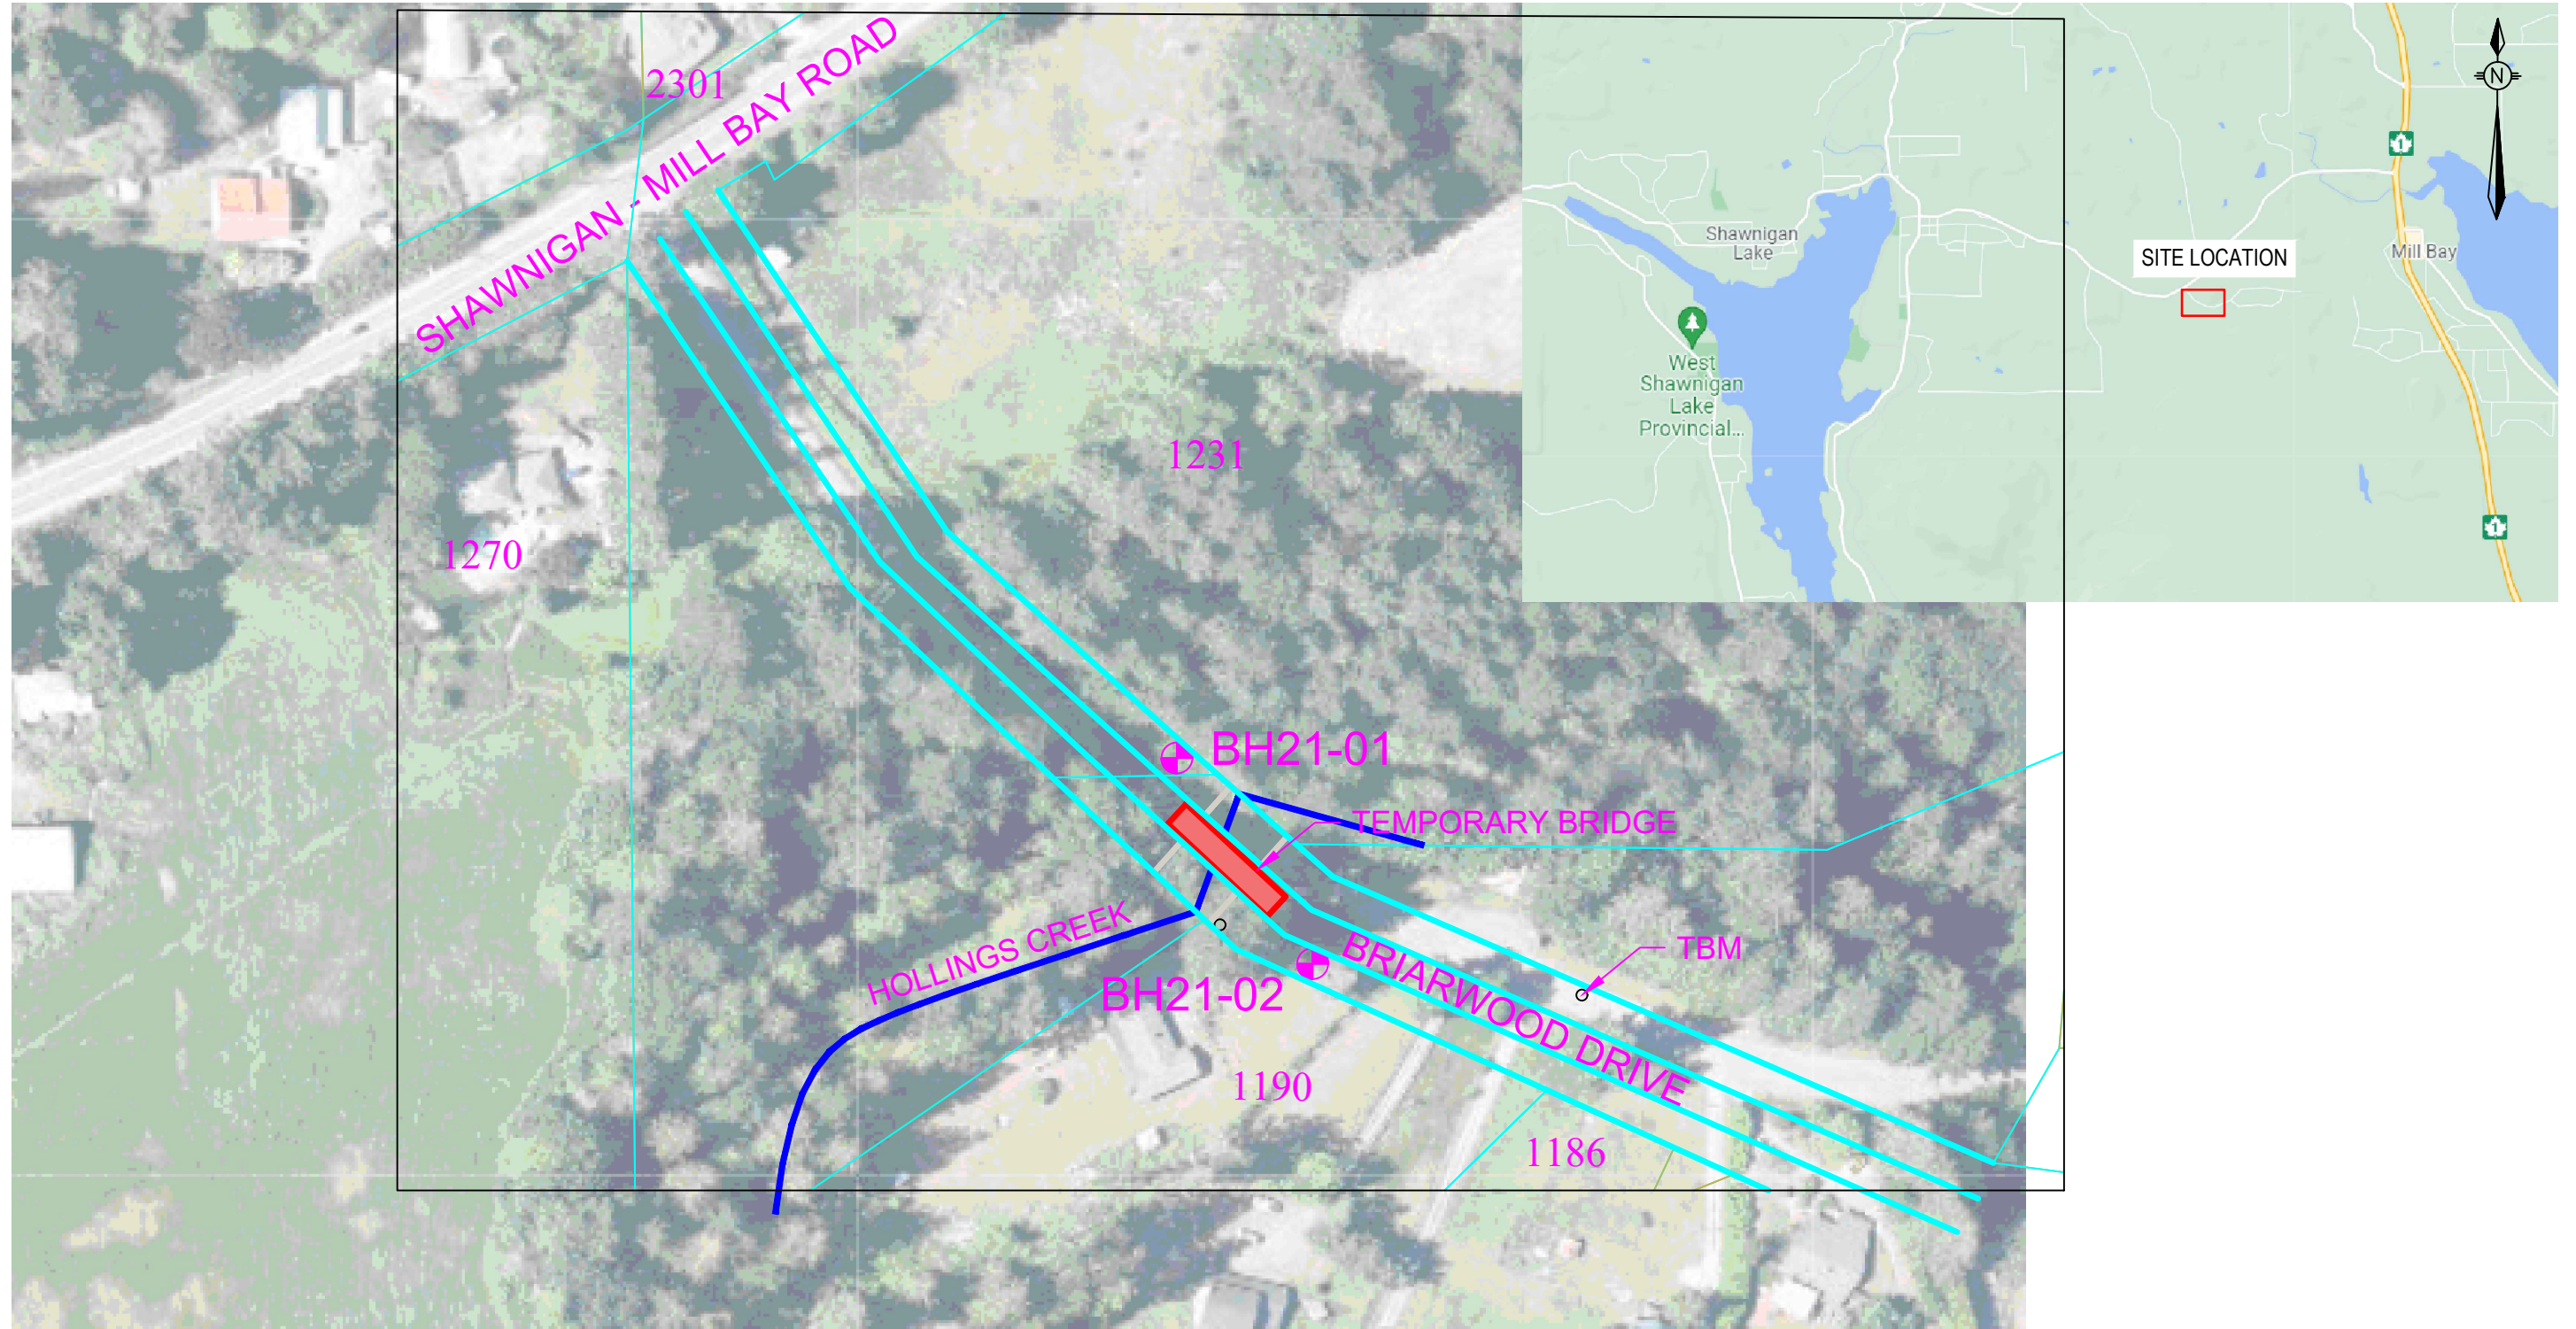
PROJECT:		BRIARWOOD DRIVE
CLIENT:		MINISTRY OF TRANSPORTATION AND INFRASTRUCTURE
TITLE:	SLOPE CONDITIONS WITH BOREHOLES	
DRAWING:	02

A cross-section showing the borehole logs and the observed exposed soil conditions is shown on Figure 2. Note that the elevations shown on Figure 2 are relative only and are based on an assumed Temporary Benchmark (TMB) elevation of 100.00m. The TMB was a nail placed at the base of a Hydro pole located on the north side of the road, east of the temporary bridge crossing.
