**Timber Evaluation, Tree Risk
Assessment and Cultural
Modified Trees Identification,
Initial Data Collection and
Reporting**

**Gulf Islands National Park
Reserve of Canada, Canal
Road, Pender Island, B.C.**

2023-01-11 | Revision #1

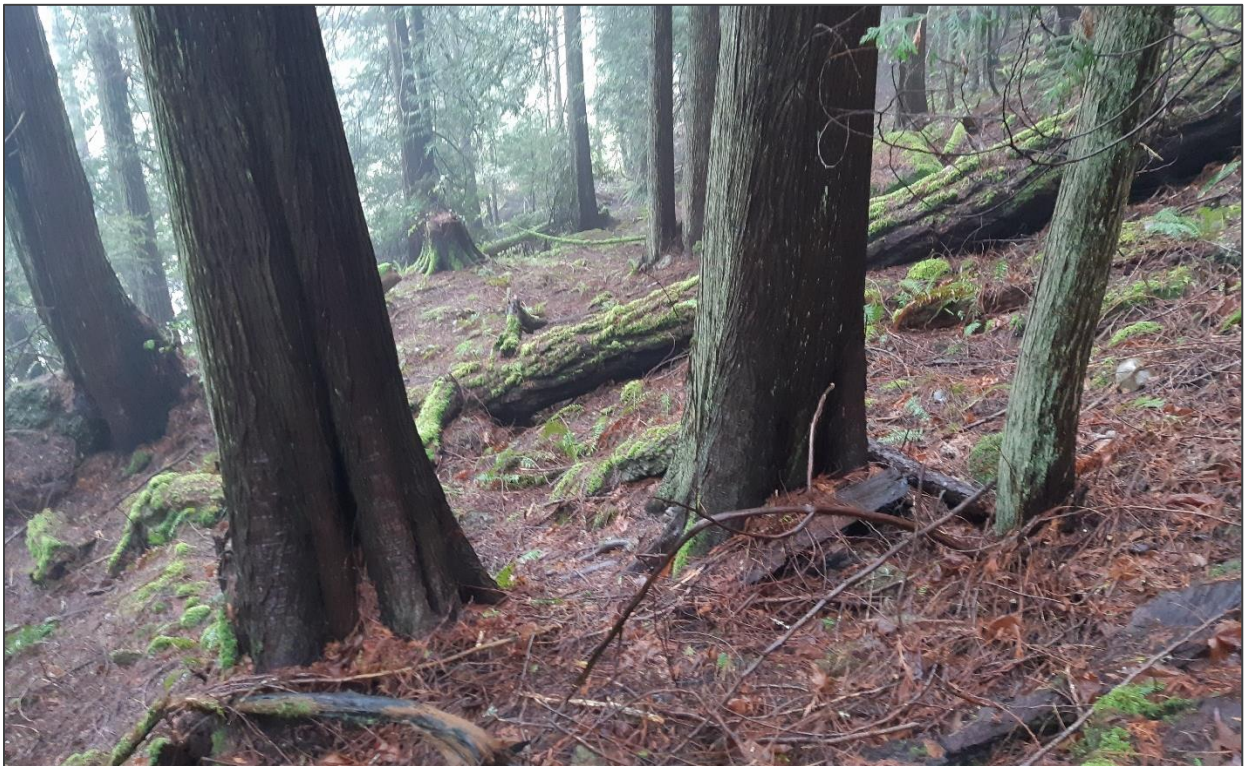
Figure 12. Image of the interior of the forest stand with a large Western redcedar component.
