*Project number: 4435-029*  
*Document number: R3663*  
*Version: 3*  
*Date: February 21, 2014*

## **MILE 122.7 DERAILMENT – COAL RECOVERY PLAN FOR SILVER CREEK, BURNABY LAKE AND BRUNETTE RIVER**

# ENVIRONMENTAL MANAGEMENT PLAN – SILVER CREEK AND BURNABY LAKE COAL RECOVERY PROGRAM

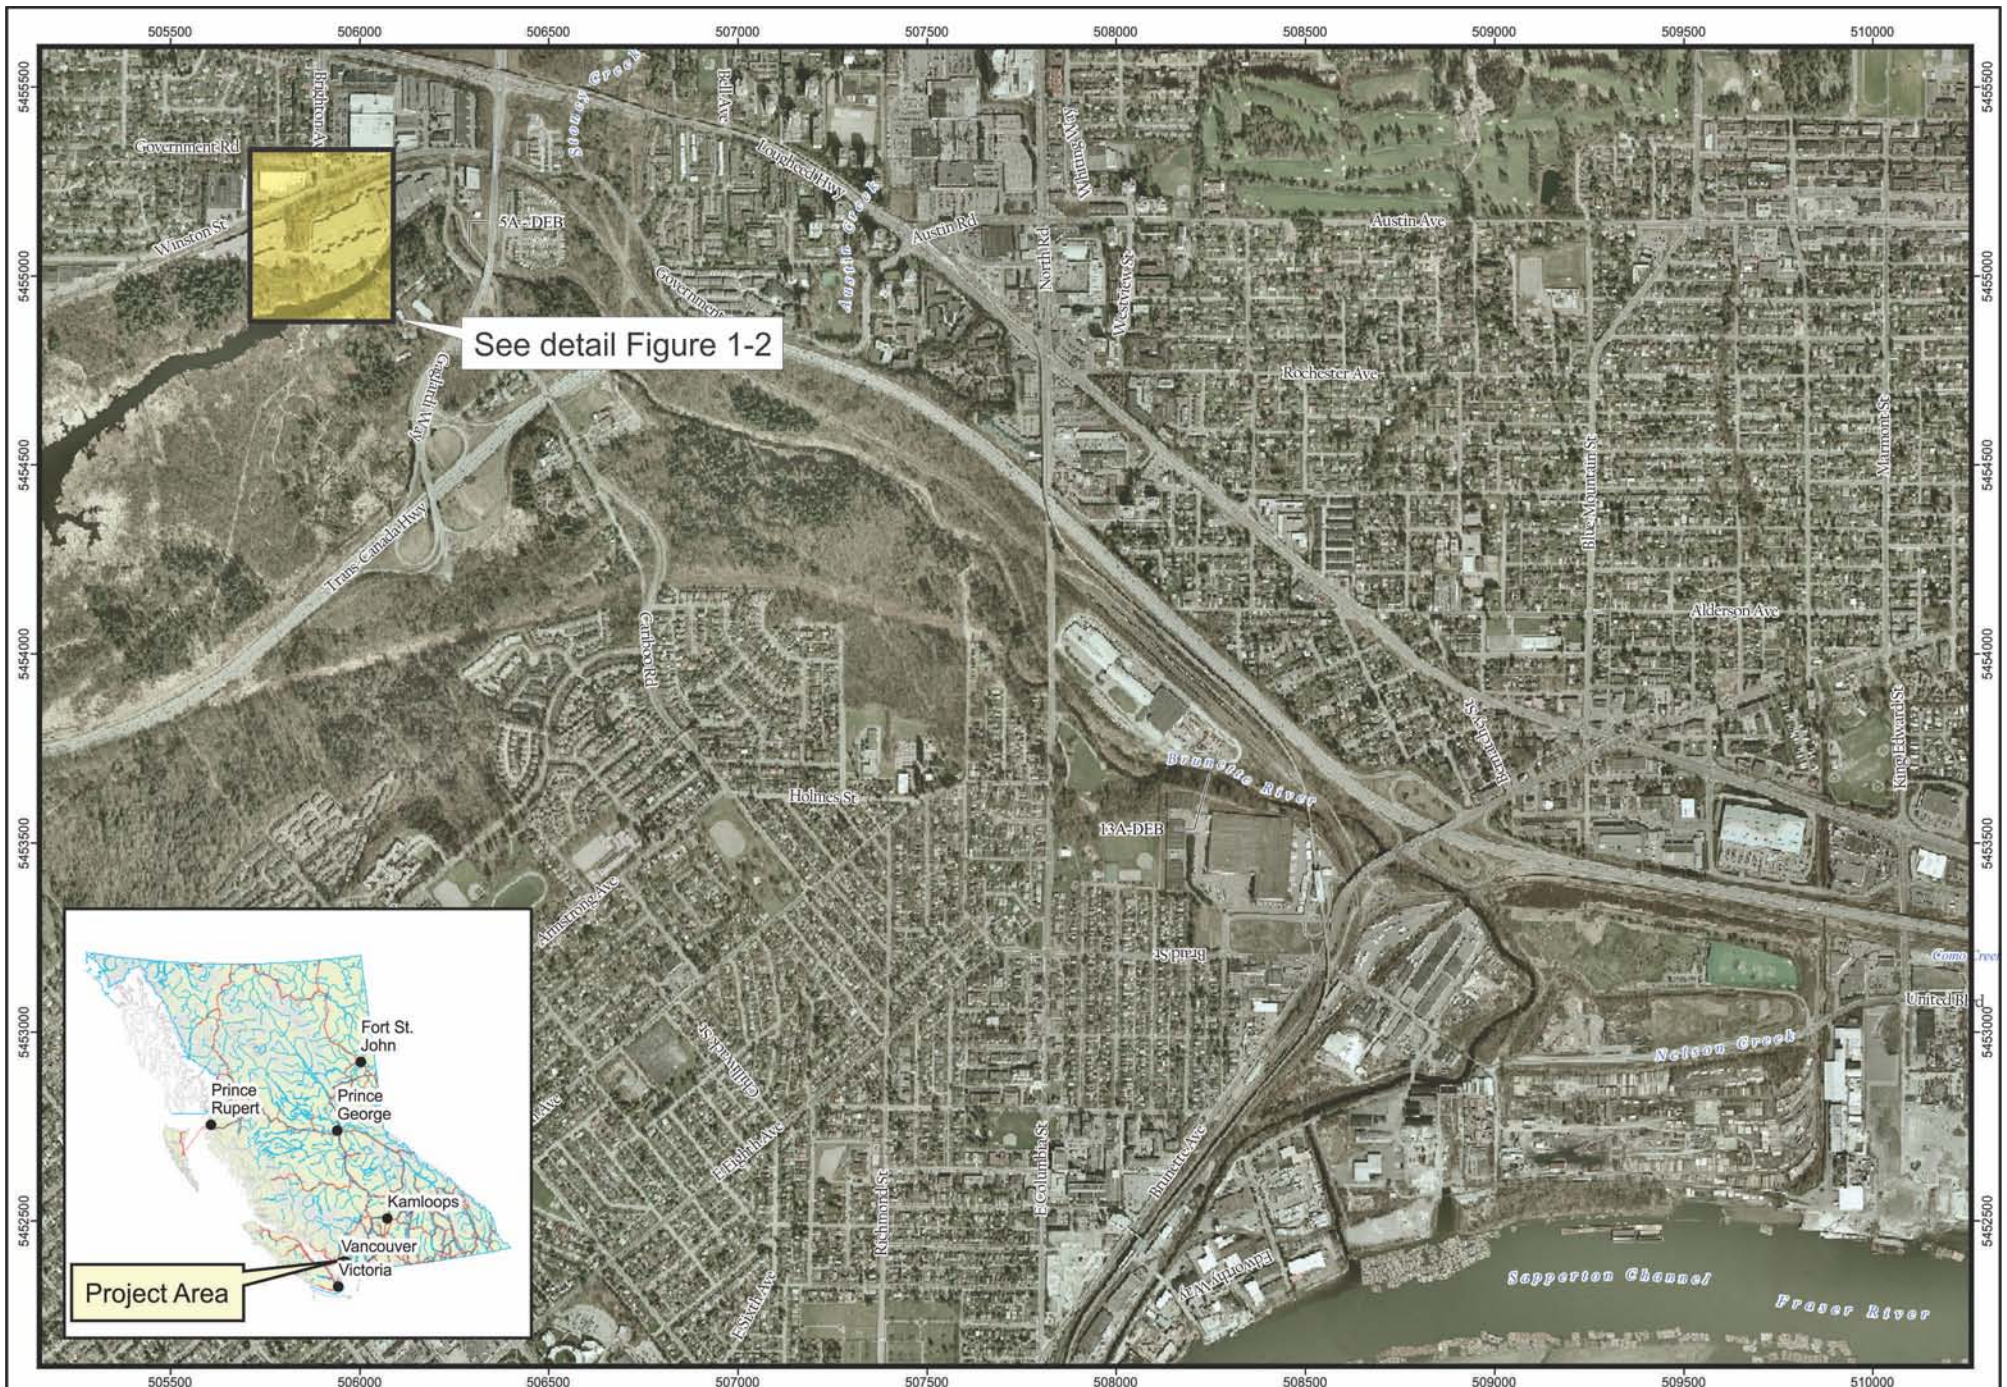
Figure 1-1.  
Location of Silver Creek at  
Burnaby Lake confluence

Triton Environmental Consultants Ltd. (Triton) was retained by the Canadian National Railway Company (CN) to provide technical environmental services following a train derailment at Mile 122.7 of the Yale Subdivision in Burnaby, BC. The derailment occurred on January 11th 2014, and caused the partial release of metallurgical coal from three rail cars into and adjacent to Silver Creek. From the derailment site, Silver Creek flows approximately 350 m before entering Burnaby Lake, 200 m upstream of Cariboo Dam (Figure 1-1 and 1-2). From Cariboo Dam Brunette River flows approximately 6 km before entering the Fraser River.
