DETECTION OF SEPTIC TANK LEACHATE INFLOWS  
FROM SHORELINE DEVELOPMENT - OSOYOOS LAKE

P.F. Epp  
Waste Management Program  
Okanagan Sub-Region

Penticton, B.C.  
April 1985

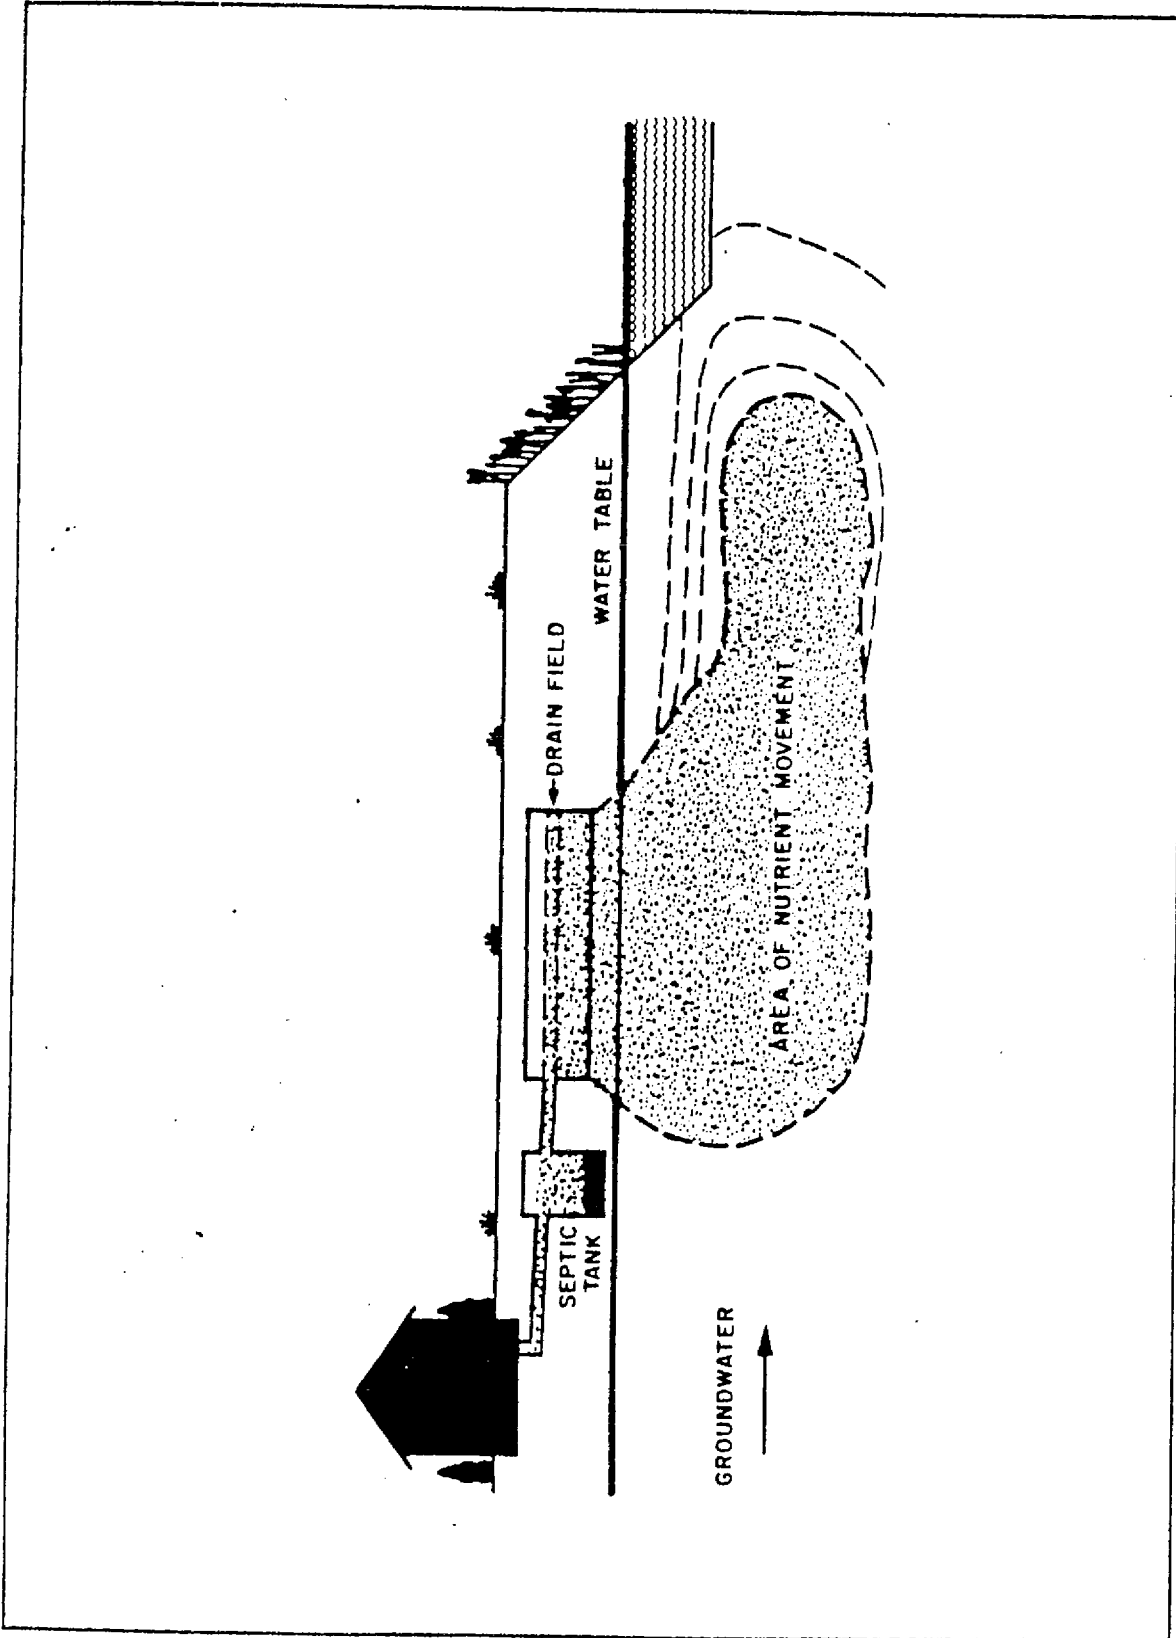
FIGURE 2: The Movement of Leachate From a Drainfield into a Lake

The use of septic tanks with drainfields near a lake shore can result in inadequate septic leachate treatment by the soil (refer to Figure 2). Water tables in such areas are often close to the soil surface and effluent may move with groundwater into the lake. Leachate plumes can emerge near lake shore. This may cause weed and algae growth due to increased nutrient inflows.
