Closed-bottom corrugated-steel embedded culverts in British Columbia: overview of twelve sites

Clayton T. Gillies,
Western Division

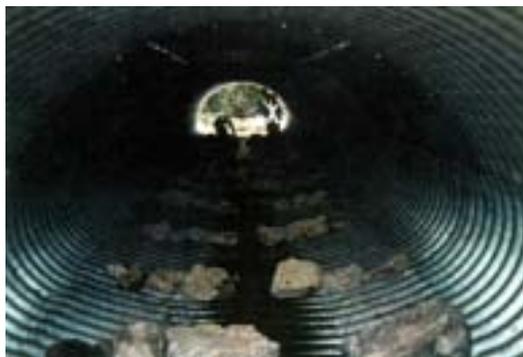
Figure 6b. Hand-placed boulders during installation (photo courtesy of Slocan Group, Mackenzie).

- Deposition of streambed material has occurred within the culvert. Small portions of the culvert were devoid of substrate (Figure 6c).
- Some of the smaller hand-placed boulders have moved and shifted within the culvert, while others have migrated downstream. The larger boulders have assisted in retaining natural bedload material.

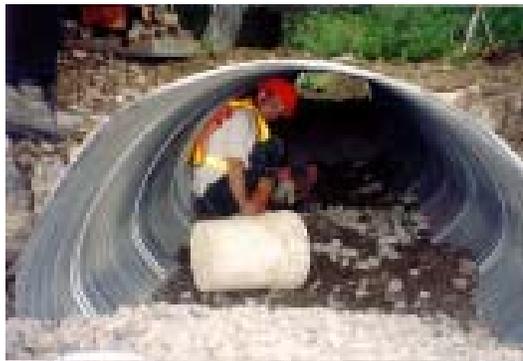
- The culvert was filled by hand, using buckets to deliver material through the culvert (Figure 7b).
- The majority of the material used within the culvert was road fill gravel. Approximately six rock lines, made of larger-sized cobbles, were installed prior to completing the infill. The rock lines are expected to help keep the finer material in place. This was capped with a layer of delivered drain rock. Large cobbles were placed randomly over the surface to promote the development of a low-flow channel.

Figure 7b. Worker delivering material within the culvert during installation (photo courtesy of Canadian Forest Products Ltd., Fort St. James).

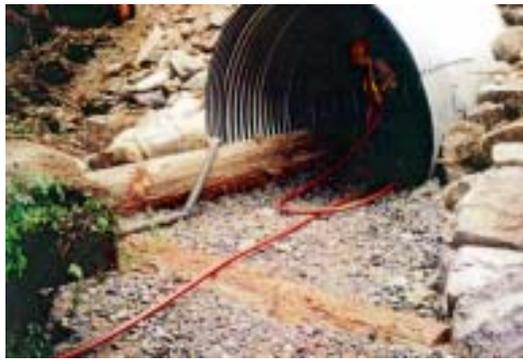
- Cobble-sized material from within the culvert has migrated approximately 9 m downstream in the two years since completion. A “stop-log” and/or weir-log at the outlet (Figure 11b) was completely covered with bedload material during the field visit. The height of material within the culvert completely covered all the baffles.
- Boulders placed along the surface of the simulated streambed, such as the boulder at the inlet of the culvert shown in Figure 11c, should be considered when designing the hydraulic capacity of the culvert.

Figure 11b. Outlet of embedded culvert, showing woody debris placed within the culvert and worker conducting final wash of simulated streambed (photo courtesy Weyerhaeuser, Stillwater Timberlands).

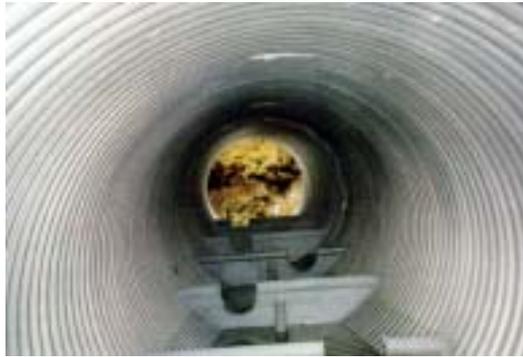
- A site plan and detailed, signed and sealed set of design drawings were produced by StoneCroft Project Engineering of Black Creek.
- Two benchmarks were established in the field; culvert inlet and outlet elevations, relative to field benchmarks, were shown on the design drawings.
- The culvert was designed with seven 600-mm-high notched baffles spaced at 2-m intervals. The baffles can be seen in Figure 12b.

Figure 12b. Embedded culvert before placing material within it, showing height of baffles (photo courtesy Weyerhaeuser, Stillwater Timberlands).
