Assessing fuel treatment effectiveness:

A case study of the Nohomin Creek wildfire encroachment on the community of Stryen 9

January 2024

Project number: 301015438 Report number: WFTR 2024 N.3

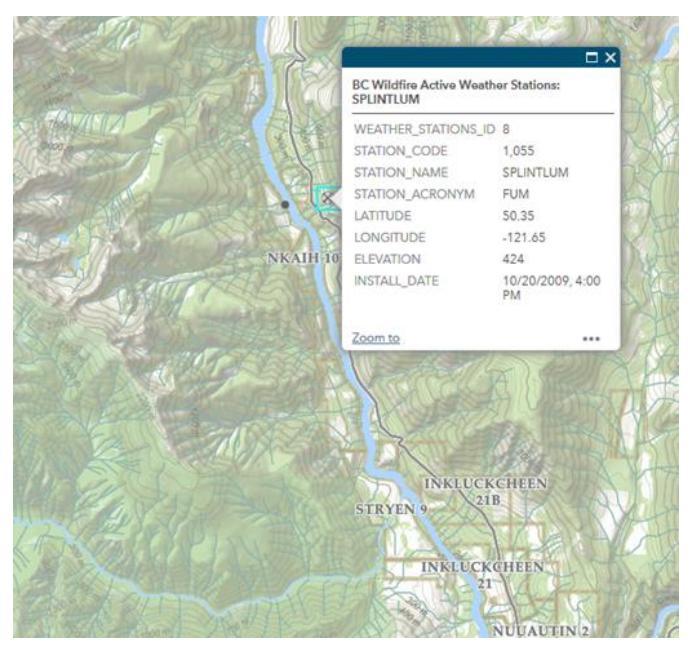
Figure 7. Location of the Splintlum fire weather station relative to the surrounding First Nation communities.

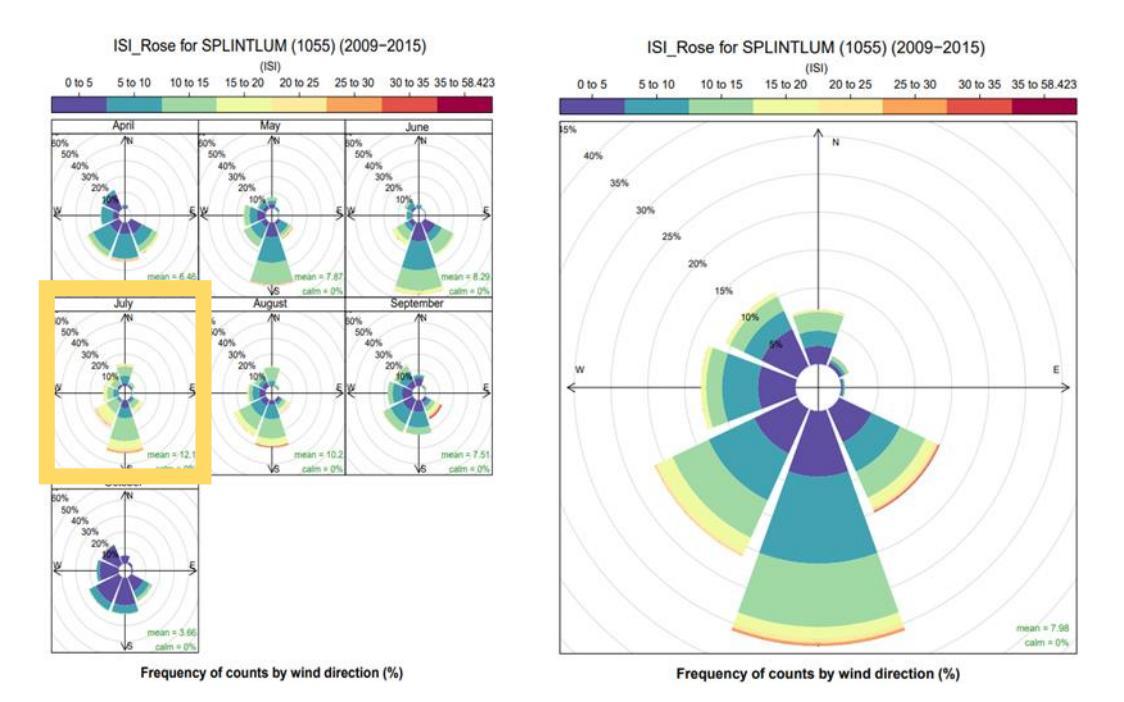
Wind was consistent throughout the burning day with speeds between 15 and 20 km/h from the south-southwest; this direction is typical for the valley as can be seen in the Initial Spread Index (ISI) roses in Figure 8.

Figure 8. Initial Spread Index (ISI) roses for the Splintlum weather station. The greatest proportion of spreading days occurs from the south (right). Proportion of spread days in July are dominated by the south, followed by the southwest (left, yellow box).

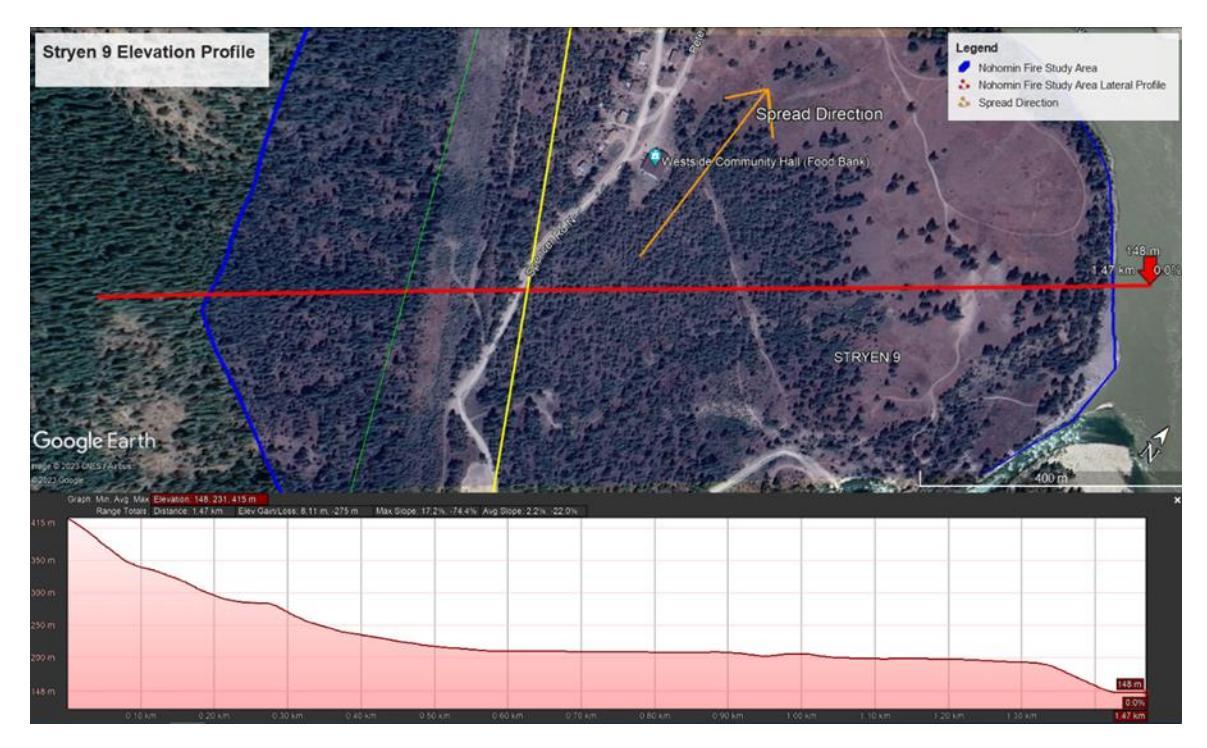
Figure 10. The lateral elevation profile of Stryen 9 showing the nearly-level topography of the community.

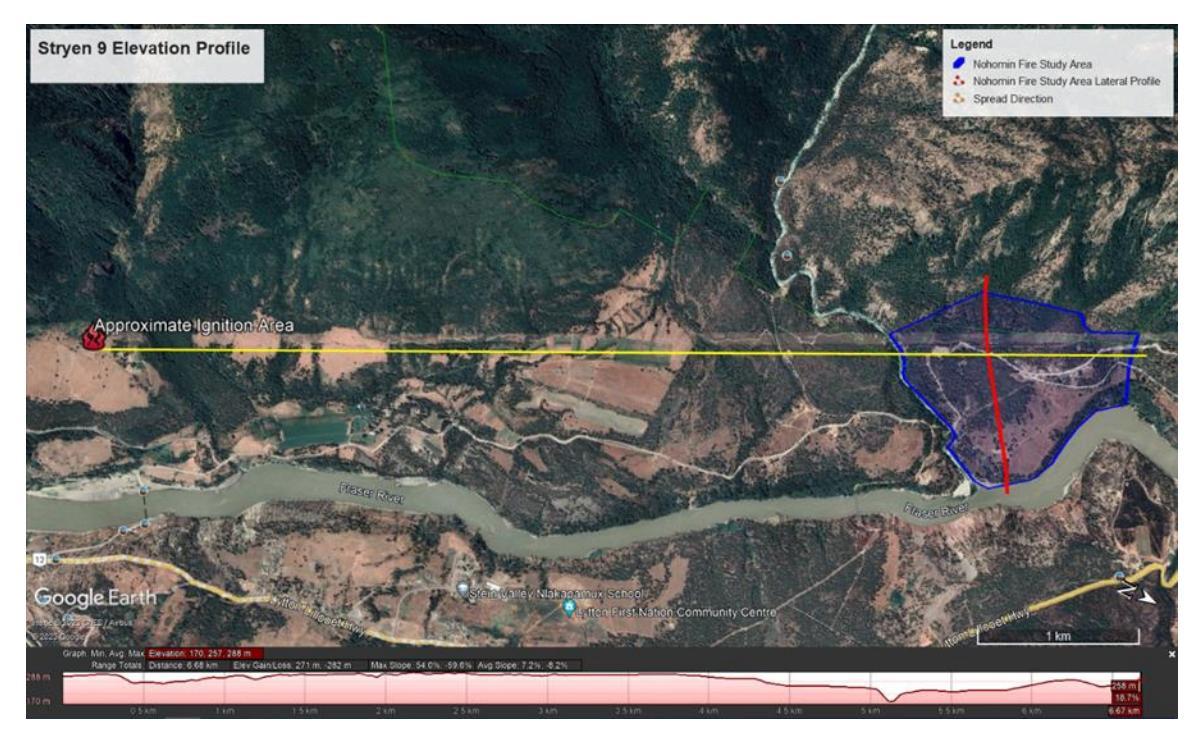
Figure 11. The elevation profile (top image) from point of origin north northwest towards the community of Stryen 9 (left to right). The topographical low at approximately 5 km indicates the Stein River. The elevation profiles have been adjusted to show no vertical exaggeration.
