Highway 91/17 Upgrade Project

Submittal No.	PGC-SUB-001947	Document No.	H9117-EV-MRP-0026
Title	Environmental Monthly Report June 2022	Revision:	1
Date Submitted to MoTI		July 14, 2022	
Prepared by:	Nuzhat Beig, M. Eng, EIT (MESL)

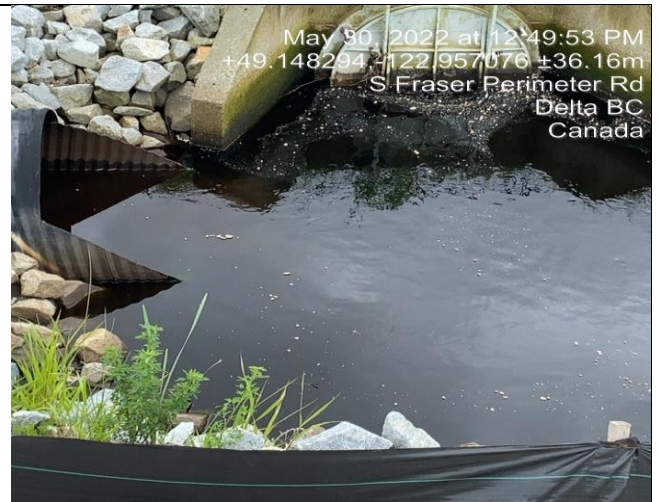
Photo 75: L525. Unauthorized pumping to 96 St Ditch US.

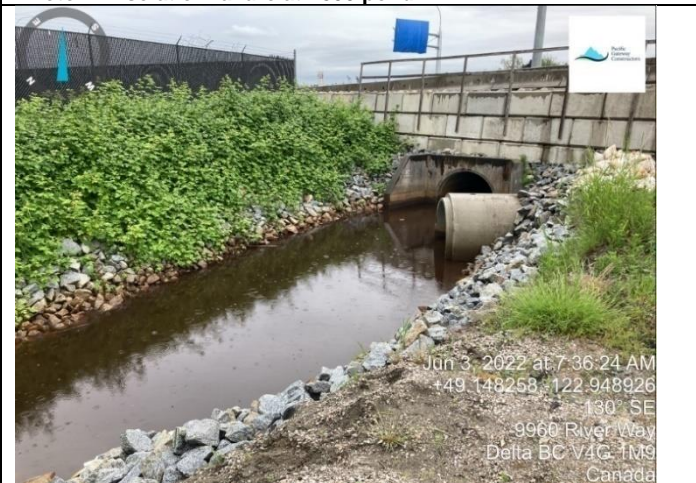
Photo 78: Culvert discharge location in Silda Ditch, 2 June 2022 at 09:13 (240 NTU)

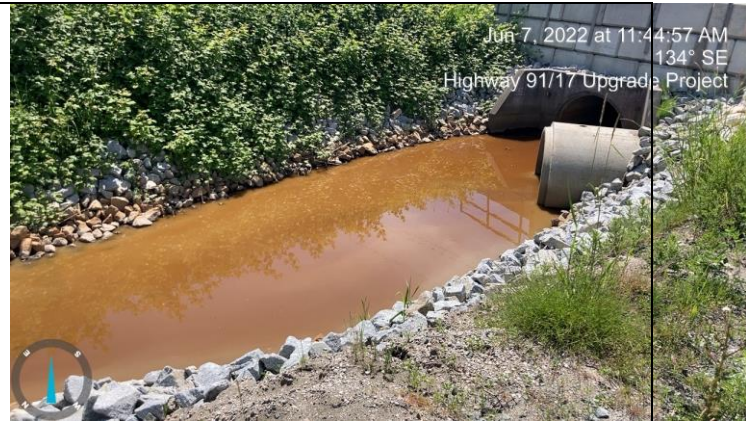
Photo 81: Re-established isolation at L500 pond.

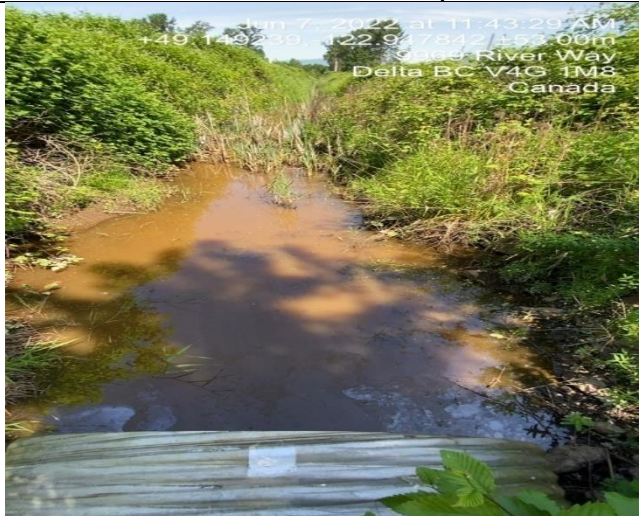
Photo 82: Low water levels and elevated turbidity at Silda culvert discharge location.

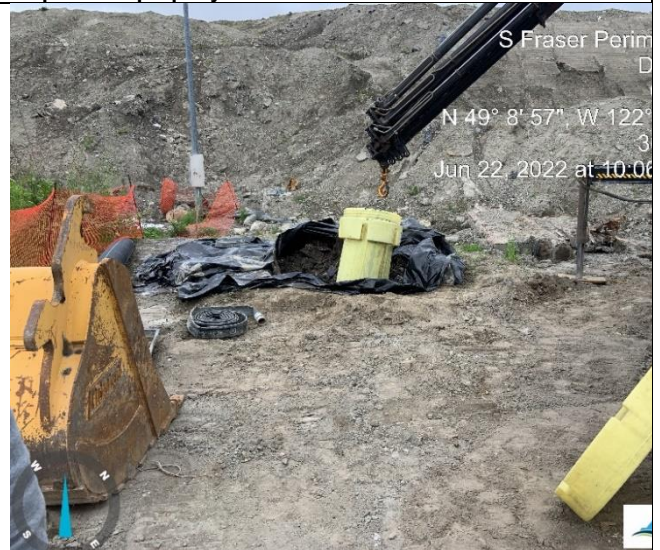
Sunbury Mounds	Barrel excavated from Sunbury work area	0.25 m ²	Hazardous material was placed in a secure tote and removed from site by Secure Energy.	22 June 2022

Photo 89: Hazardous waste material from Sunbury Mounds contained for removal from site by Secure Energy.

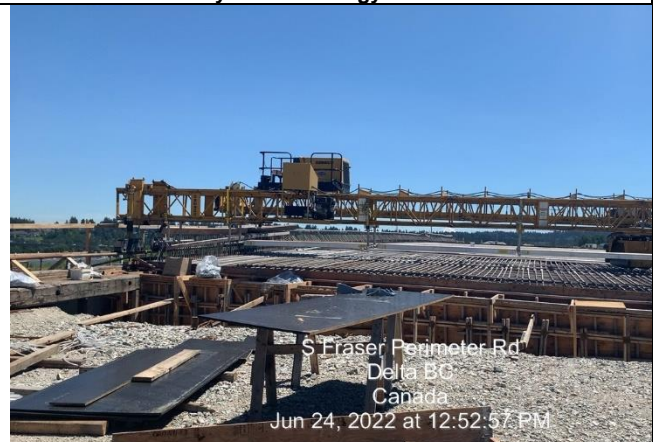
Photo 91: Jacob Brothers S2 Bridge worksite cleanup – general waste sorted into appropriate receptacle.

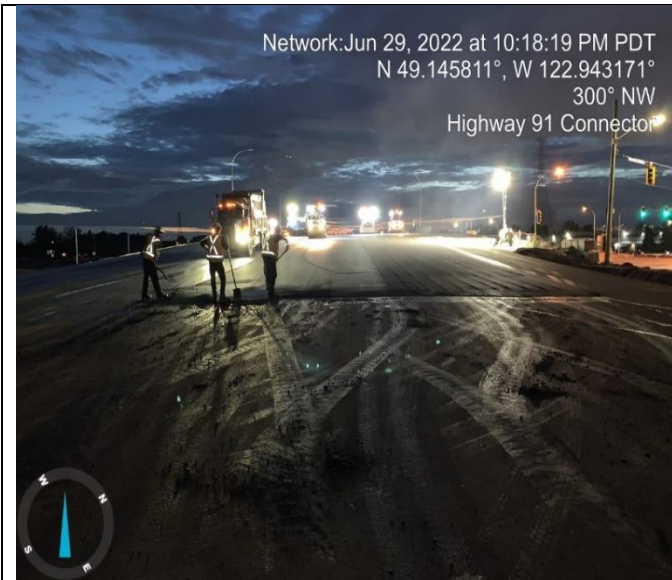
Photo 93: L500, S3 bridge ramp. All Roads paving the top lift on the S3 bridge ramp.

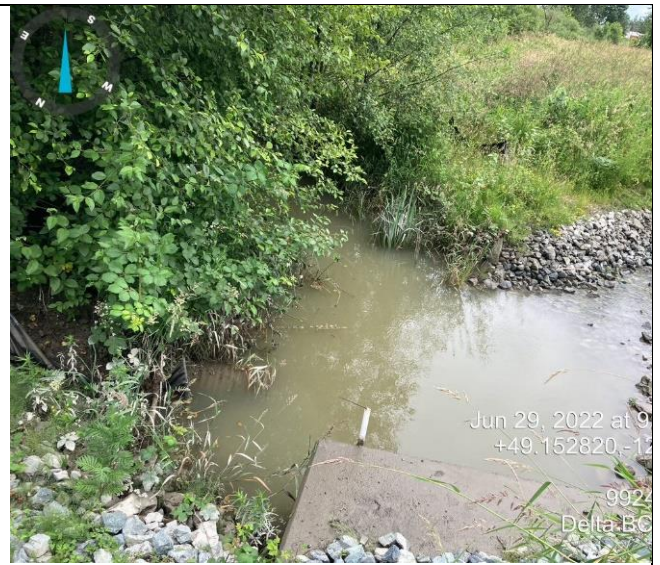
Photo 94: Downstream Silda Ditch showing turbidity influence from Fraser River.

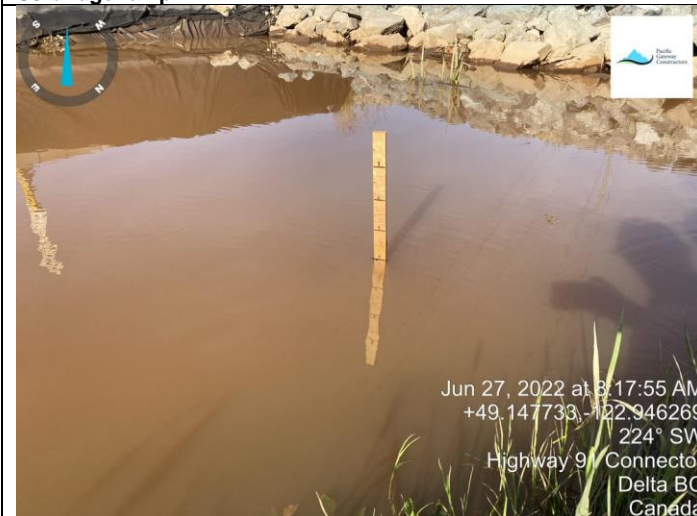
Photo 95: Silda Ditch Upstream showing tidal influence (high tide at 04:22) and water conditions variability.

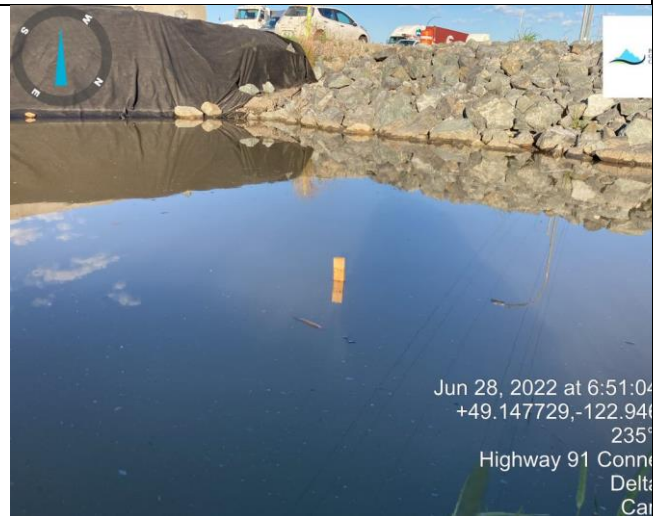
Photo 96: Silda Ditch Upstream showing tidal influence (high tide at 04:53) and water conditions variability.

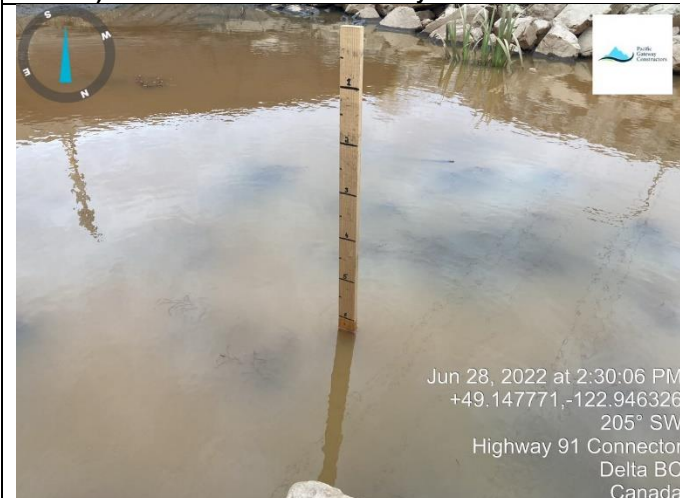
Photo 97: Silda Ditch Upstream showing tidal influence (low tide at 14:22) and water conditions variability.
