ROCKWELL DRIVE RECOVERY PROJECT FISHERIES ACT REQUEST FOR REVIEW SUPPORTING INFORMATION

February 2023

MOTI10866 VERSION 2.0

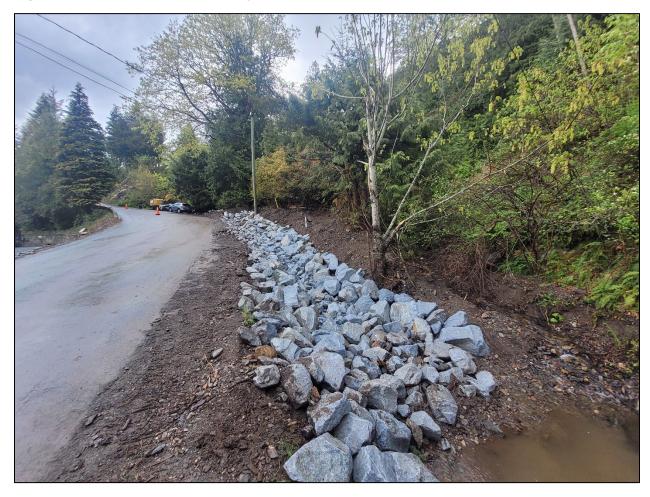
Figure 7 Short-term recovery works at site DF2 (April 26, 2022).

Downstream view of the Rockwell Drive culvert inlet where the roadside ditch and altered channel converge.

original altered stream channel and newly incised flood channel converge at the Rockwell Drive culvert inlet. Short-term recovery works in April 2022 included armouring the roadside ditch with riprap to prevent further erosion during spring freshet (Figure 7).

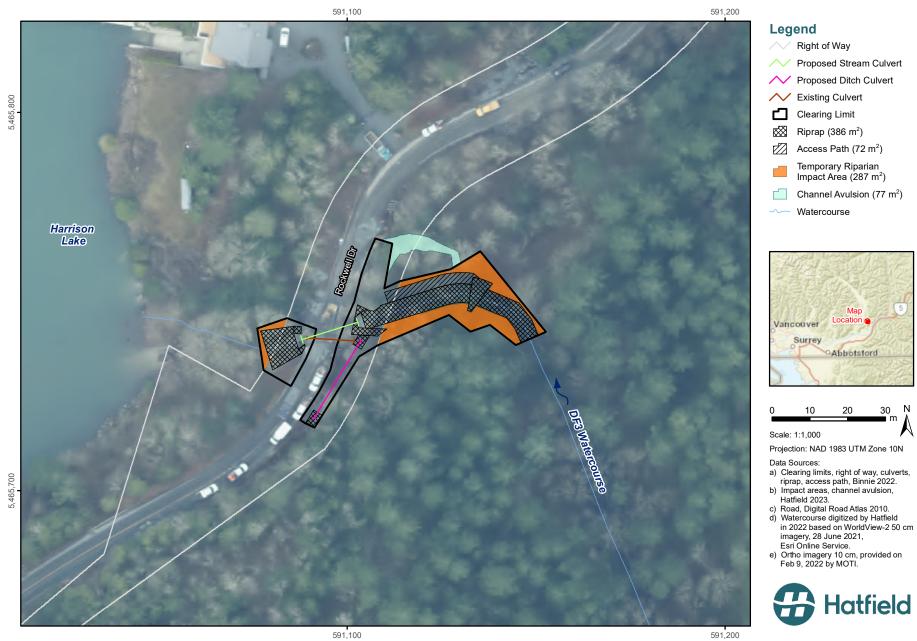
Figure 9 Assessment of impacts for site DF3, Rockwell Drive Recovery Project.

Approximately 287 m² of riparian habitat will be temporarily impacted during clearing and grubbing activities at site DF3 (Figure 9).

Emergency and short-term repair works associated with the November 2021 flood event have been conducted at all three sites pursuant to *Water Sustainability Act* (WSA) Section 91 Order 268448, and MOTI intends to develop permanent (long-term) solutions for each site. Emergency and short-term repair work conducted in 2021 and 2022 aligned with the Fisheries and Oceans Canada (DFO) code of practice for culvert maintenance, except for site DF2 where repairs included regrading and amouring a watercourse upstream of the Rockwell Drive culvert (DFO File 22-HPAC-00359). Permanent long-term repairs at all three sites include culvert replacements; however, instream channel erosion protection is also required upstream of the site DF3 crossing (refer to Figure 9 in Section 3.0).

The Project will provide a long-term net benefit to the surrounding aquatic and terrestrial environment at site DF3 through the installation of scour protection. This scour protection will prevent future erosion of the watercourse and riparian environment, as well as reduce sediment delivery to downstream fish habitat (i.e., Harrison Lake); however, approximately 386 m2 of aquatic habitat will be permanently modified as a result of the riprap scour protection and 72 m2 of riparian habitat will be lost as a result of a 3 m wide access path required for future maintenance (Figure 9).

The channel avulsion that occurred as a result of the 2021 flood event damaged approximately 77 m² of riparian habitat (Figure 9) which will be regraded to pre-flood conditions and revegetated per Section 4.1.1 below.
