Cutts Pit No. 1062 Technical Summary

December 2023

Pit Name: Cutts Pit

Provincial Pit Number: 1062

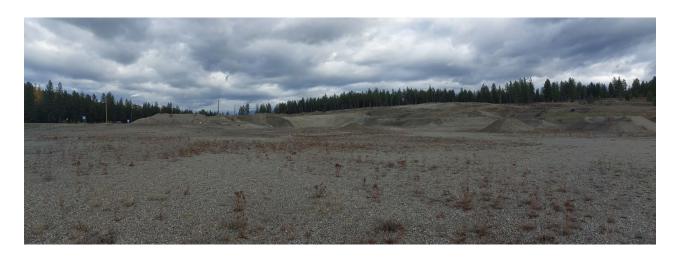
View of main pit area, facing north. Access road on left side of photo. November 2023.

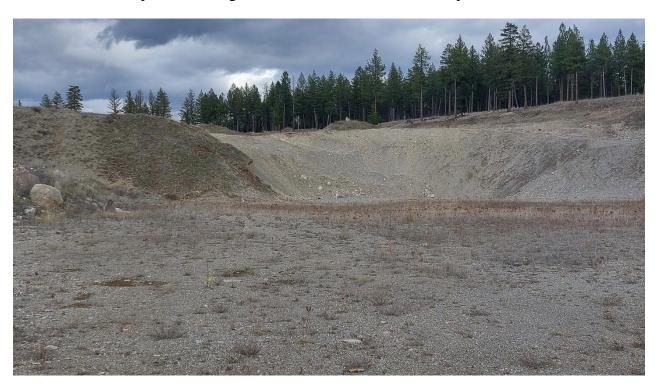
Main pit face, facing north. November 2023.
