HIGHWAY 1 – 264 STREET TO WHATCOM ROAD WAR#4 - BRADNER ROAD REST AREA IMPROVEMENTS GEOTECHNICAL REPORT FOR ISSUED FOR TENDER

At the request of Associated Engineering (B.C.) Ltd. (AE), Thurber Engineering Ltd. (Thurber) has conducted a geotechnical investigation for the above-mentioned project in Abbotsford, BC. This letter presents the results of the investigation and provides our recommendations. This report supersedes the version which was issued on October 21.

We understand that the British Columbia Ministry of Transportation and Infrastructure (MoTI) proposes to improve the Bradner Road Rest Area as part of the Fraser Valley Highway 1 Corridor Improvement Program. We have reviewed design drawings which comprise part of the Issued for Tender (IFT) package. The improvements will include an expansion of the parking area and construction of a multi-use path with the installation of the following features requiring geotechnical input:

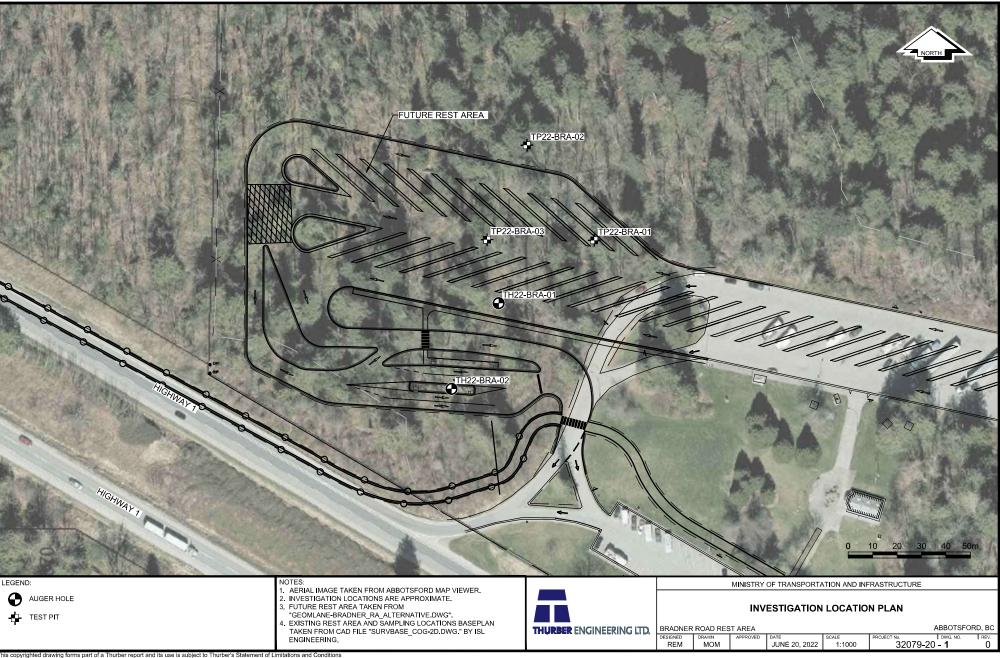
Ministry of							Hole #: TH22-BRA-0
	TISH	Transportation and Infrastructure	Project:				d Rest		e(s) Drilled: March 3, 2022
	IMBIA	and Infrastructure 32079	Location: A Datum: UT			C			npany: On-Track Drilling Inc. er: Andrew
Тера	Thurber E	ingineering Ltd.	Northing/Ea			563 7	76 541	C C	Make/Model: Track
Logged	d by: RM	Reviewed by:	Elevation:	oung. o			•,•		ing Method: Solid Stem Auger

(E)			Shear Strength (kPa) 300 400		TYPE	E NO	VERY (%) SYMBOL	SOIL	COMMENTS
DEPTH	DRILLING DETAILS	▲ SPT "N" (BL W _P % 20 - 40	OWS/300 mm) ▲ V% WL ● 60 80	%	SAMPLE TYPE	SAMPLE NO	RECOVERY (%) SOIL SYMBOL	SOIL DESCRIPTION	COMMENTS TESTING Drillers Estimate {G % S % F %}
0			68;9		R	1		OH - ORGANIC SILT, some sand, trace rootlets, dark brown, soft. 0.46m	
-1		20.5	«		R	2		CL - SILTY CLAY, some sand, grey-brown-orange, very stiff to hard.	Atterberg (Sa#2): PL:20% LL:31%

1.52m	Water level estimated at 0.0 m depth from VWP127422 read on March 31, 2022
-2		•			15	3		CL - SILTY CLAY, trace sand, trace gravel, grey-orange-brown, hard.	
		248			ע גו	4			
-3		2317			сц	-		- very stiff below 2.5 m depth CL	
4		229 1 ×			R	5		- stiff, occasional pockets of sand at 3.7 m depth	Atterberg (Sa#5): PL:20% LL:33%
5		× + + + + + + + + + + + + + + + + + + +			R	6		- blue-grey below 4.9 m depth	Atterberg (Sa#6): PL:18% LL:33%
6									
7		× 23,9			R	7		- very stiff below 6.7 m depth	
8					מ	9			
9		23.B			Ц	8		CL 0.11m	
·10								End of hole at required depth. Hole open to 5.8 m depth. Water observed at 2.7 m depth upon completion of test hole. Vibrating Wire Piezometer VW127422 installed at 6.8 m depth.

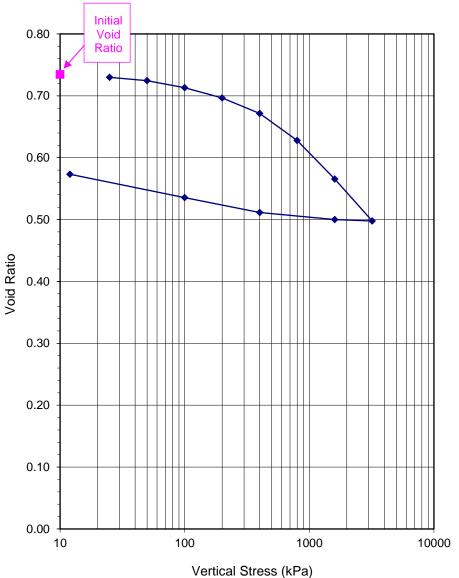
Void Ratio (end of load increment) Vs Log of Pressure

Client: MoTI Project: Highway 1 - FVCIP File No.: 32079 TH22-BRA-02 @ 5' - 7' Report Date: June 30, 2022 Test Dates: June 10-27, 2022

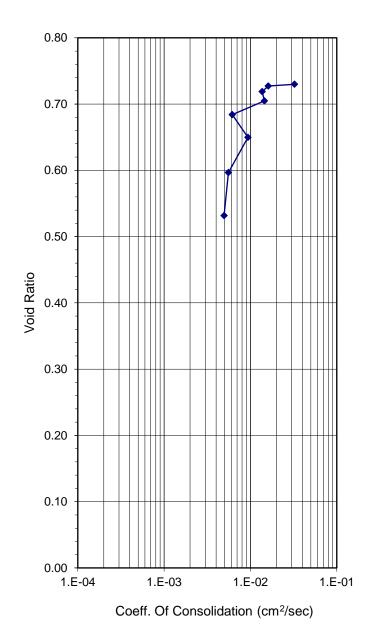
One-Dimensional Consolidation Test Report Co 22-2 Summary of Test Data

Client: MoTI Project: Highway 1 - FVCIP File No.: 32079 TH22-BRA-02 @ 5' - 7' Report Date: June 30, 2022 Test Dates: June 10-27, 2022

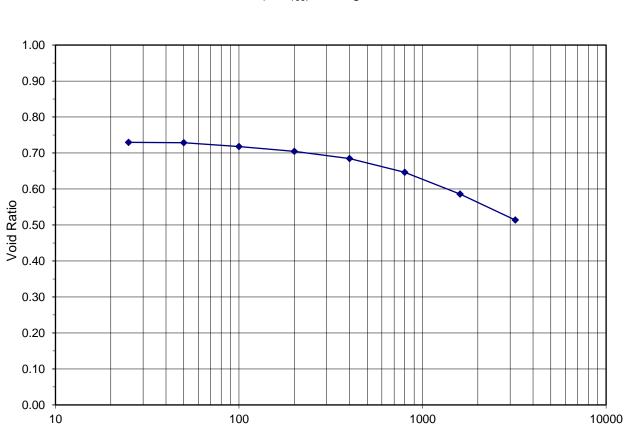
Void Ratio (@T₁₀₀) Vs Log of Pressure

Client: MoTI Project: Highway 1 - FVCIP File No.: 32079 TH22-BRA-02 @ 5' - 7' Report Date: June 30, 2022 Test Dates: June 10-27, 2022

Vertical Stress (kPa)
