TEAPOT HILL EAST CULVERT REPLACEMENT

Reference: Supplemental Project Information Report to Support the Teapot Hill East Culvert Replacement Request for Review, Cultus Lake, BC

ISL Engineering and Land Services Ltd. (ISL) has prepared a design for a culvert replacement on Columbia Valley Road, east of Teapot Hill. The design includes replacement of the existing corrugated steel pipe (CSP) crossing with a pre-cast concrete box culvert, and channel armoring to provide increased erosion protection and protection of the infrastructure during future storm events.

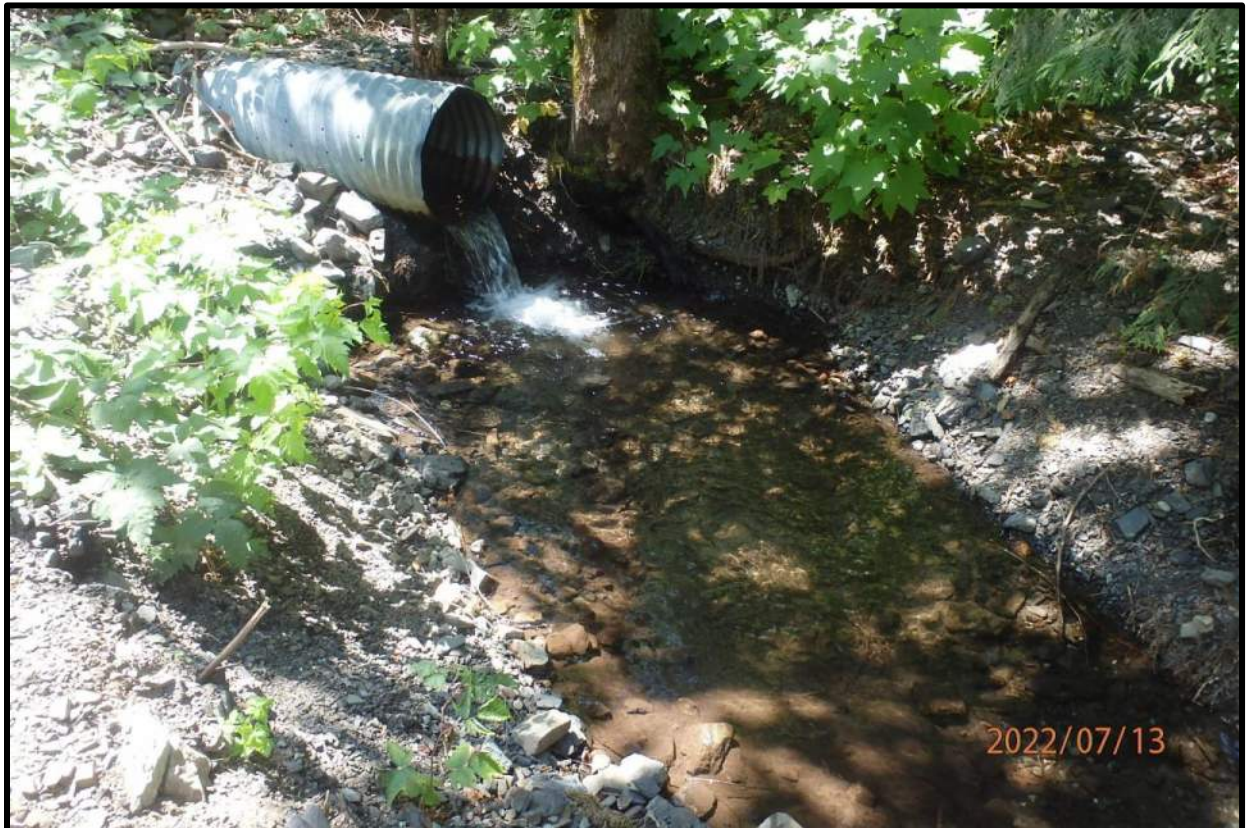
The Teapot Hill east culvert is located on a < 1.5 m wide stream which flows into Cultus Lake. There is potential fish access to the outlet of this culvert from Cultus Lake, however, the culvert itself is elevated above the outlet and the plunge pool lacks depth to facilitate upstream fish passage (**Figure 3**).

Figure 3. Culvert outlet is elevated at Teapot Hill east culvert.

The Teapot Hill east culvert is located on a < 1.5 m wide stream which flows into Cultus Lake. There is potential fish access to the outlet of this culvert from Cultus Lake, however, the culvert itself is elevated above the outlet and the plunge pool lacks depth to facilitate upstream fish passage (Figure 3).

The stream was wetted throughout multi-season assessments in April, July, and January. Substrate consisted of road fill with trace cobble which is highly embedded from sediment deposition. No fish were observed.

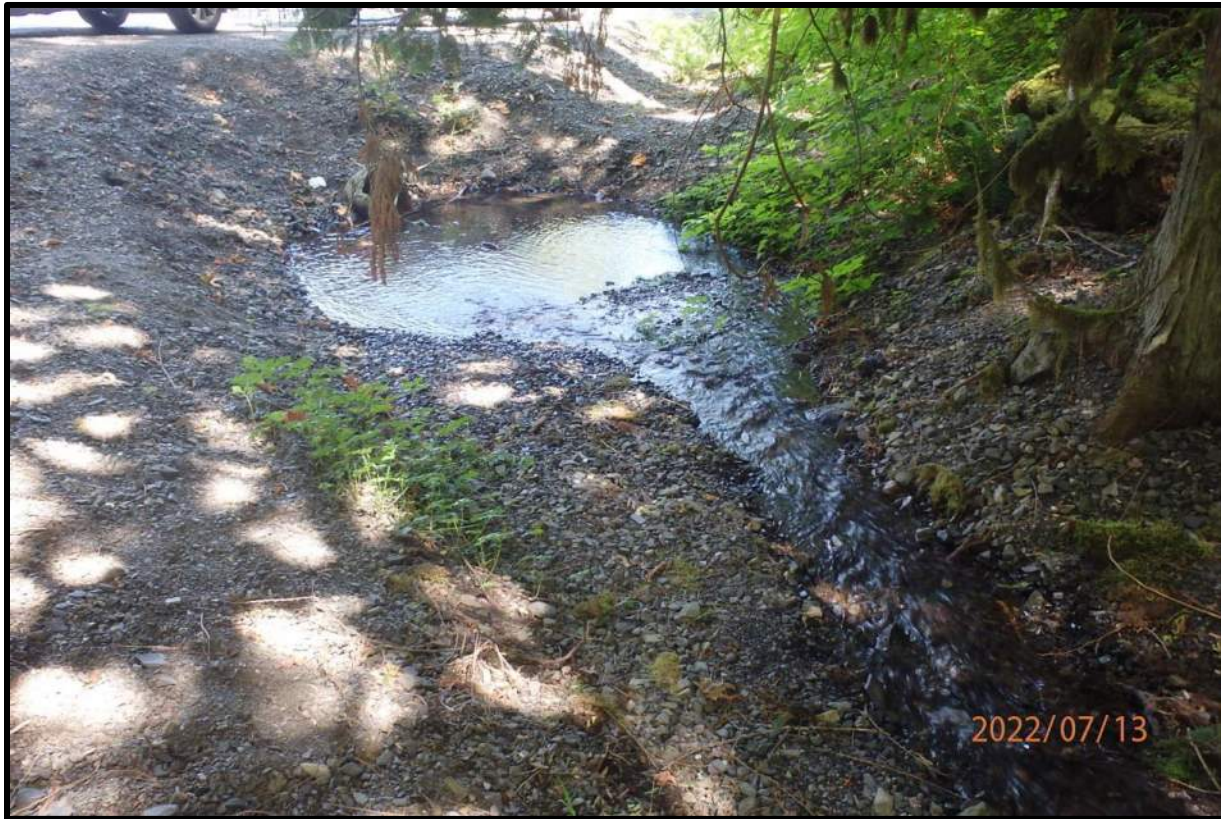
Upstream of the culvert, there is low gradient sub-reach (**Figure 4**) that extends for approximately 30 m, at which time the stream bifurcates, and both of these braided channels have gradients of a sustained +25% up Teapot Hill. There is no potential for resident fish habitat on slopes of this kind, in small stream channels of this size.

Figure 4. Low-gradient stream channel at the inlet to Teapot Hill east culvert, upstream of Columbia Valley Road.

Upstream of the culvert, there is low gradient sub-reach (Figure 4) that extends for approximately 30 m, at which time the stream bifurcates, and both of these braided channels have gradients of a sustained +25% up Teapot Hill. There is no potential for resident fish

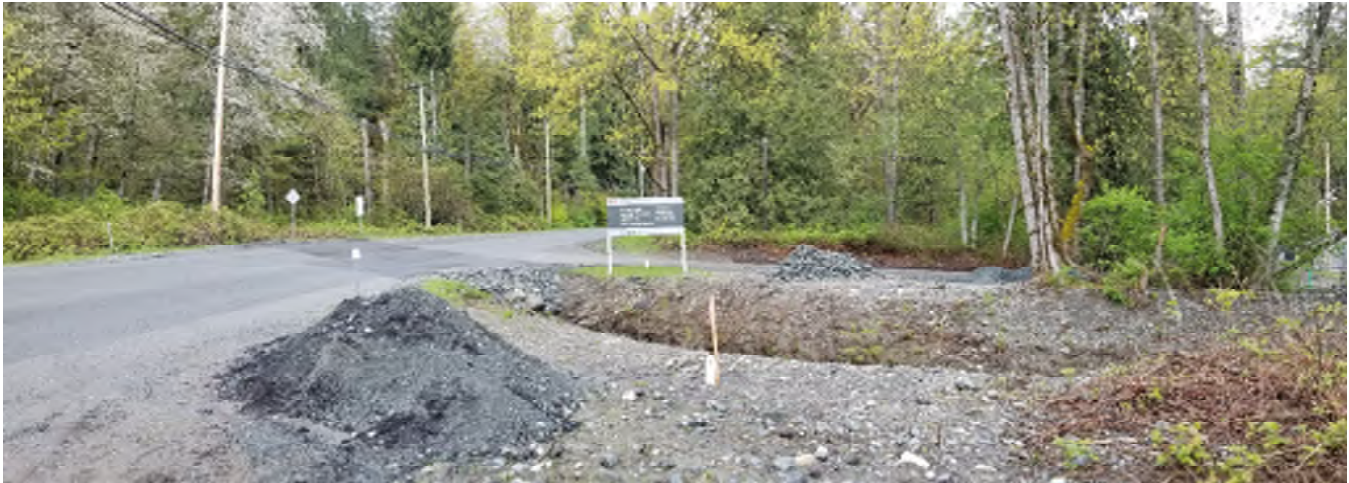
5.1 Site 1 – Hatchery Creek (Sweltzer Creek Tributary) at Lakeshore Drive

Site 1 is located on Hatchery Creek below Lakeshore Drive with emergent fish present during investigation. The assessed section is a low gradient reach that flows into Sweltzer Creek with no permanent barriers observed downstream. The culvert bottom has collapsed on itself and is currently operating at reduced capacity. Flows were moderate and water was clear, however substrate was packed with fine silts and organic composite indicative of recent disturbance.

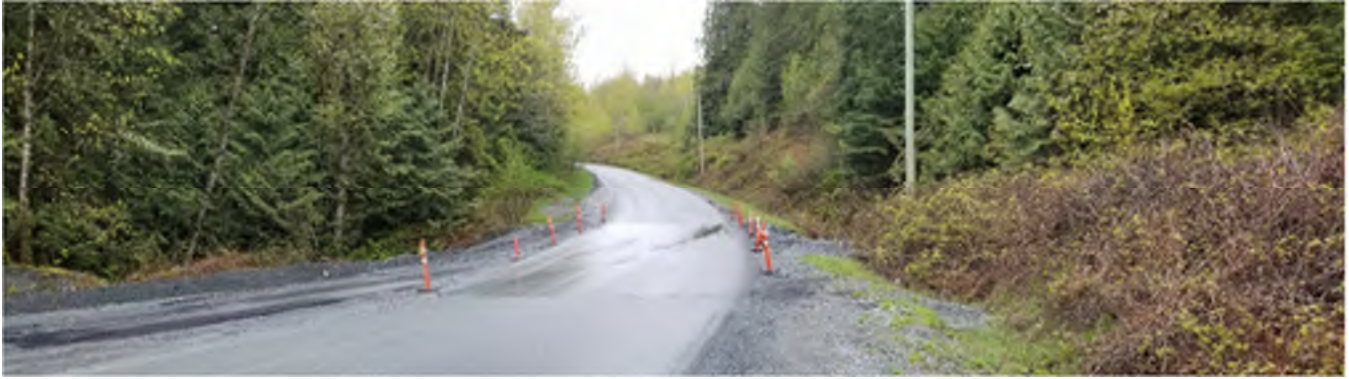
5.2 Site 2 – Sweltzer Tributary at Parmenter Road

Site 2 is located on Hatchery Creek at Parmenter Road. The crossing has been replaced with a temporary CSP, which would appear undersized for Q200 discharge. Both the temporary and existing culvert are well elevated above the channel bed. The site would appear to have been the location of a natural cascade, which would have been a barrier to anadromous fish access. The potential for upstream resident fish presence needs to be investigated. Invasive *Lamium* sp. was observed in the forest immediately adjacent to the temporary crossing.

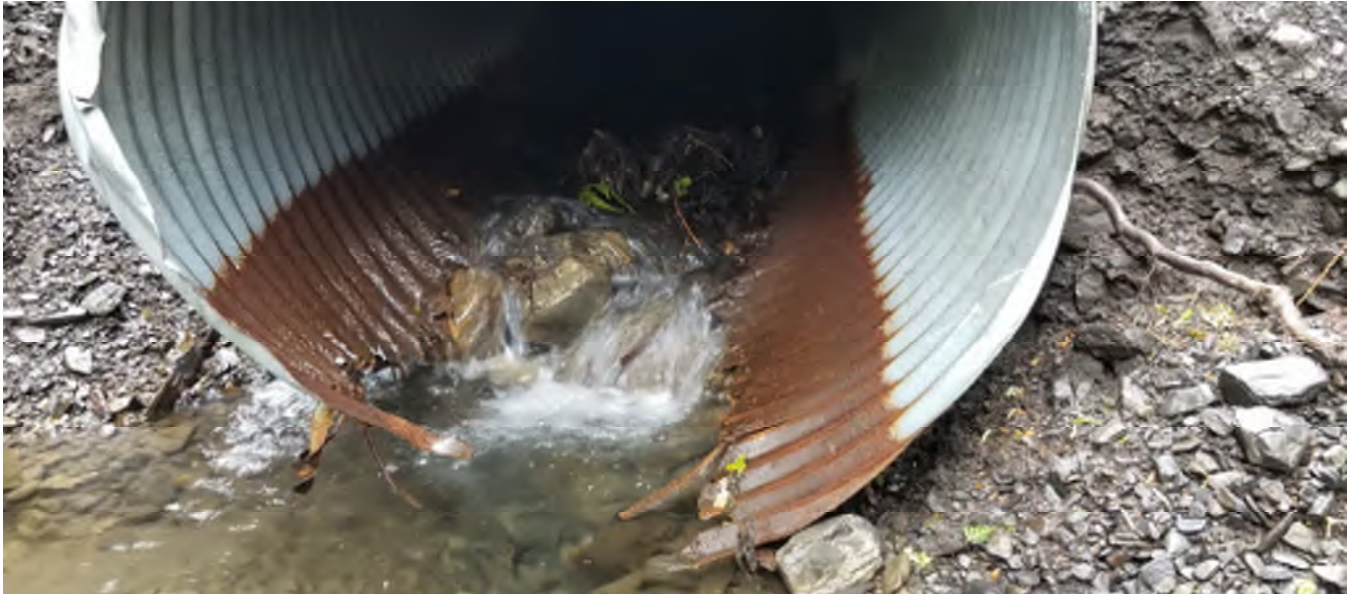
5.3 Site 3 – Hwy Culvert adjacent to Delta Grove Campground

Site 3 is a moderately sized (3 m wide) seasonal to ephemeral stream that flows into Sxótsaqel (Cultus Lake) through the Deltagrove Campground. The stream was entering its seasonal dry period in April, with reaches downstream of the Columbia Highway exhibiting only intermittent discharge. Upstream from the lake 60 m the stream channel was entirely dry. The potential for this stream to support fish or species at risk is very limited because of the lack of scour at the beach combined with what appears to be extended dry periods (May through to October).

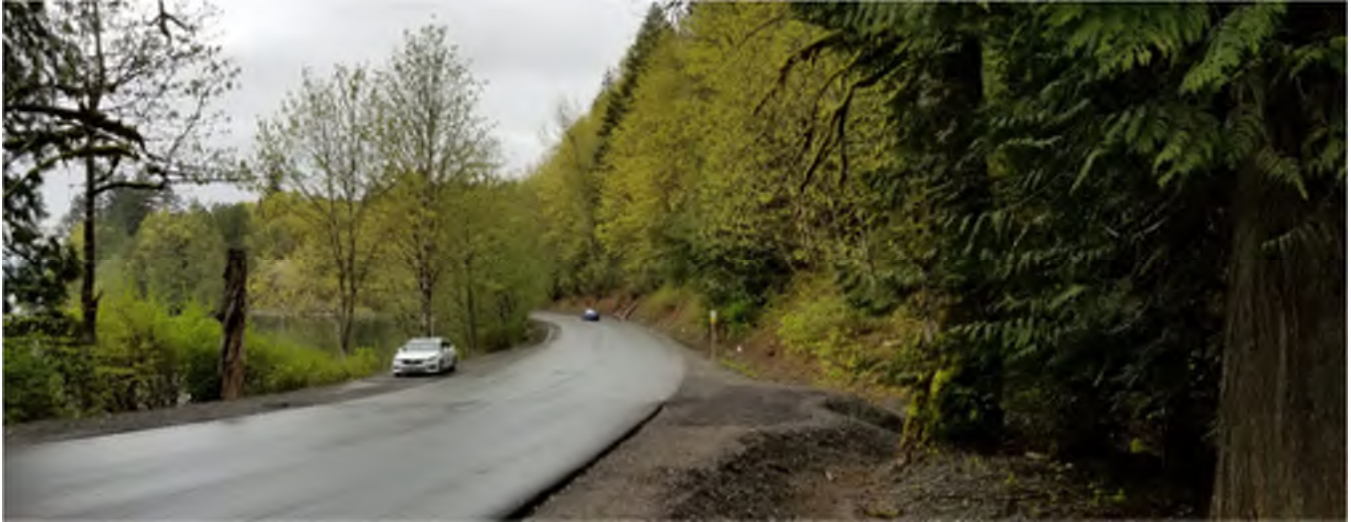
5.4 Site 4 – Culvert at Teapot Hill Parking Area

Site 4 is a small <1.5 m wide stream that flows into Sxótsaqel (Cultus Lake). The highway culvert is elevated above the outlet stream and the plunge pool is insufficient in this small stream to facilitate upstream fish passage. Upstream of the highway there is only a short (<20 m long) section of low gradient stream channel. Upstream of this point the stream bifurcates and these two <0.75 m wide channels are on slopes well in excess of 20%.

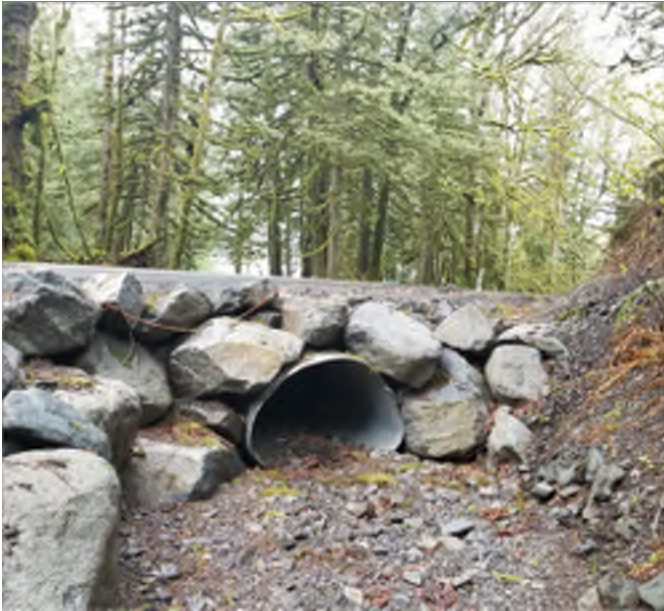
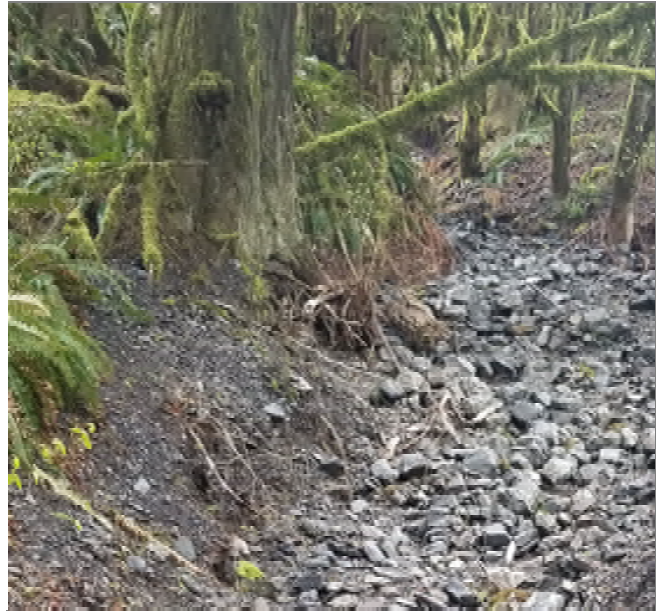
5.5 Site 5 – Culvert at Teapot Hill/Honeymoon Bay Campground

Site 5 is a moderately sized channel that was completely dry during investigation. This ephemerally wetted channel may be an avulsion of another stream channel (wetted at the time of assessment) that is approximately 200 m south of this location. This avulsion channel likely only forms a connection to Sxótsaqel (Cultus Lake) during rare peak flow events, providing no potential use for fish at the elevation of the highway.

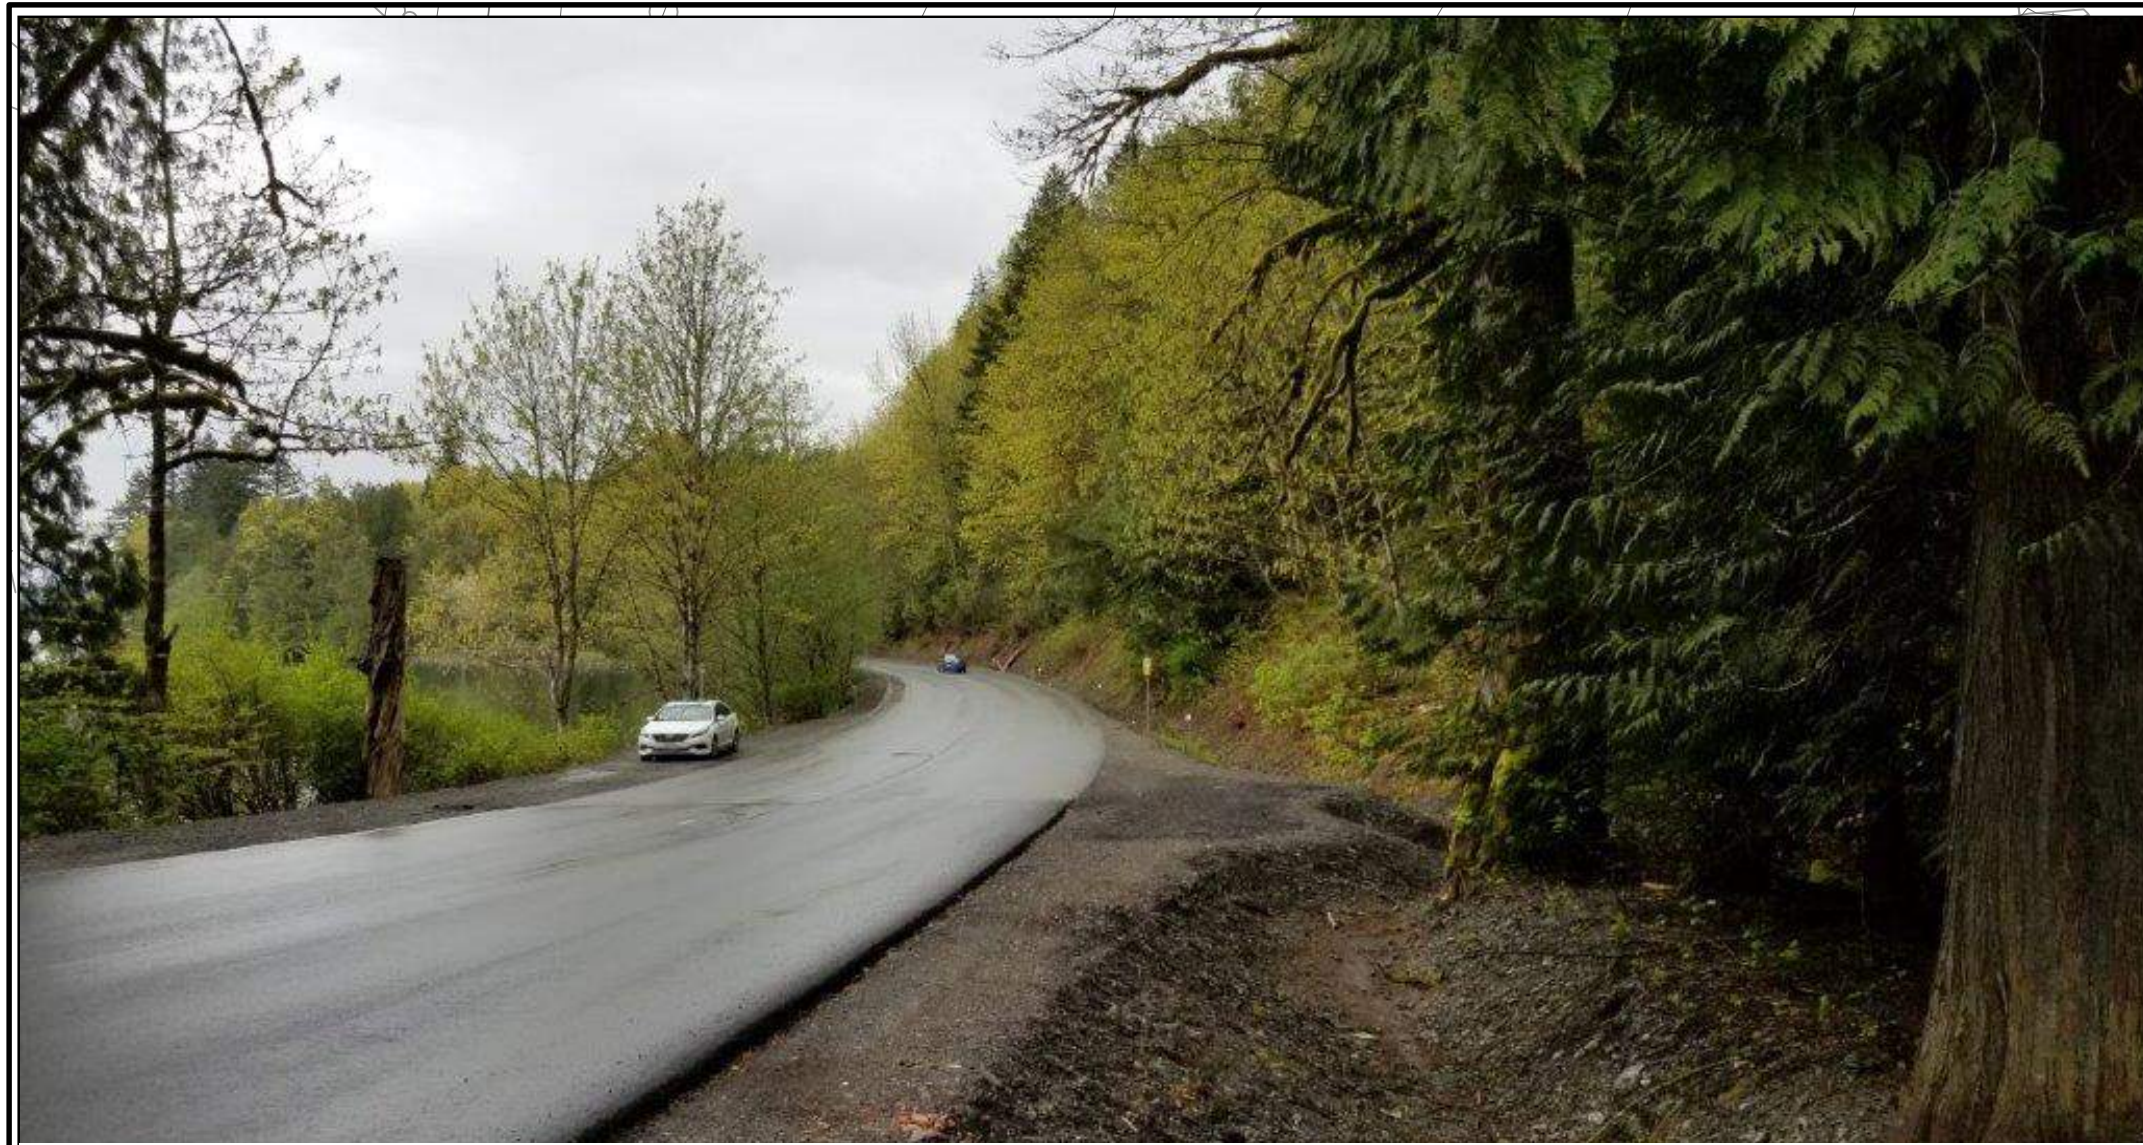
PHOTOGRAPH 4. VIEW FROM ROAD. NOTE THE INLET ON THE RIGHT AND OUTLET ON THE LEFT OF THE ROAD.

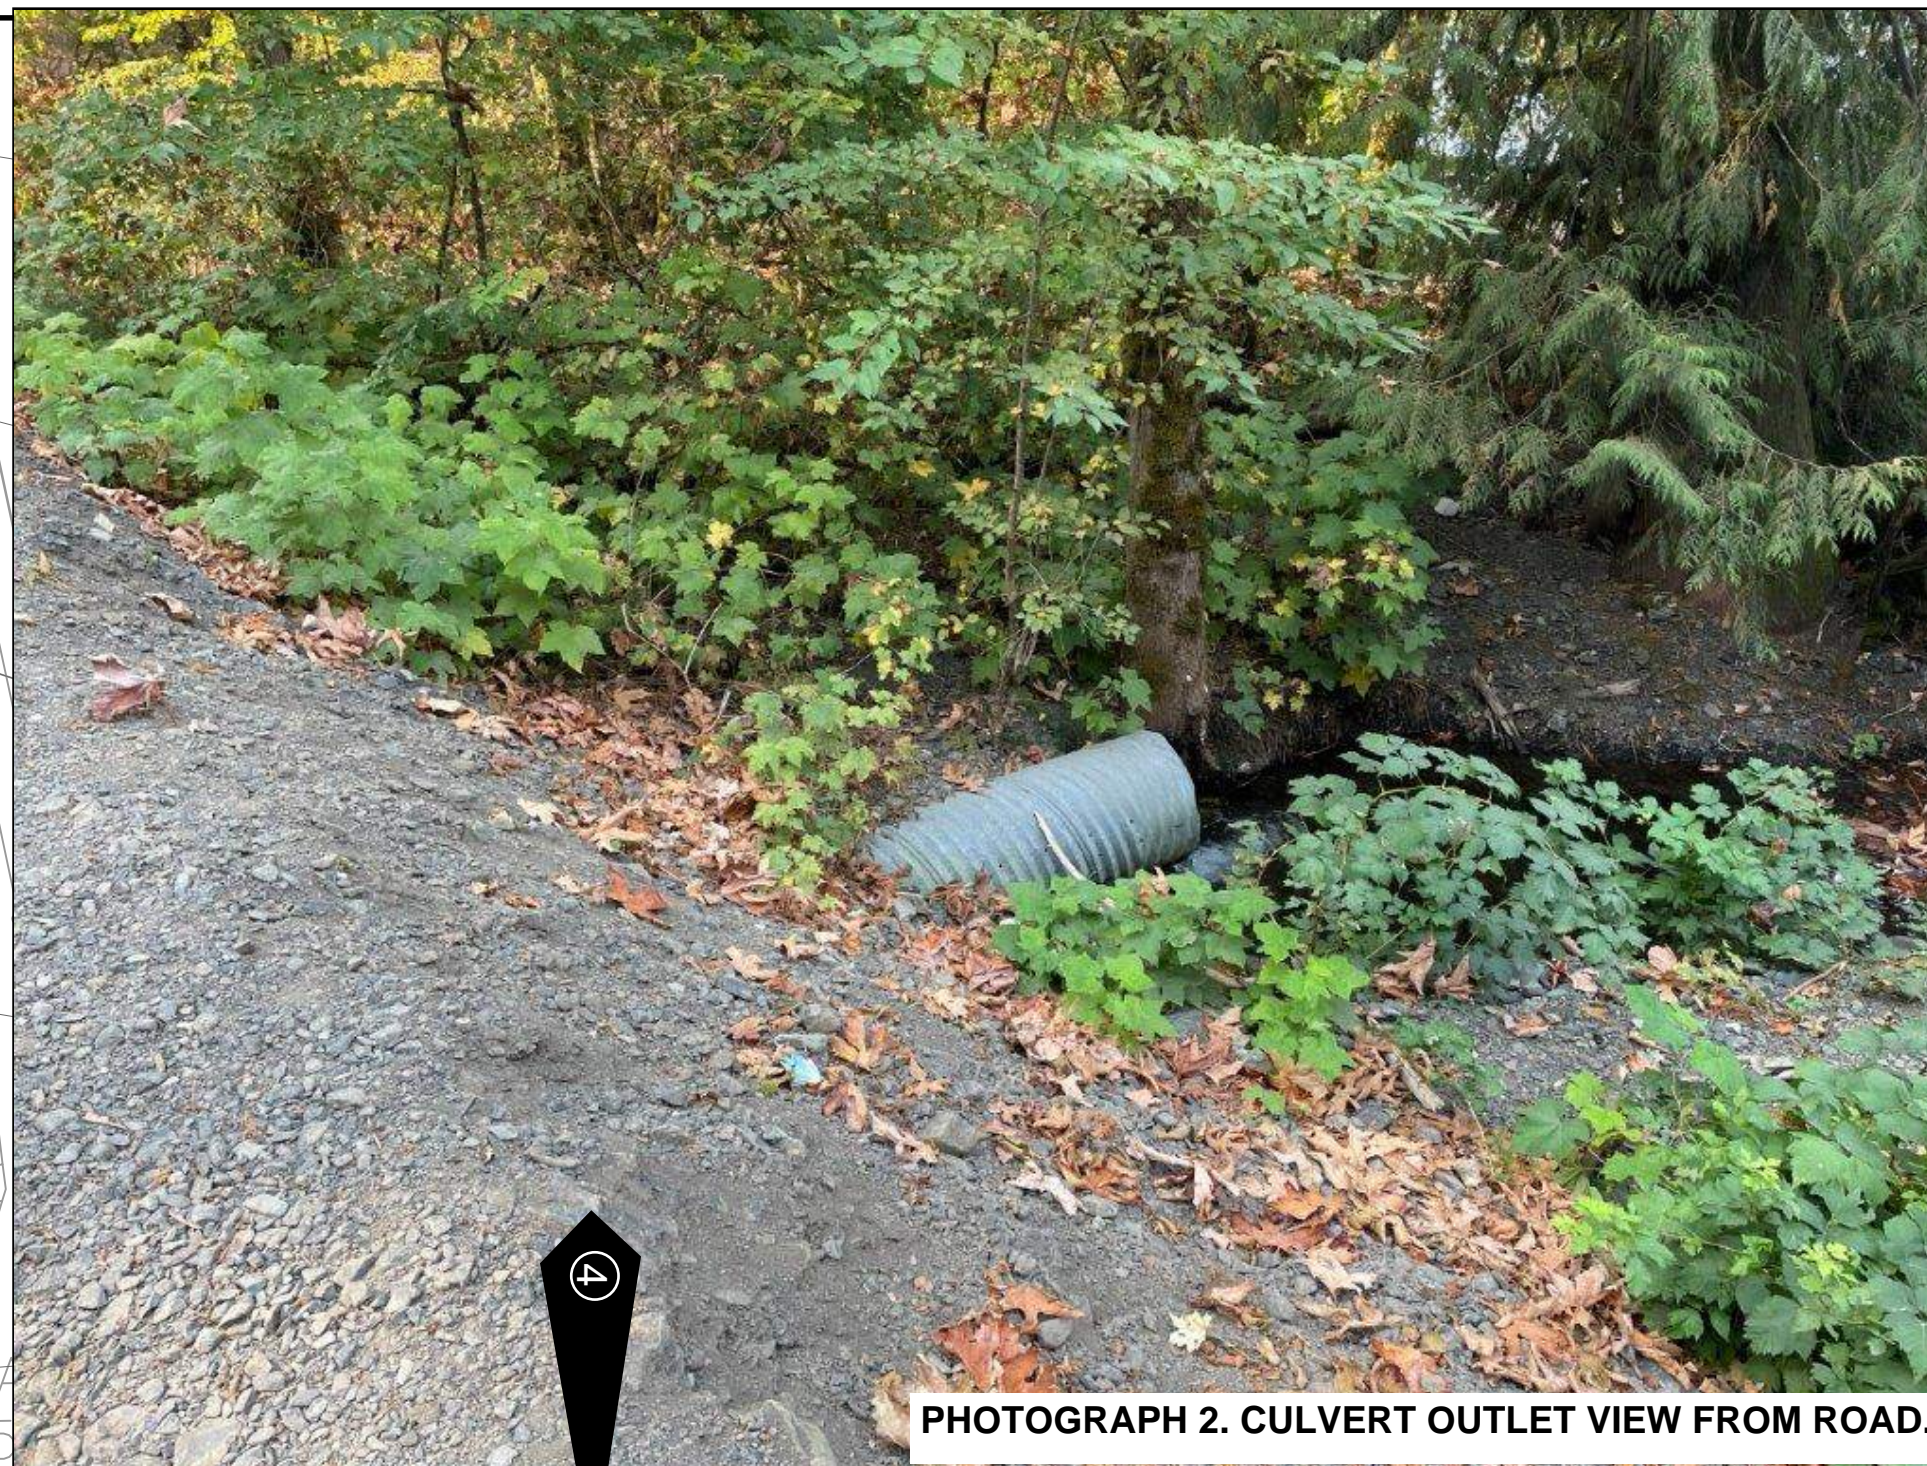
PHOTOGRAPH 2. CULVERT OUTLET VIEW FROM ROAD.

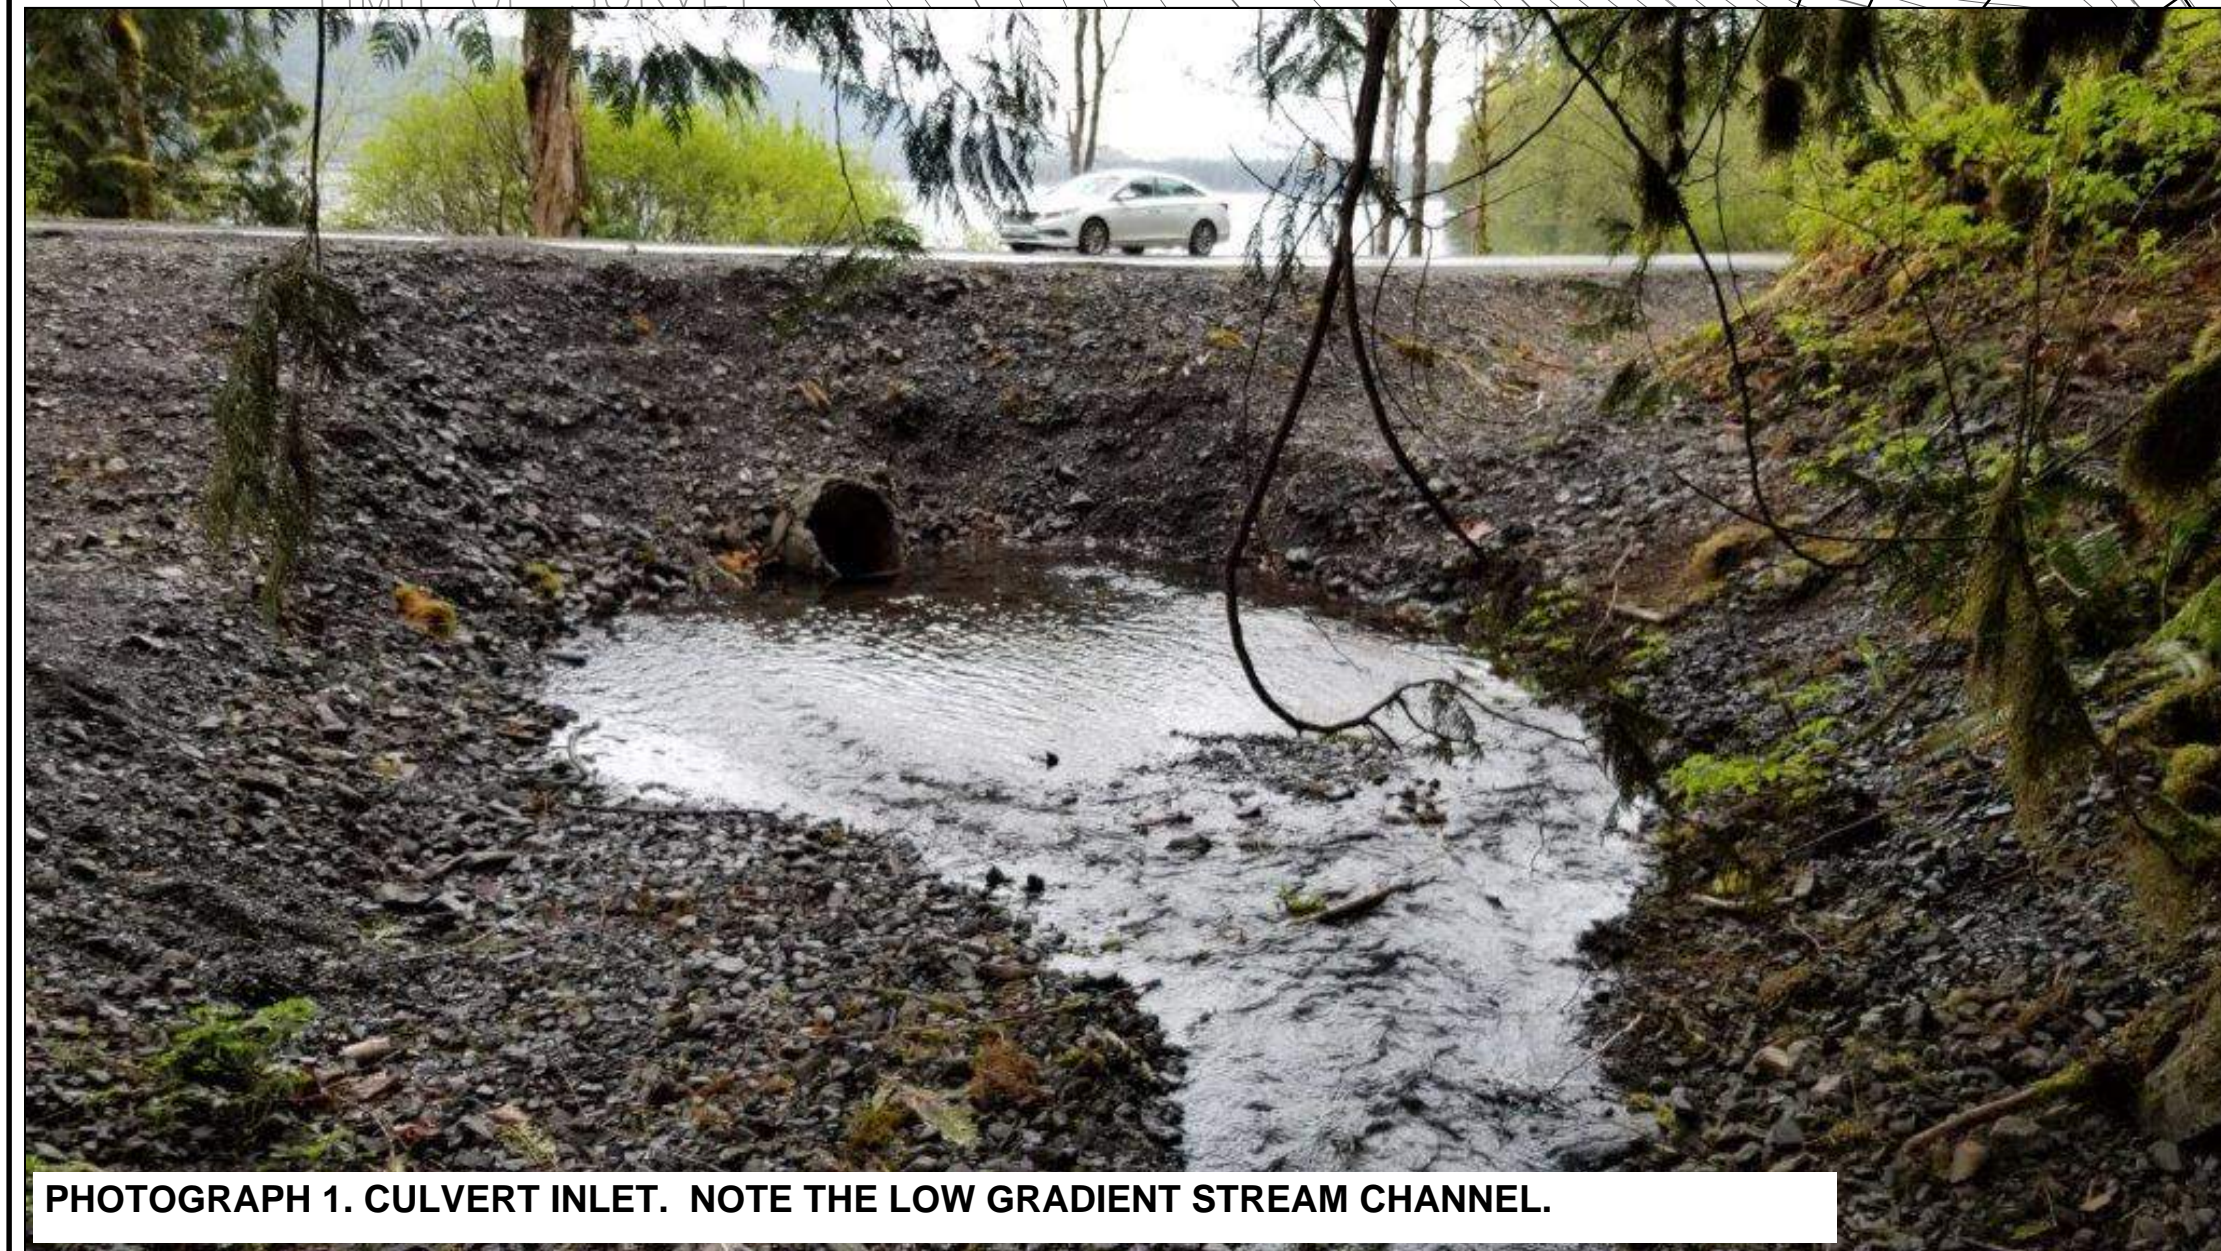
PHOTOGRAPH 1. CULVERT INLET. NOTE THE LOW GRADIENT STREAM CHANNEL.
