**KICKING HORSE RIVER DIKE IMPROVEMENT PROJECT
HYDROTECHNICAL DESIGN REPORT
TOWN OF GOLDEN, BRITISH COLUMBIA**

Report Prepared for:
THE TOWN OF GOLDEN

Prepared by:
MATRIX SOLUTIONS INC.

Version 1.0
October 2018
Calgary, Alberta

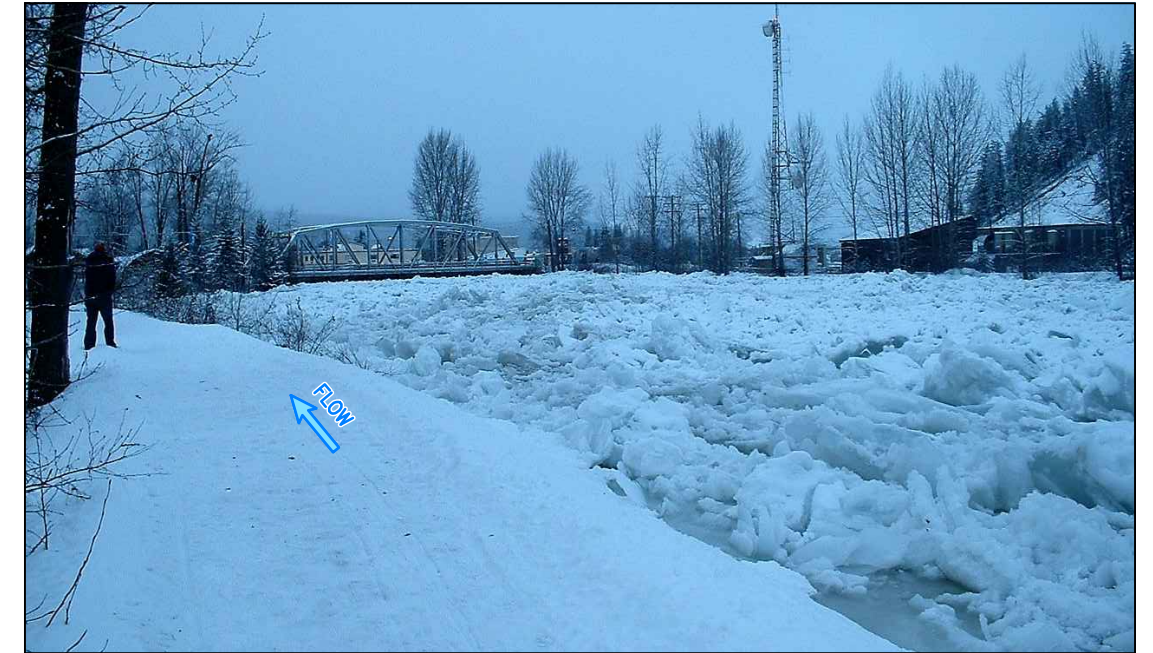
JAM OF RECORD (2005)

LOOKING DOWNSTREAM AT HIGHWAY 95 BRIDGE. PHOTO TAKEN JANUARY 7, 2005 BY PAUL DOYLE.

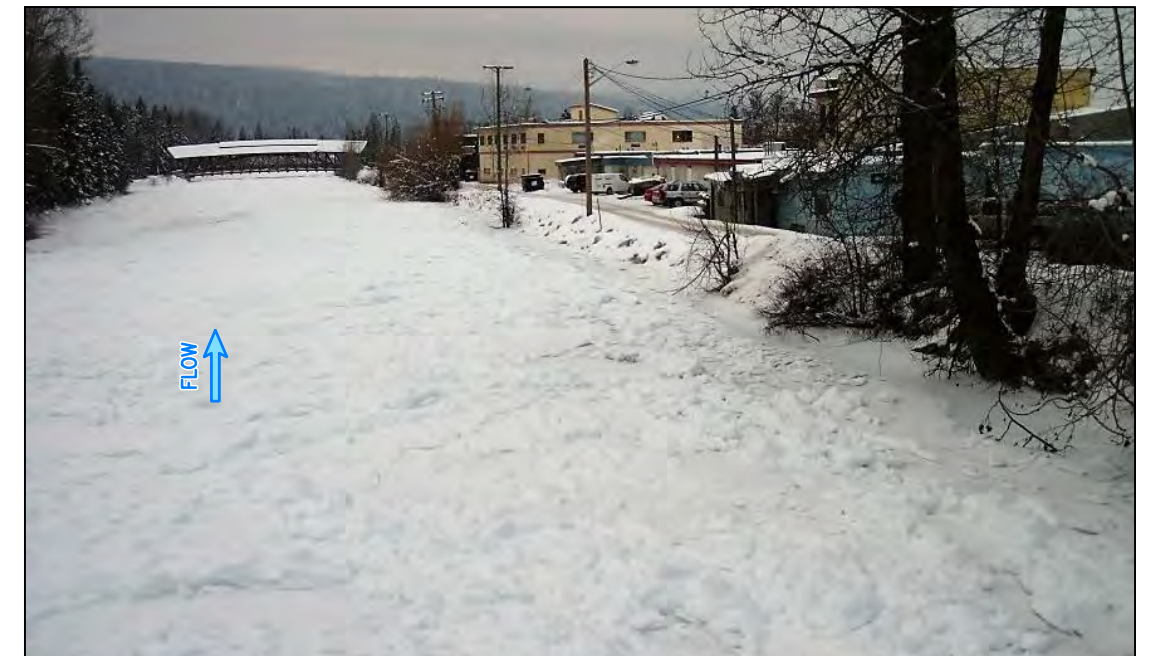
2015 ICE JAM

LOOKING DOWNSTREAM AT PEDESTRIAN BRIDGE FROM HIGHWAY 95 BRIDGE. PHOTO TAKEN DECEMBER 1, 2015 BY DWAIN BOYER.
