BC Dam Safety Pocketbook

A QUICK REFERENCE GUIDE

Introduction

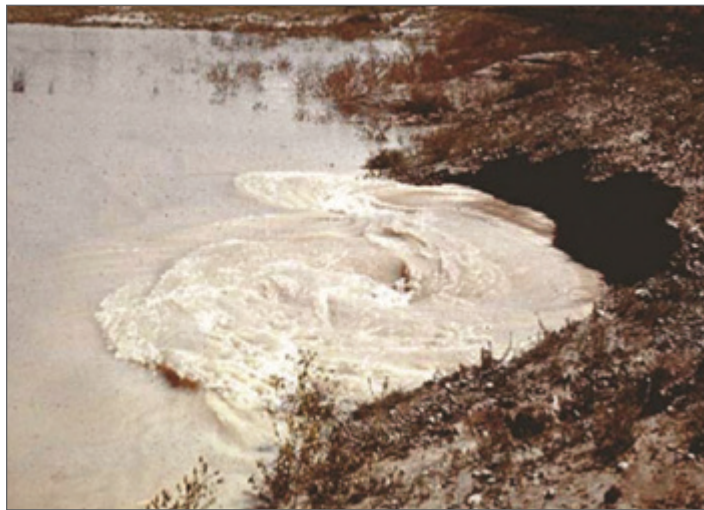
Whirlpools Indicate Advanced Piping Issue

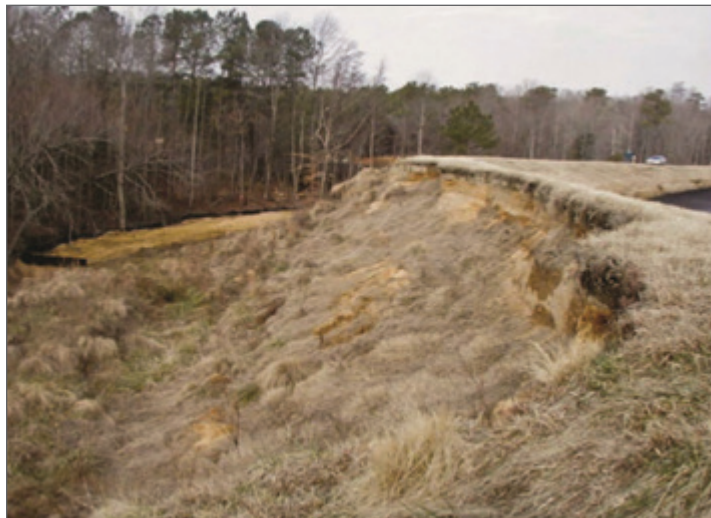
Slumping on the Downstream Face

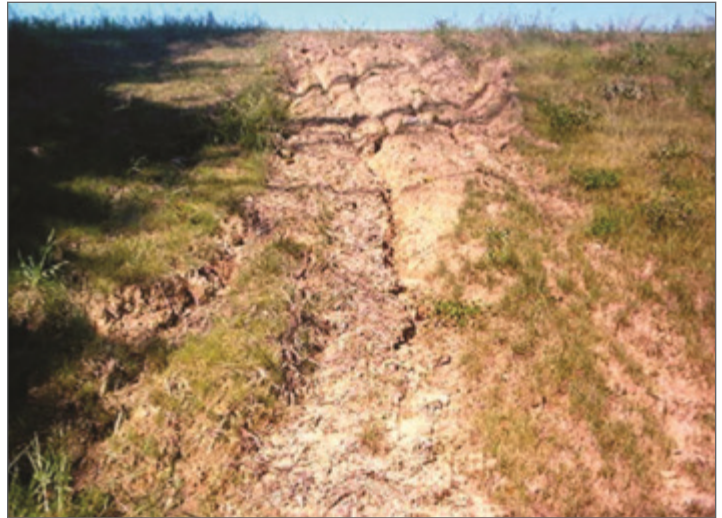
Erosion on the Downstream Face of the Dam

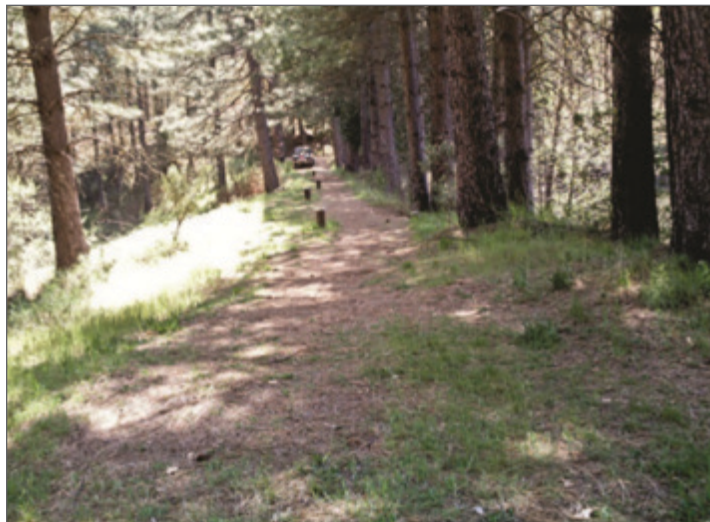
Trees Growing on the Crest and Faces of the Dam

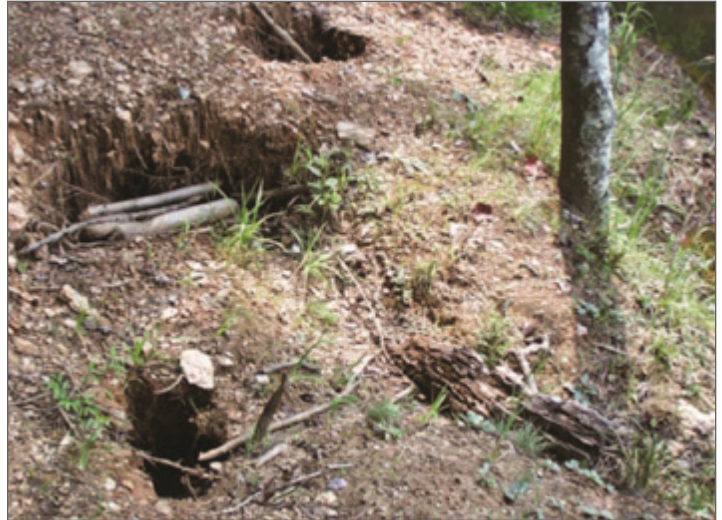
Rodent Holes on the Face of the Dam

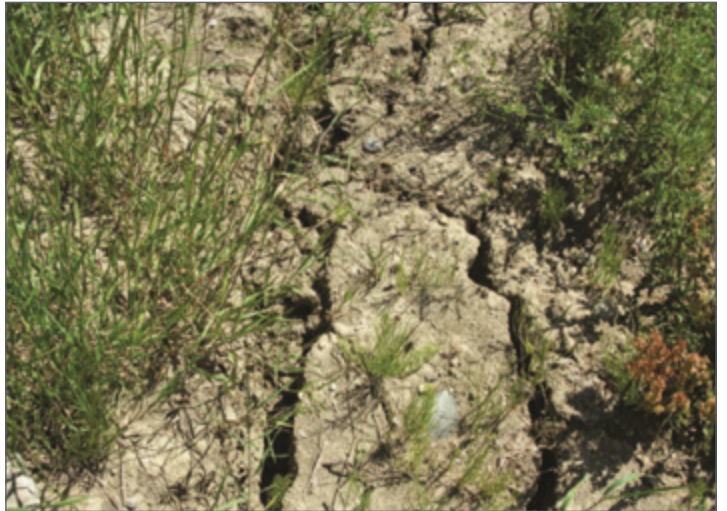
Transverse Cracks Indicate Dam Instability

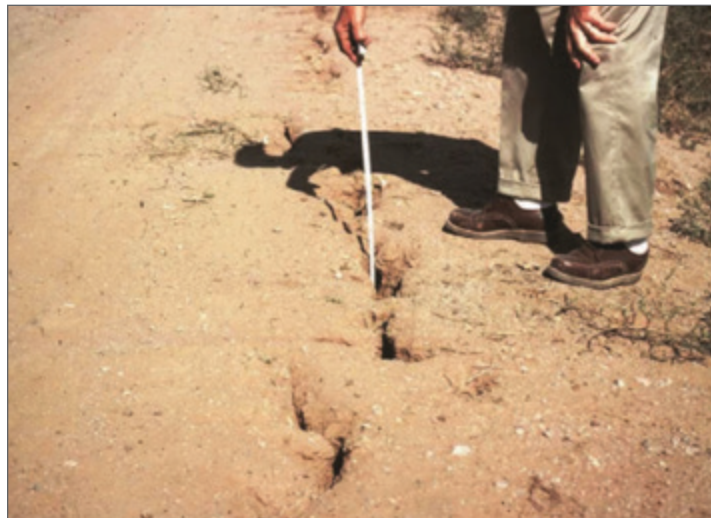
Longitudinal Cracks Indicate Dam Instability

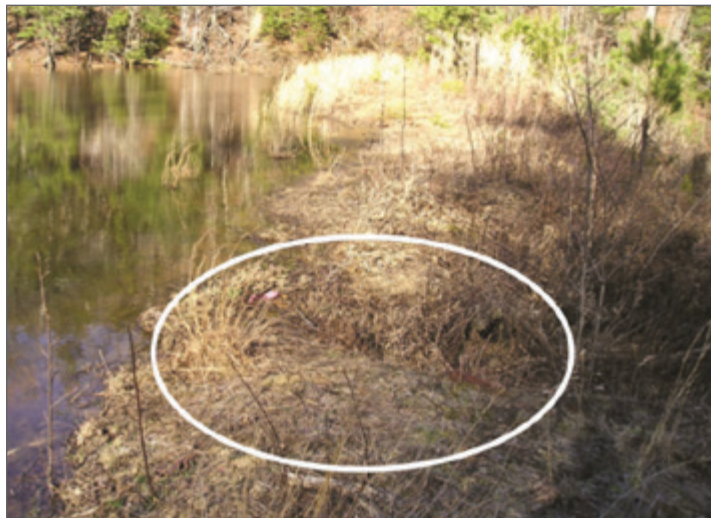
Low Areas in Crest Will Reduce Freeboard

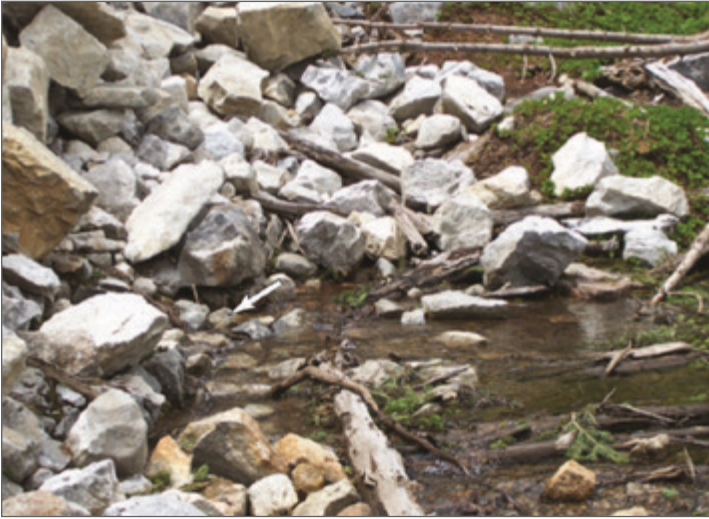
Water Piping Through Toe of Embankment

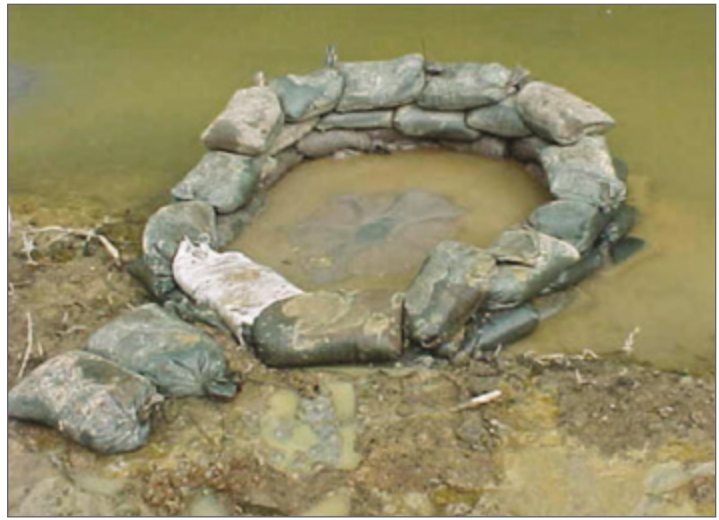
Sandbags Surrounding a Boil on Downstream

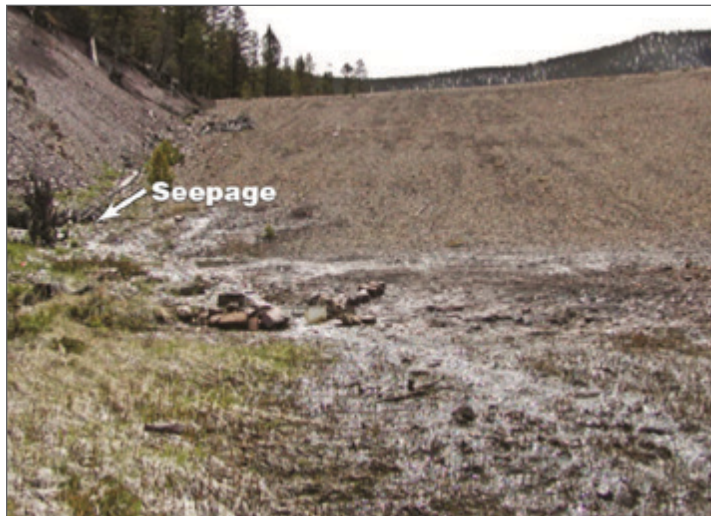
Abutment Seepage May Lead to a Dam Failure

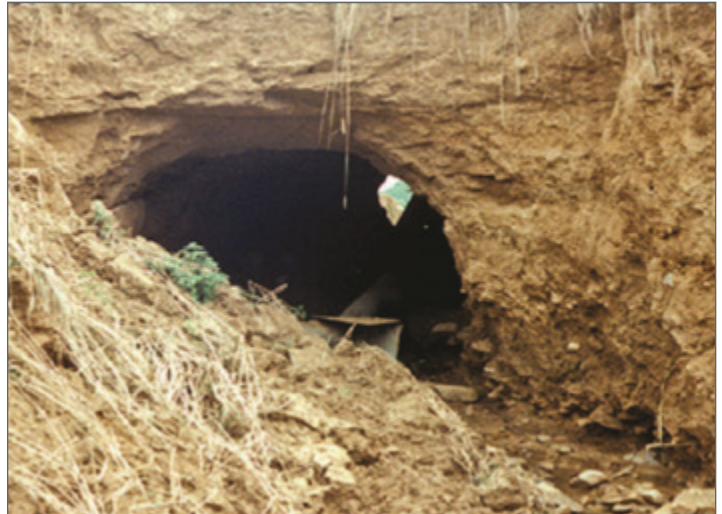
Piping of Water Alongside an Outlet Pipe

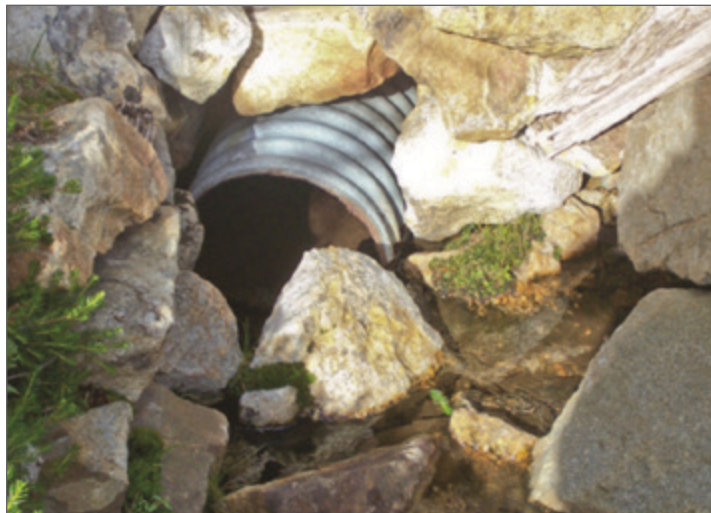
Rock Failure Around an Outlet Pipe

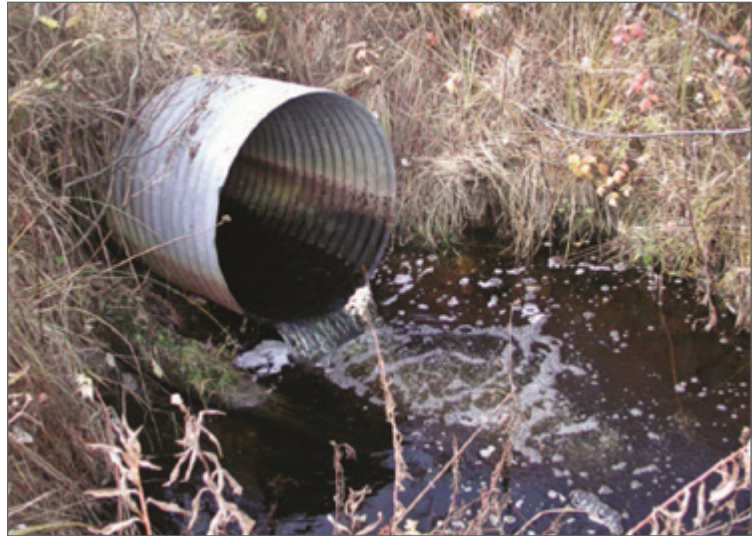
A Scour Hole at an Outlet Erodes Toe of Slope.

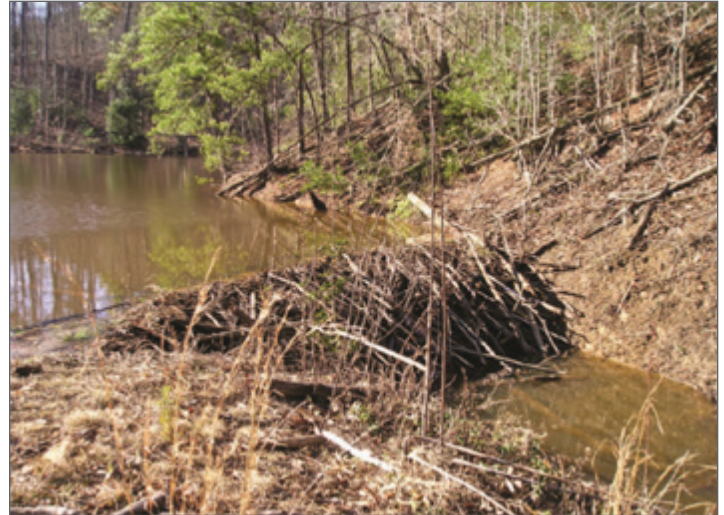
Blocked Spillway Channel of a Dam

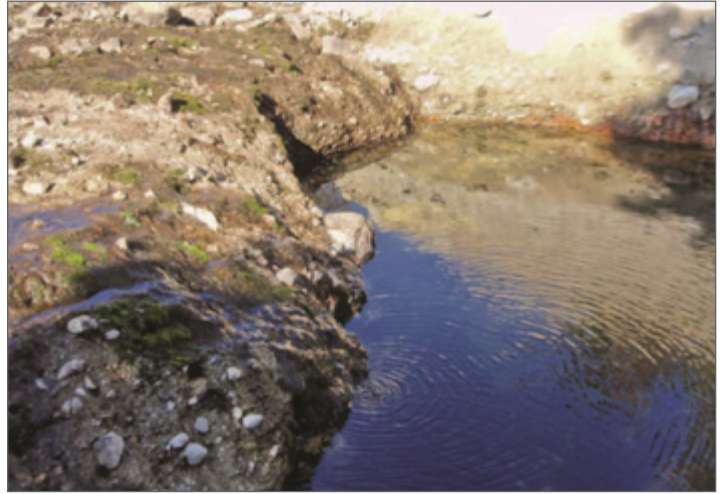
Erosion of Spillway May Lead to Slumps/Slides
