Installation of a structural-plate corrugated-steel round culvert along a fish-bearing stream in Alberta

The Forest Engineering Research Institute of Canada (FERIC) monitored and documented the installation of a culvert along a fish-bearing stream in Alberta. Detailed installation procedures and cost information are presented, as well as suggestions for implementation of future culvert projects.

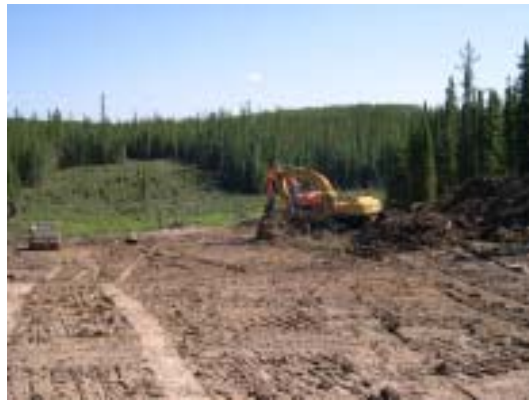
Figure 1. View of the wetland depression and right-of-way clearing on far side of crossing.

Piche Road was built during the summer and fall of 2004 and leads into the eastern portion of Alberta-Pacific's FMA area. The road location was planned and preliminarily mapped in advance of ground-truthing and lay-out in the field. The road was built to a Class 3 standard: a permanent road for use up to 20 years, built with an 8-m-wide running surface, with a cleared right-of-way from 25 to 30 m (Alberta-Pacific 2003). Large amounts of fill were required to accommodate the vertical alignment of the road through the depression at the water crossing (Figure 1).

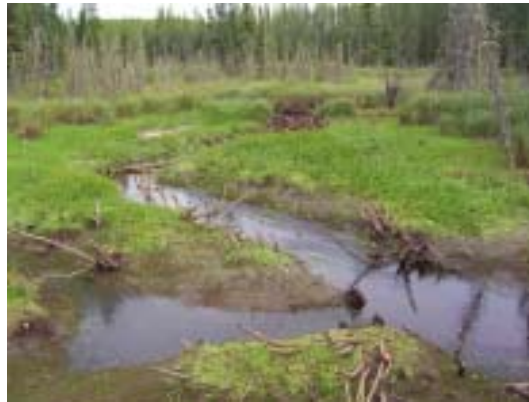
Figure 2. Upstream of the crossing showing meandering channel through grassy wetland (photo courtesy of Alberta-Pacific).

and dead or dying spruce trees (Figure 2). The distinct division between the grasses and taller sedges indicated a 3- to 5-year flood event boundary.

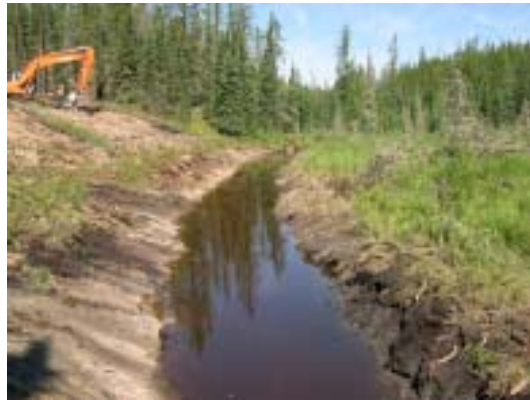
Figure 3. Looking downstream along the open diversion trench (before the decision was made to use round culverts).

At the beginning of the construction, the excavator prepared a diversion trench on the camp side of the stream crossing through the edge of the wetland area (Figure 3), connecting the downstream end to a backwater/meander of the stream. The upstream side of the trench was not connected to the main stream at this time. The diversion trench had filled with water due to the high water table and seepage associated with the wetland area. Two fences made of geotextile were constructed downstream to slow water movement and promote the settling of fines (Figure 4). The excavation was to be used as a gravity-fed open-trench bypass for the stream.

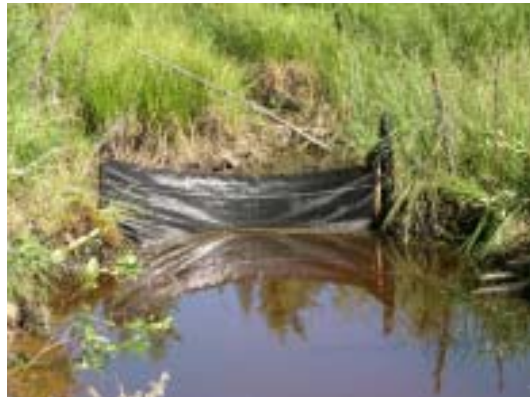
Figure 4. Fence made of geotextile near the outlet of diversion trench.

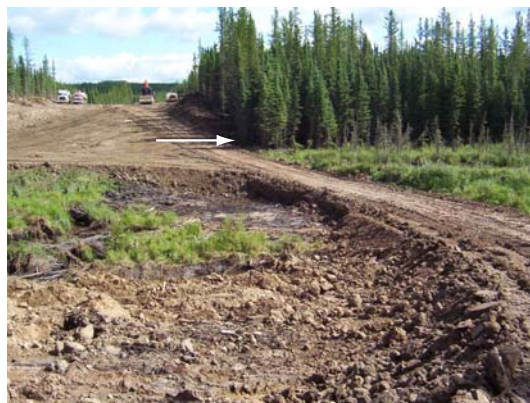
Figure 5. Tote road which allowed equipment to pass the culvert installation site. Arrow shows the abrupt and distinct boundary between the wetland area and forested area (photo courtesy of Alberta-Pacific).

A tote road was built so machinery could pass and continue roadbuilding past the crossing (Figure 5), and to give heavy equipment access to both sides of the culvert during installation.

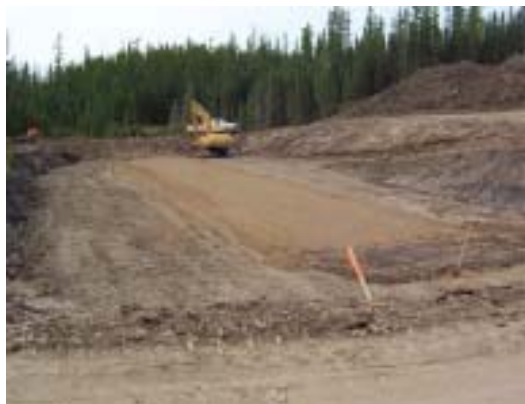
Figure 6. Vibrating-drum pad-foot roller used for compaction during various stages of construction.

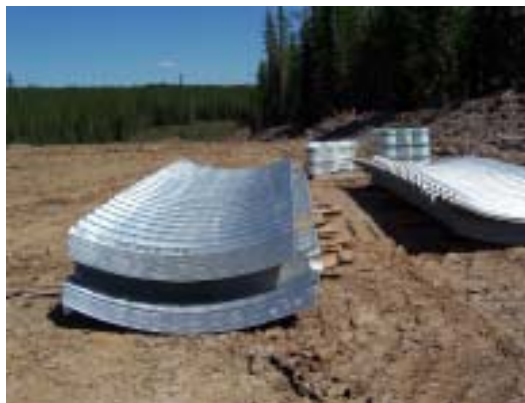
Figure 7. Sandy bedding prepared to a level surface (photo courtesy of Alberta-Pacific).

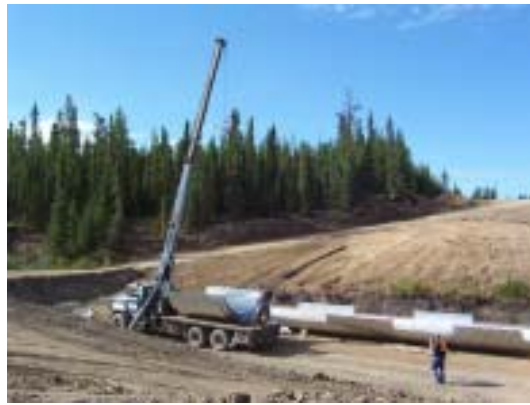
Figure 9. Truck with extended crane to lift pre-assembled sections into place during construction. Note the sections on the back of the truck (photo courtesy of Alberta-Pacific).

The erecting crew for the culvert consisted of 5 members, and was on-site for 4 days for a total of 40 hours per crew member. Up to three plates were joined together on the road, away from the excavation, where there was ample room to work. These pre-assembled sections (connected plates) were then transported to the construction site on a truck equipped with a crane and lifted into place (Figure 9). The bolts were kept loose until the entire assembly was complete to allow

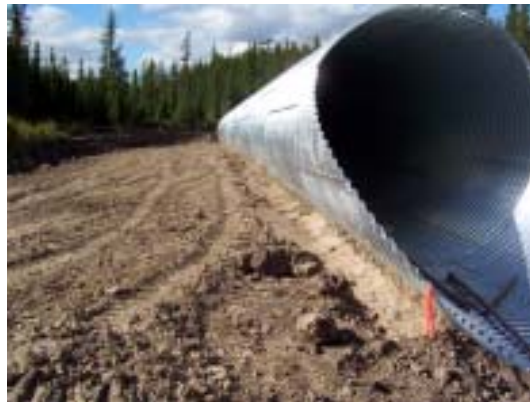
Figure 10. Assembled culvert showing clay material placed next to the culvert and above the lowest bolt holes (photo courtesy of Alberta-Pacific).

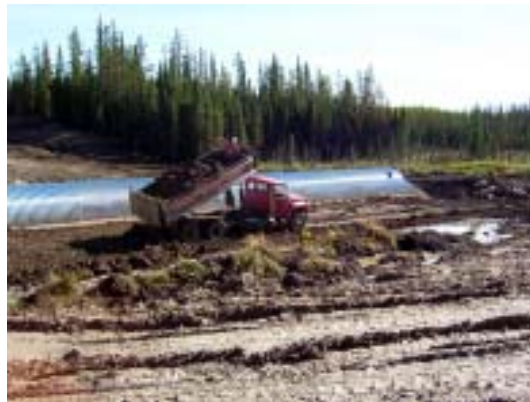
Figure 11. End-dump truck delivering backfill material (photo courtesy of Alberta-Pacific).

Backfilling around the outside of the culvert continued once the rainy weather had changed, and the threat of construction-related erosion and suspended sediment had been reduced. Backfill material was delivered next to the culvert by the end-dump trucks (Figure 11) and was spread by the crawler tractor (Figure 12). The material within one metre of either side of the culvert was compacted using a jumping-jack style compactor, while the remaining width of the lift was compacted using the vibrating drum roller. The backfilling and compaction were completed after 5 shifts (3 day and 2 night), with an average compacted height of 60 cm per shift.

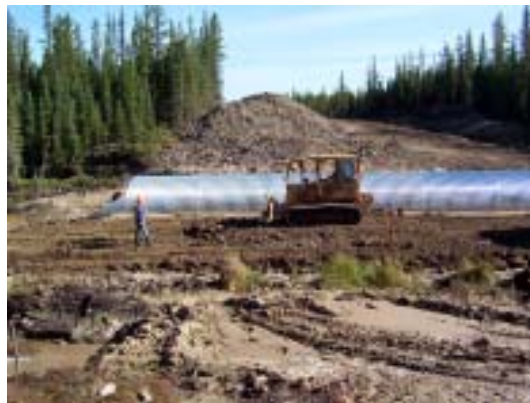
Figure 12. Crawler tractor spreading backfill material. Note the large pile of excavated material on the far side of the culvert (photo courtesy of Alberta-Pacific).

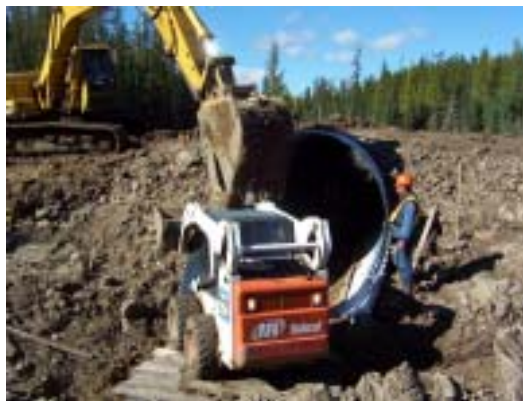
Figure 13. Excavator placing infill material into the bucket of the front-end loader during the infilling of the culvert (photo courtesy of Alberta-Pacific).

bucket (Figure 13). A staging area just outside of the culvert was prepared by placing wooden pallets for the loader to work on. These pallets kept the staging area from becoming excessively muddy, and kept the majority of the soil material from being carried into the culvert on the loader's tires. Plywood was placed through the length of the culvert to protect the loader's tires from bolts, and was eventually removed once it was no longer required.

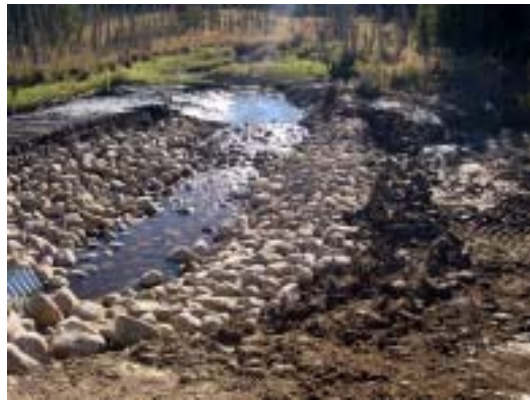
Figure 14. Inlet of culvert showing length of reconstructed stream channel, size and amount of rock, and stream-riffle section near the end of the armoured streambanks.

In order for the stream to enter the culvert without making an abrupt turn, a section of stream channel was reconstructed. One meander upstream of the culvert was isolated from the main flow path and a straight section of channel was constructed. Geotextile was laid along the streambanks of this straightened channel and rounded rock similar to that used inside the culvert was placed on top as armouring. The reconstructed section of stream blended in to the natural stream approximately 15 m from the inlet, and a 15–30 cm difference in streambed elevation occurred which resulted in a riffle characteristic (Figure 14).

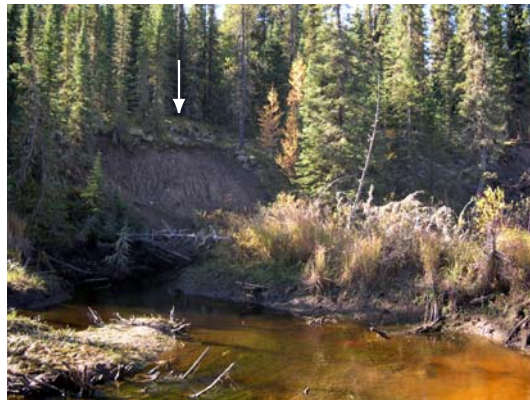
Figure 15. Arrow points to un-vegetated and ravelling bank.

Eliminating the flow in the upstream meander will lower future sediment inputs to the stream because the meander was eroding the toe of a steep and un-vegetated ravelling bank (Figure 15). The meander may still function as a backwatering/refuge area for aquatic wildlife.

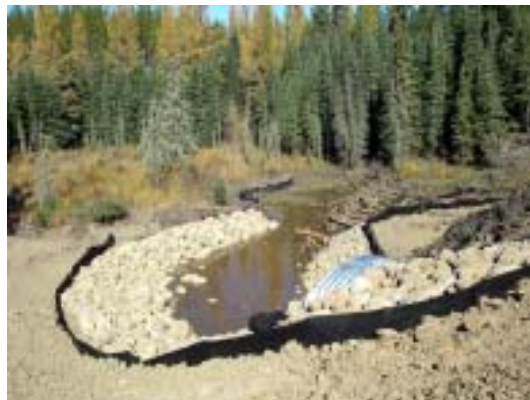
Figure 16. Outlet of culvert showing streambank armouring.

The stream channel downstream of the culvert also had some modifications. Although the outlet of the culvert was purposefully positioned to flow into a downstream meander of the stream, a short redirection of the channel was necessary. The streambank along this redirection, and portions of the original streambank, were armoured using rounded rock (Figure 16).

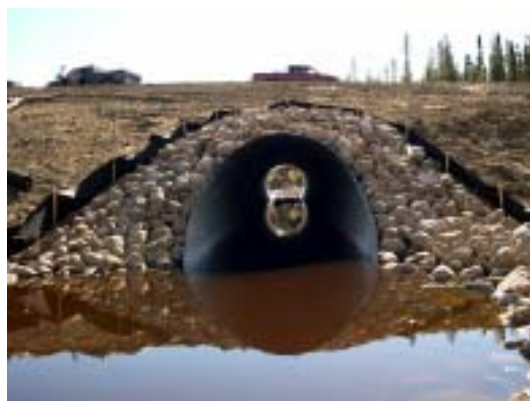
Figure 17. Outlet of culvert showing fillslope armouring and geotextile fencing.

Fillslopes were armoured above and around the culvert at both the inlet and outlet. The armouring extended to just below the road surface and up to 3 m on each side of the culvert (Figure 17). Geotextile fencing was installed around the entire armoured areas. The bottoms of the geotextile fences were placed in a hand-dug trench, and wooden support stakes were placed at 2-m intervals. The fillslopes above the culvert were 15–20 m in length and had an average gradient of 40%.

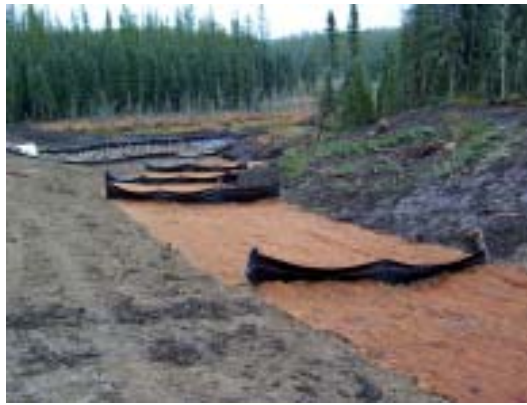
Figure 18. Fibrous matting and geotextile fences placed across ditchline (photo courtesy of Alberta-Pacific).

Ditchlines immediately entering the wetlands area were protected against further erosion by use of fibrous matting (Figure 18). Geotextile fences were also constructed in

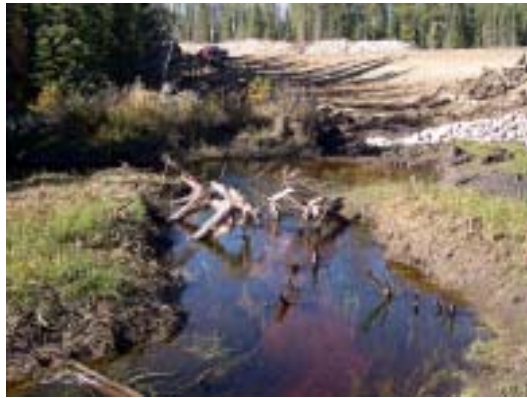
Figure 19. Root wads placed upstream of culvert within main channel of stream.

To compensate for the destruction and/or alteration of fish habitat, specific conditions were directed by Fisheries and Oceans Canada within the authorization document that was initially presented by the proponent of the project. Specified compensation works were correlated to the predicted area of lost habitat (150 m²) and, in this case, primarily made reference to the placement of root wads upstream and downstream of the culvert crossing. The root wads were strategically placed to offer shade and bank-scour protection. They will also offer protection for fish from overhead predation, add habitat diversity, and give micro-habitat flow characteristics (Figure 19).

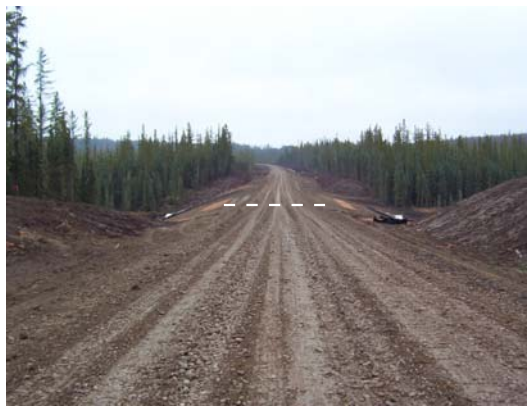
Figure 20. View of road surface across the installed culvert (photo courtesy of Alberta-Pacific).
