Ministry of Energy and Mines
British Columbia

Synthesis and Analysis of Submissions
to the Chief Inspector's Orders

Project Management, Engagement and
Geotechnical Review of Dam Safety
Inspections in BC

H348238-0000-15-124-0001
Rev. 0
January 29, 2015

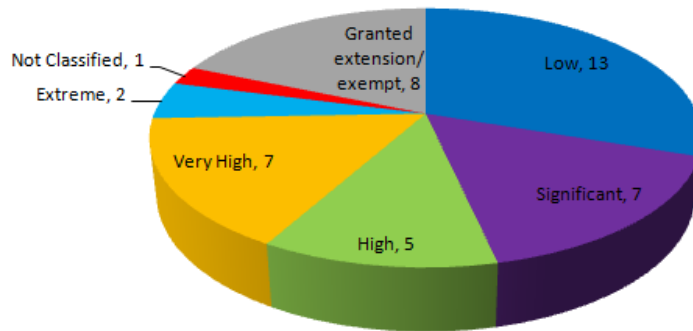
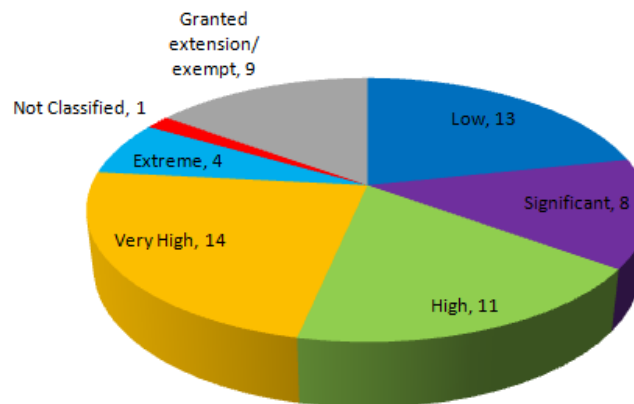
Figure 3: Highest dam consequence classification status for studied Tailings Storage Facilities (TSF)

Under Construction or Operating TSFs

Under Care and Maintenance or Closed TSFs

All Studied TSFs

Table 4-4 and Figure 3 shows the distribution dam consequence classifications for all TSFs as noted on the 2014 DSIs. Of the total 60 mines, 9 were exempted or granted extension, 21 of the mines have a TSF with consequence classification of Low to Significant, and 29 mines have a TSF with consequence classification of High to Extreme (dam classification for one mine is still under review).

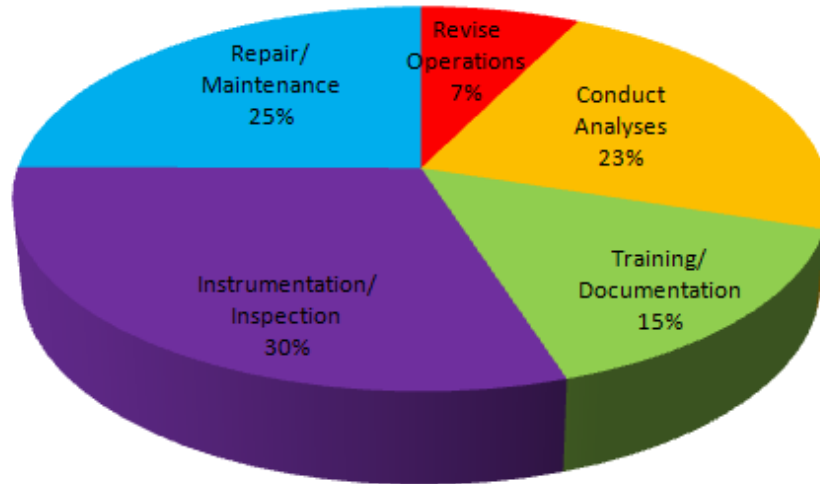
Figure 5: Types of recommendations provided by DSI or TPR studies

Under Care & Maintenance and Closed TSFs

Under Construction and Operating TSFs

The distribution of recommendations are shown in Table 4-8 and Figure 5.
