Ministry of Energy, Mines and Petroleum Resources

HAZARD ALERT

Number 9

EXPERIENCED WORKER LOSES FOREARM

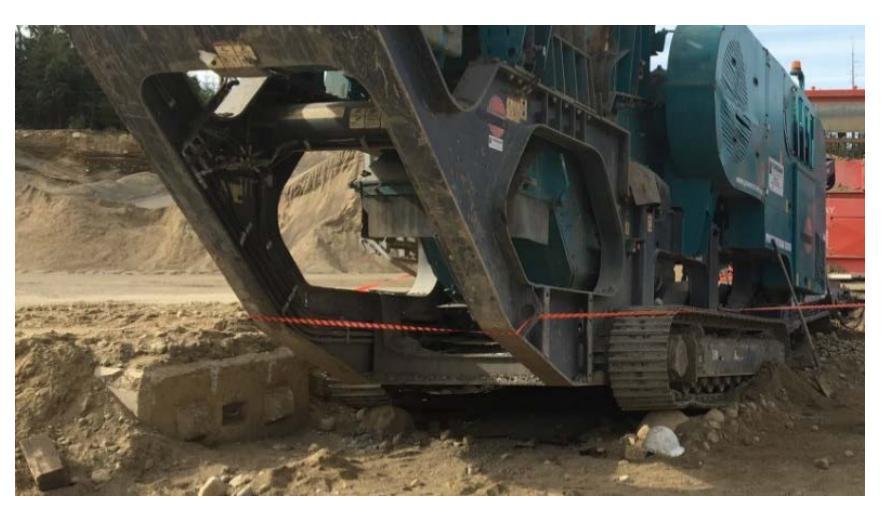
In April 2018, while working in a gravel pit, a worker's arm became entangled in the conveyor system of a rented portable crushing unit. The worker was "bumping" the conveyor to sweep the underside of the belt to clear rocks from the tail pulley. When the conveyor stopped, the worker failed to recognize that a rock had jammed the pulley and that the conveyor was still in the "on" position. When the worker reached in and cleared the jammed rock, the conveyor resumed movement, rotating the tail pulley and catching the worker's arm. The serious injury to the arm resulted in amputation.

The investigation determined that the experienced injured worker became entrapped because he believed he was safe: the conveyor was not moving, and he had done this activity before. Additionally, on the day of the incident, he changed his work procedure by directing assistance from a worker he knew was unfamiliar with the machine and task, resulting in confusion at the controls and a delayed emergency shutoff. While clearing rocks, the injured worker placed himself within dangerous proximity to the tail pulley, not recognizing that the conveyor had become jammed and was still energized. Being a supervisor and responsible for lock-out training in the past, the injured worker knew of the hazards associated with energized conveyors and working near tail pulleys. Nevertheless, he intentionally violated safe work procedures by not locking-out the equipment.

- **Risk Assessment** A risk assessment was not conducted prior to the task. Risk assessments or reassessments should be completed for all non-routine, new work, or when any changes to safe work procedures are made.

- **Equipment** When possible choose equipment that facilitates workers to perform their work safely and effectively and makes it easy for them to comply with requirements such as lock-out. Lock-out was awkward and difficult to access on this piece of equipment.

- **Guarding** The injured worker reversed the machine onto blocking to create space underneath to access the tail pulley. Guarding must be effective and must never be defeated without following a proper lockout procedure.

- Lock-out/Tag-out The injured worker decided not to lockout in order to bump the belt. Equipment must be deenergized and locked-out & tagged-out before maintenance/repairs are carried out, this includes mitigating all "potential-energy" hazards (stored energy, etc.)

- **Training** The injured worker was the only one trained on the rental equipment. All workers that could work on equipment or have to stop it in case of an emergency, should be trained on the safe operation of the equipment, particularly emergency stopping procedures and lock-out/tag-out procedures.
