RECORD OF DECISIONS

POLLUTION ABATEMENT/PREVENTION ORDERS

HULLCAR AQUIFER WATER QUALITY ISSUE

OCTOBER 26, 2016

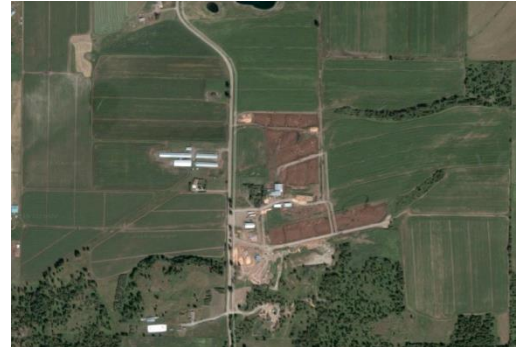
- Other manure storage systems and the extent of use of manure as fertilizer or soil conditioner are unknown.
- It is unknown if Curtis Farm is part of Environmental Farm Plan Program, as no Environmental Farm Sign is displayed on the gate/fence.

- On February 23, 2016, Ministry staff was in the area and noted that there was no containment system for surface water, and there were many large piles of manure observed without cover.

- Well logs indicate that the soils at 5058 Parkinson Road are comprised of sand, silt and gravels (consistent with the general description of substrate from the 2016 FLNR memo) which are highly porous and enable surface water to permeate through the soils to the aquifer.

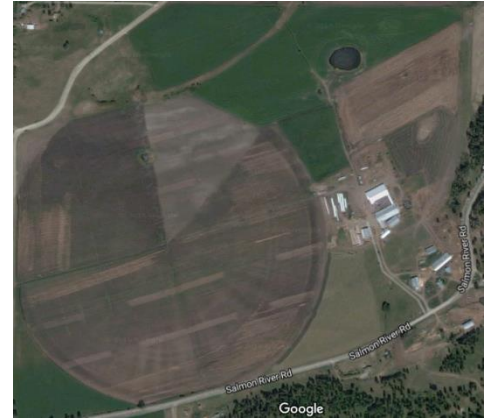
- Brown staining was observed on the snow covering one of the farm fields. An adjacent field was covered in white snow.
 - The site manager advised that the manure was sprayed on the field the previous week.

- The storage facility is not of sufficient capacity to store all the agricultural waste produced or used on the farm for the period of time needed to allow for the application as fertilizer or soil conditioner.

- The application of manure effluent on fields of snow without crops was due to lack of storage capacity and not as a fertilizer or soil conditioner.
 - It could not be determined if runoff or escape of the agriculture waste caused pollution of a watercourse or groundwater, or went beyond the farm boundary.

- On February 23, 2016, Ministry staff was in the area and noted that there was a tractor with an effluent spreader filling up with effluent.
- It is unknown if the operation is part of the Environmental Farm Plan Program, as no Environmental Farm Sign is displayed on the gate/fence.

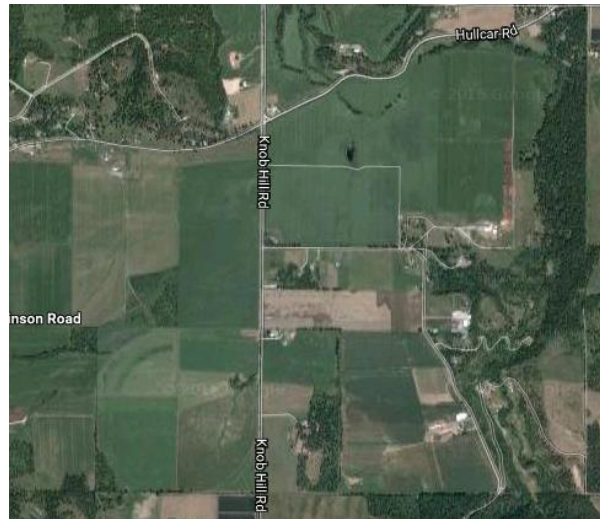
- On March 17, 2016, the Ministry received the 2016 manure management plan for H.S. Jansen & Sons Farm Ltd. The plan included soil sample results and groundwater sample results which

showed the groundwater for Curtis East Well (Sylvia field) has 21.5 mg/L nitrate and Curtis West Well (Sylvia Field) has 12.0 mg/L nitrate. These wells are located in close proximity to the back of the Jansen barns.

- On April 10, 2016, a Ministry Environmental Protection Officer inspected the dairy operation for compliance with the Agriculture Waste Control Regulation. There were several requirements where the inspection finding was 'not determined'.
 - The inspection report detailed that at the time of inspection weather was hot and dry. Agricultural waste was being applied on some corn fields. There was no visible pooling of effluent runoff occurring. Not able to visually determine if pollution to groundwater was occurring.

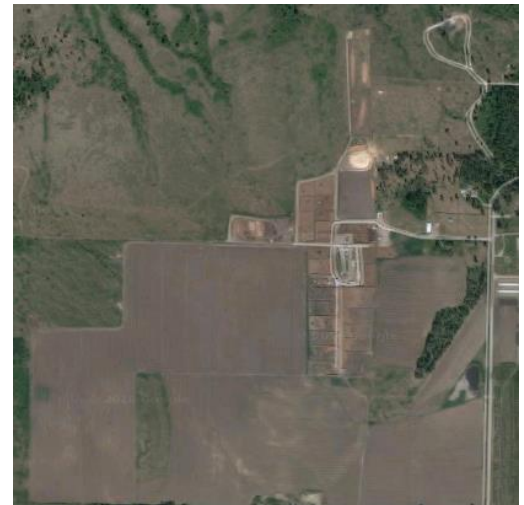
- The inspection report detailed that some of the pens have 8ft of concrete from the pen to the feed bunk to allow for easier manure clean up and improved animal health. Solid manure is stored in the pens in a pile and later spread on crop fields. They lease approximately 98 acres

of land to grow corn. Surface water runoff from the wood waste storage area and the pen is directed via overland ditching and from a constructed drain pipe system to storage ponds at the bottom of the property. This runoff is either used as irrigation water or directed under Hullcar Road to a ditch at the Purple Springs Nursery Inc. where it disappears to ground. The inspection report stated that pollution of a watercourse or groundwater could not be fully determined without additional sampling and analyses since the lagoon runoff analysis is only one contributing source from both the feedlot and nursery operations.

- Site photos showed:
 - Large amounts (i.e. piles higher than the fence line) of solid manure stored in outdoor pens.
 - Snow that had melted on ground occupied by cattle and snow covered land elsewhere.
 - Manure impacted runoff was being directed across the property (via feedlot pens).
- Water samples for both retention ponds were provided and showed low nitrate levels (below detectable limits). Sampling protocol was not provided. Laboratory used was A&L Canada Laboratories located in London Ontario.
- On February 23, 2016, Ministry staff was in the area and noted that the feedlots were on the hill adjacent to the tree nursery. Noted high probability for impacted surface water runoff towards Hullcar Valley bottom.
- It is unknown if the operation is part of the Environmental Farm Plan Program, as no Environmental Farm Sign is displayed on the gate/fence.

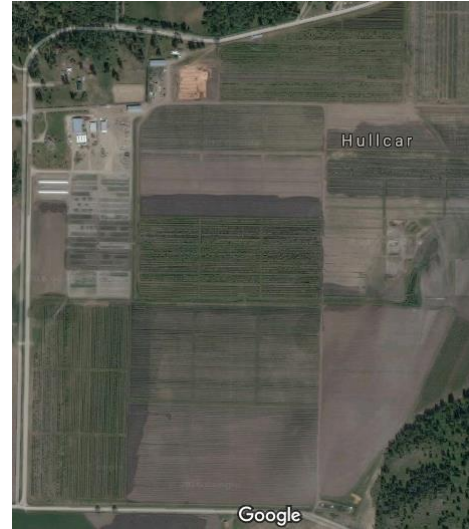
- Lab analysis records were provided for the surface water drainage that initiates at the high point of Ken and Brenda Regehr Feedlot and is diverted via storage ponds, drainage ditches and pipes under Hullcar Road to the tree nursery. The inspection report noted the lab sample was taken from the culvert outside of the nursery property and does not include any contributions from the nursery. Pollution of a watercourse or groundwater could not be fully determined without additional sampling and analyses since the lagoon runoff analysis does not include contributions from the tree nursery operations. As well, no application of agricultural waste to land was observed at the time of the inspection.

- Currently there is no leachate collection system for the facility.
- It is unknown if the operation is part of Environmental Farm Plan Program, as no Environmental Farm Sign is displayed on the gate/fence.

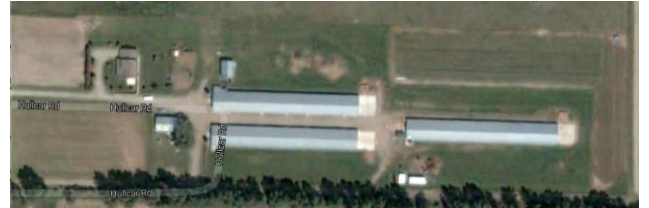
- Canyon Road Farm Ltd. is a broiler poultry operation with three large poultry barns.

Located at 3888 Canyon Road and also located over Aquifer 103. Farm is north east of Steele Springs water source.

- The area geology is loamy, sandy soils which are high permeability for water.
- Well logs indicate that the soils near 3888 Canyon Parkinson Road are comprised of sand, clay silts and brown and black soil (consistent with the general description of substrate from the 2016 FLNR memo) which are highly porous and enable surface water to permeate through the soils to the aquifer.

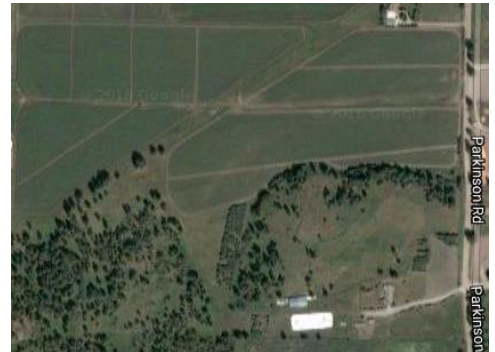
- It is noted that 5021 Parkinson is located on a rise in elevation from the neighboring property and some of the property is located on bedrock.
- Per Table 6.7 of the BC Environmental Farm Plan Full Reference Guide, Broiler Poultry manure has an average Manure N Concentration of 15.8 kg N/m³, which is 4.6 times the concentration of beef cattle manure and 5.6 times the concentration of dairy cattle manure (medium slurry).

- On February 23, 2016, Ministry staff was in the area and noted that this operation was in close proximity to H.S. Jansen & Sons Farm operation. Manure (poultry litter) storage could not be observed from the roadway.

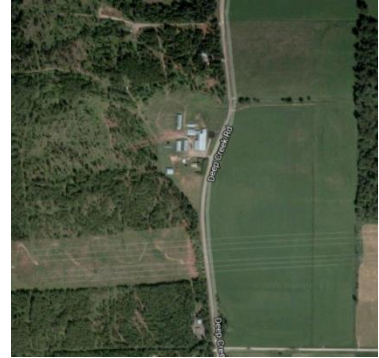
- Wilma and Thys Haambuckers are the landowners of 2160 Deep Creek Road which is a small dairy cow operation.
- On February 10, 2016, a Ministry Environmental Protection Officer was onsite to provide promotional compliance information.
- It is noted that the west side of the property is sloping eastward towards Deep Creek.
- A tributary stream runs from the west side of the property downslope to the east side of the property (through a culvert under Deep Creek Road) and into Deep Creek.
- On February 23, 2016, Ministry staff were in the area and noted that this operation had a manure pile stored in the field within 30 meters to this tributary to Deep Creek (within 30 meters of a watercourse (AWCR s. 8 (2) b)).

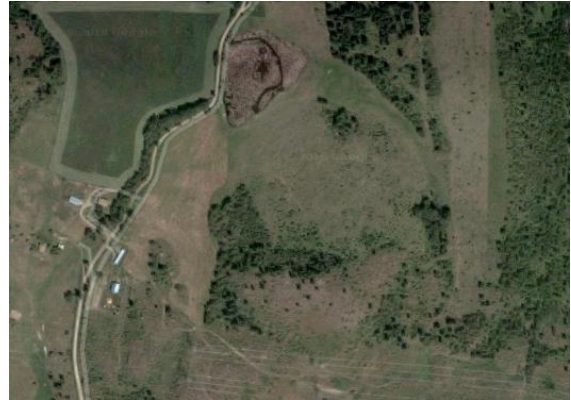
- Darlene Huxley is the landowner of 2148 Pyott Road which is a small (approximately 25 cow and calf pairs) farm operation (Willoughby Simmentals).
- On February 23, 2016, Ministry staff was onsite and noted that this property is sloping south towards Hullcar Valley and that the land is cleared. A manure pile was observed to be in contact with surface water runoff.
- It is noted that ditching/drainage structure has been constructed across the property near the roadway and runs through other properties to the south.
