Highlands Lakes Water Quality Assessment 1997 – 2003

Kevin Rieberger
Water Protection Section
Ministry of Water, Land and Air Protection

November, 2003

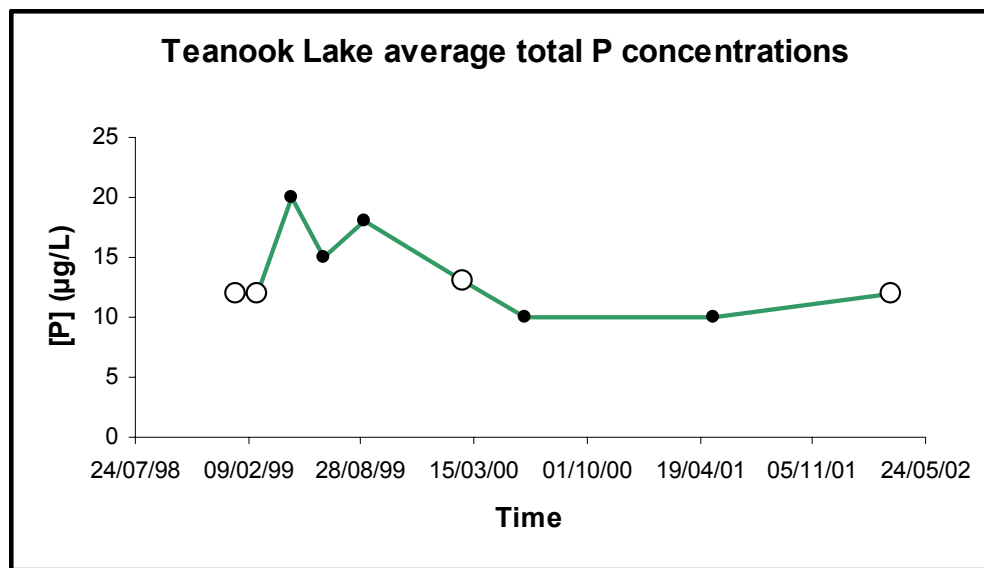
Total phosphorus – The average total P concentrations over time are illustrated in Figure 7. The results show higher average values in 1999 with more recent results closer to the guideline for protection of drinking water sources of 10 µg/L. The average concentration at spring overturn, however, has remained consistent at 12 µg/L to 13 µg/L.

Figure 7: Average total P concentrations for Teanook Lake. Spring overturn values are denoted with ○.

The nutrient concentrations measured indicate that this lake is mesotrophic. The P concentration at spring overturn has been slightly higher than the guideline of 10 $\mu\text{g/L}$ for the protection of drinking water source water and recreational use; further sampling should be conducted at spring overturn to confirm these levels. Volunteers have started

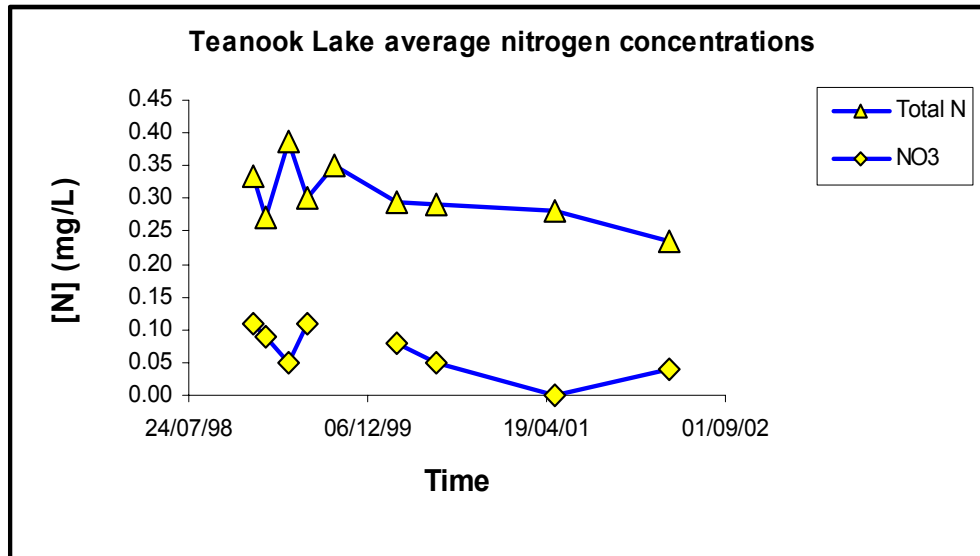
Nitrogen – Average total nitrogen and dissolved nitrate concentrations over time for Teanook Lake are illustrated in Figure 8. Average concentrations for each parameter were low: total N was 0.28 mg/L and dissolved nitrate was 0.048 mg/L, well below the guideline of 10 mg/L for the protection of drinking water sources.

Figure 8: Average total nitrogen and dissolved nitrate concentrations and for Teanook Lake.
