Tailings Line Unblockage Fatality

Created: January 11, 2024 FILE No. 20-02

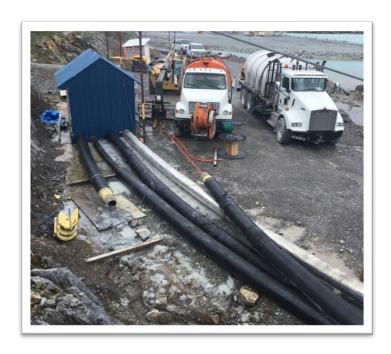
On Friday, July 31, 2020, an incident resulting in a fatality occurred involving the unblocking of a tailings line. The jet hose being used to unblock the tailings line had become stuck and was unable to be retrieved using a vacuum truck hose spool. During the first pull attempt with a telehandler the hose had been stretched and unknowingly placed under tension and was pinned beside the next tailings line. On the second pull with the telehandler the jet hose moved suddenly from its pinned position and across the other tailings lines. A worker standing on the tailings line was forcefully knocked off their feet during the second pull, sustaining critical injuries and later passing from those injuries.

FIGURE 1. Line blocking work area where incident occurred.

A Hazard Alert to be issued and in November 2021, Hazard Alert No.15 was published <u>Hazard Alerts - Province of British Columbia (gov.bc.ca)</u> by the CIM. The Hazard Alert included awareness of this incident and other investigations that identified poor work planning resulting in severe injuries, including fatalities. The Hazard Alert highlights the importance of completing Safe Work Plans and Job Hazard Analysis and for the continuous and regular monitoring for new hazards throughout undertaking the task.
