Report Date:April 03, 2018 Report Number: 080743

#### Re: Non-compliance Advisory Letter, Permit 17667, Powell River

Authorization: 17667	Client Name: West Coast Fishculture (Lois Lake) Ltd.
NRIS IR #: 80743	(Date) Site Inspection Photos: March 13, 2018
Photo 1 Authorized ozone separation system located at West Coast Fishculture (Lois Lake) Ltd. fish processing plant.	
Photo 2 Authorized Sedimentation Tank which is part of the secondary treatment plant at West Coast Fishculutre (Lois Lake) Ltd. fish processing plant.

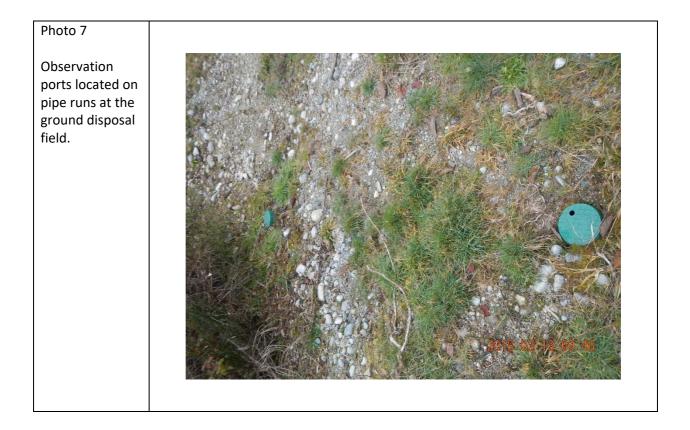
2.8: 2.8 Sludge wasted from the treatment plant shall be disposed of to a site and in a manner approved by the Director, or as authorized by regulation under the Environmental Management Act.
Details/Findings:	Mr. Ferris informed Officer Kurinka that WCF has contracted Rural Septic Services to remove sludge waste from the treatment plant which is then taken to the Powell River Wildwood municipal wastewater lagoon.
Compliance:	ln
Actions to be taken:	
Requirement Description:	<ul> <li>2. GENERAL REQUIREMENTS, 2.9. Groundwater Observation Facilities</li> <li>2.9: 2.9 Each ground disposal field shall include 4 groundwater observation wells, and an</li> </ul>
	observation port on each disposal pipe run. The location and structural details of these facilities must be satisfactory to the Director.
Details/Findings:	Officer Kurinka observed the four groundwater observation wells (Photo 6) and ports (Photo 7) on each disposal pipe run at the time of the inspection.
