October 9<sup>th</sup>, 2016  
**Land Based Investment Strategy (LBIS):  
Fish Passage Program Annual Report 2015-2016**

Attachment A1:  
**Executive Summary<sup>1</sup>:**  
**Fish Passage and Habitat Restoration Partnership Projects**  
**2015/16**

### Summary of Remediation Projects 2015/16 in partnership with LBIS, RFCPP and PSF

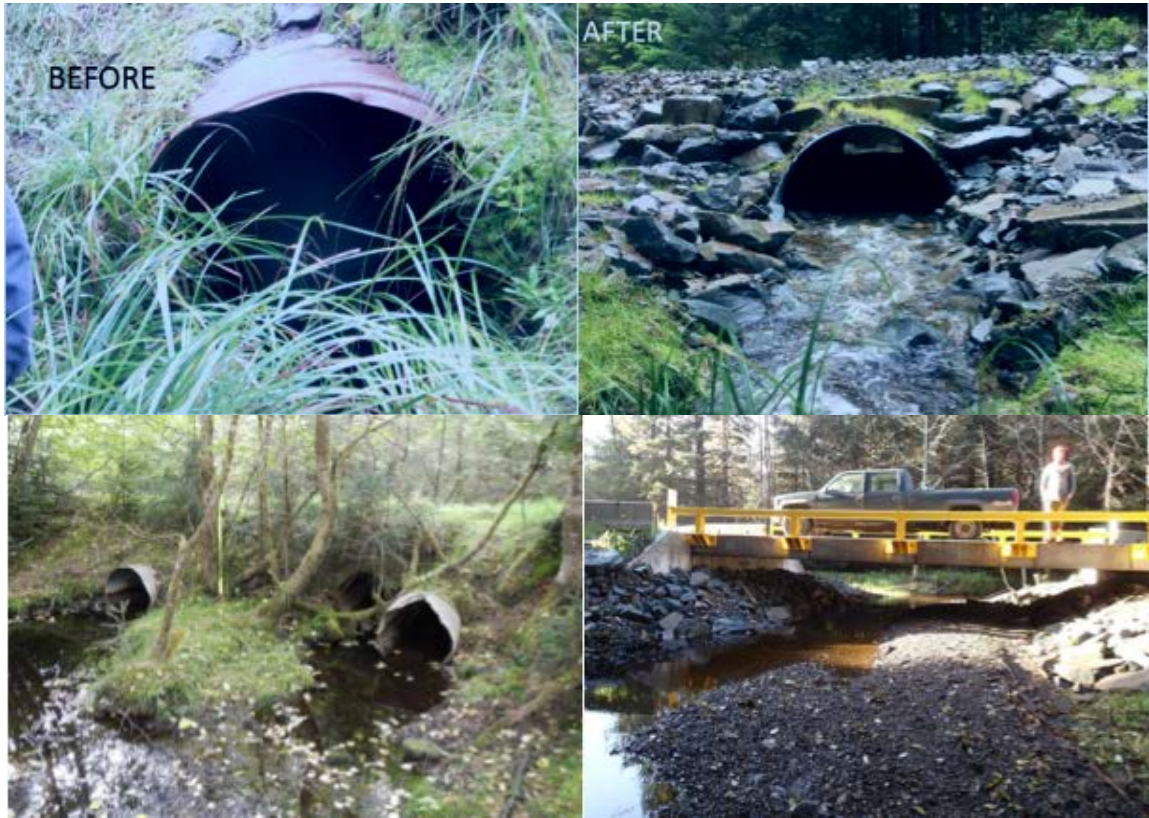
## 1. Copper Creek – Skidegate Lake Project

Photo: Top - NES 2 before and after; Bottom - Spur 30-1 before and after

The project objective was achieved with the installation of a bridge at Spur 30-1 and an embedded open bottom culvert at NES2 (also referred to as South Bay Mainline).

The project objective was to replace two crossing structures (Spur 30-1 and NES2) that impeded fish passage with two fish-friendly crossing structures that provide for safe fish passage.

The Copper Creek project restored fish access to 1700 m of high value spawning and rearing habitat at Spur 30-1 for *Oncorhynchus kisutch* (Coho), and 530 m of high value spawning and rearing habitat at NES2 for *Oncorhynchus kisutch* (Coho) and *O. nerka* (Sockeye).

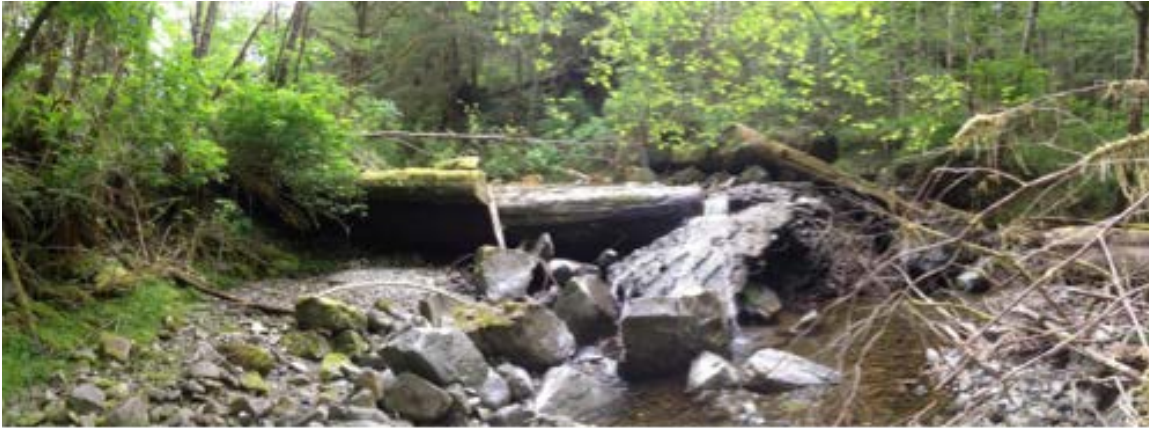
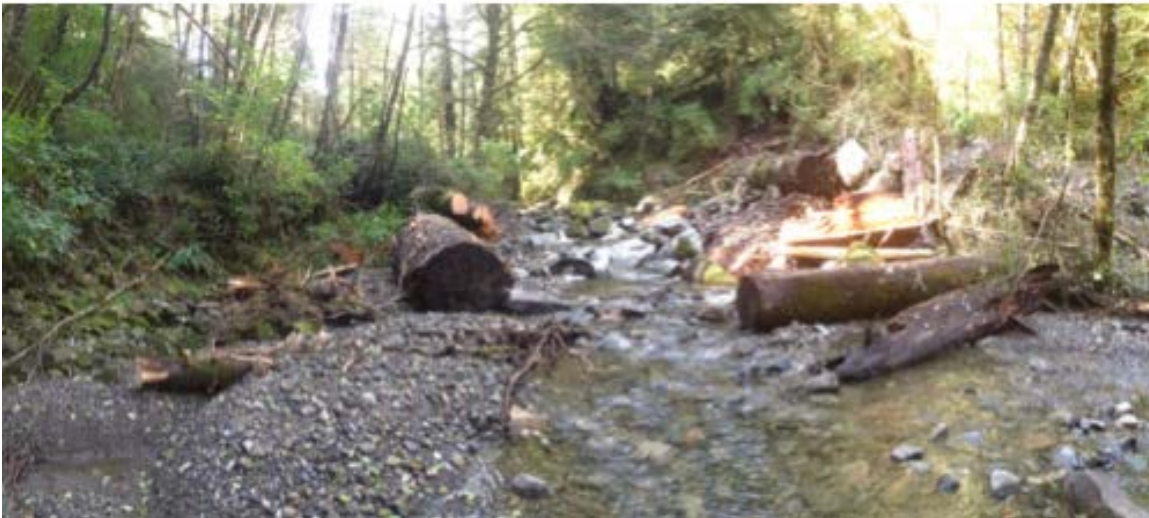
## 2. Clint Creek Project

Upper photo: Clint Creek dam before the project  
Lower photo: Clint Creek dam removed due to the project

The project objectives were achieved with the dam removal increasing access to at least 1,300 m of high and moderate value habitat for *Oncorhynchus kisutch* (Coho), *O. keta* (Chum), and *Salvelinus malma* (Dolly Varden); and 375 m of habitat restoration completed with installation of LWD structures.

1. To remove a small dam (weir) that is no longer needed and that impeded fish passage on Clint Creek in order to restore fish passage, and
2. To remediate key areas surrounding the lower 375 m of Clint Creek to improve and restore fish habitat quality through the installation of large woody debris (LWD) structures.

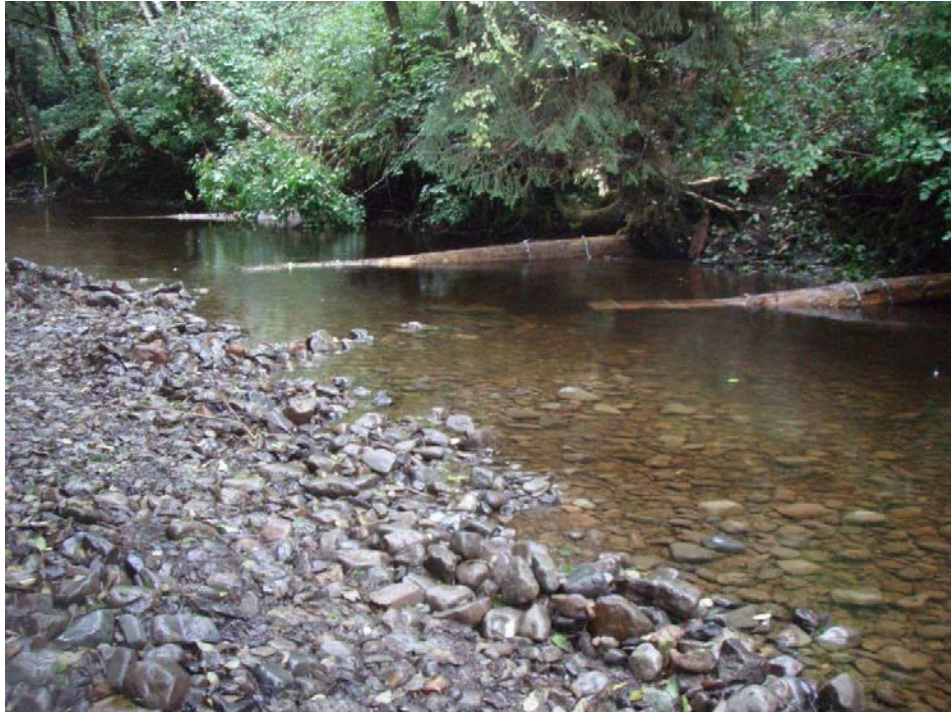
### 3. Honna River Project

Photo: Honna River large woody debris structure #7

Project Objective
The project objective was to enhance fish habitat by installing large woody debris (LWD) that is lacking in the river and is limiting salmon production.
Project Results
<p>The project objective was achieved with the installation of 9 LWD structures along 325 m of channel as prescribed in the report “<i>2015 Instream Habitat Enhancement Prescriptions: Clint Creek, Shelly Creek, and Honna River</i>” that was prepared as part of this project.</p> <p>The project enhanced 325 m of high value fish habitat for <i>Oncorhynchus kisutch</i> (Coho), <i>O. keta</i> (Chum), <i>O. gorbuscha</i> (pink), <i>O. mykiss</i> (steelhead), <i>O. clarkia</i> (cutthroat) and <i>Salvelinus malma</i> (Dolly Varden).</p>

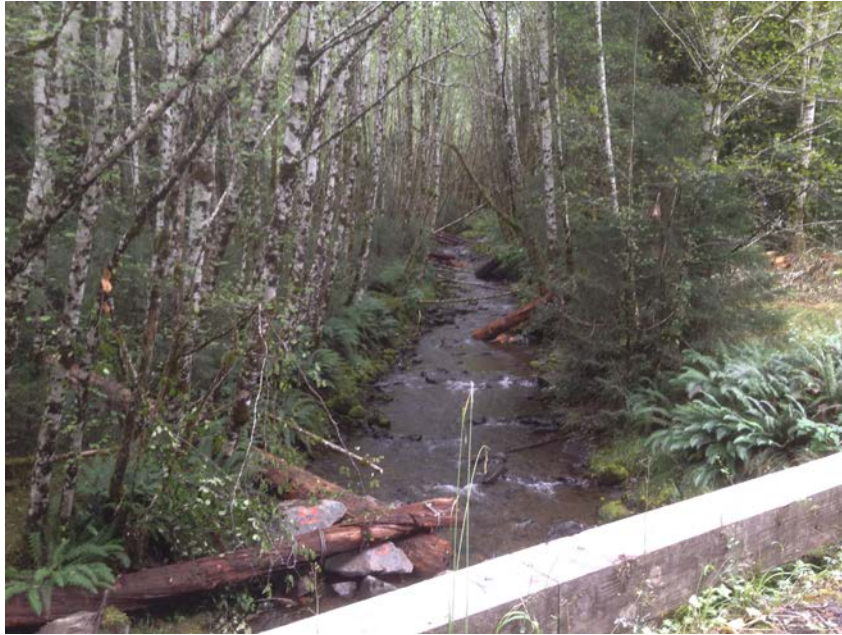
#### 4. Shelley Creek Project

Photo: Examples of large woody debris structures that were installed

Project Objective
The project objective was to enhance fish habitat by installing large woody debris (LWD) that is lacking in the creek and is limiting salmon production.
Project Results
<p>The project objective was achieved with the installation of 12 LWD structures along 285 m of channel as prescribed in the report “<i>2015 Instream Habitat Enhancement Prescriptions: Clint Creek, Shelly Creek, and Honna River</i>” that was prepared as part of this project.</p> <p>The project enhanced 285 m of high value fish habitat for <i>Oncorhynchus kisutch</i> (Coho), <i>O. keta</i> (Chum), <i>O. clarkia</i> (cutthroat) and <i>Salvelinus malma</i> (Dolly Varden).</p>

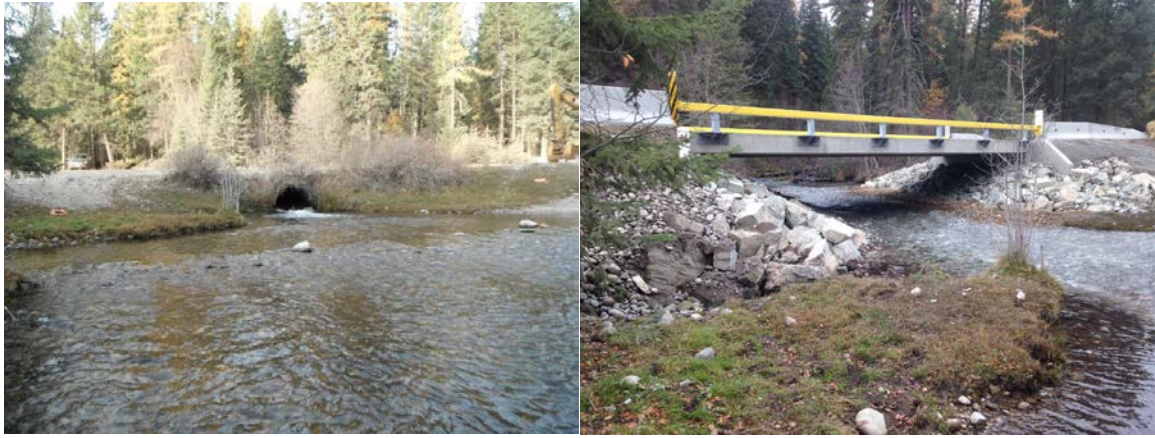
## 5. Plumbob Creek Project

Photo: Plumbob Creek Crossing – before and after

The project objective was to restore fish passage by replacing an undersized, perched culvert on Plumbob Creek, which flows into the Koocanusa Reservoir. The culvert was located on the Teepee Forest Service Road (FSR) in the East Kootenay area of British Columbia (BC). The culvert was an impassable barrier for fish.

The project objective was achieved with the installation of a clear span bridge. With the removal of the old culvert and installation of the bridge, the Plumbob Creek Fish Passage restoration project now provides fish access to 7,000 linear metres of upstream habitat for utilization by *Oncorhynchus clarkii lewisi* (Westslope Cutthroat Trout), *Salvelinus fontinalis* (Eastern Brook Trout), and *S. confluentus* (Bull trout).

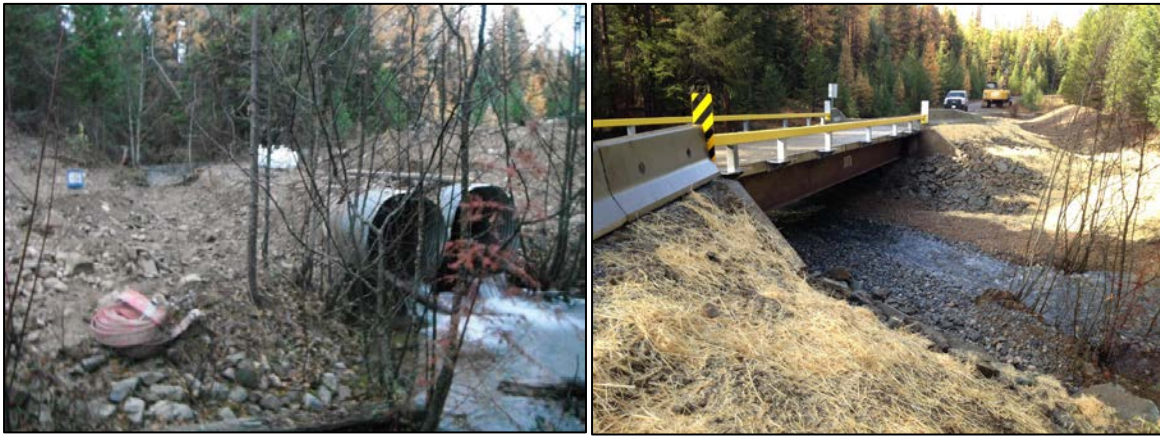
### 6. Linklater FSR – Purcell Creek Project

Photo: Purcell Creek Crossing – before and after

Project Objective
The project objective was to restore fish passage by replacing two undersized, perched culverts on Purcell Creek, which flows into the Koocanusa Reservoir. The crossing is located on the Linklater FSR in the East Kootenay area of British Columbia (BC). The culverts were an impassable barrier for fish.
Project Results
The project objective was achieved with the installation of a clear span bridge. With the removal of the perched culverts and installation of the bridge, the Linklater FSR - Purcell Creek Fish Passage restoration project now provides fish access to 7,600 linear metres of upstream habitat for utilization by <i>Oncorhynchus clarkii lewisi</i> (Westslope Cutthroat Trout), <i>Salvelinus fontinalis</i> (Eastern Brook Trout), and possibly also <i>S. confluentus</i> (Bull trout).

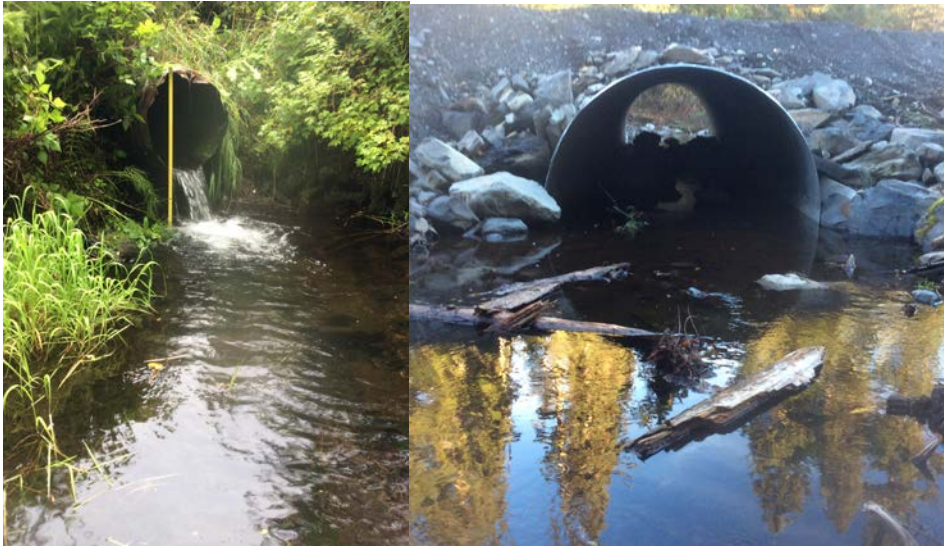
## 7. Nass River – Brown Bear Forest Service Road Project

Photo: Axnegrelga Crk (Nass River tributary) Site 262 on Brown Bear FSR – before and after

The project objective was to replace two crossing structures (Site 262 and Site 264) that impeded fish passage with two fish-friendly crossing structures that provide for safe fish passage.

The project objective was achieved with the installation of embedded open bottom culverts at both Sites 262 and 264.

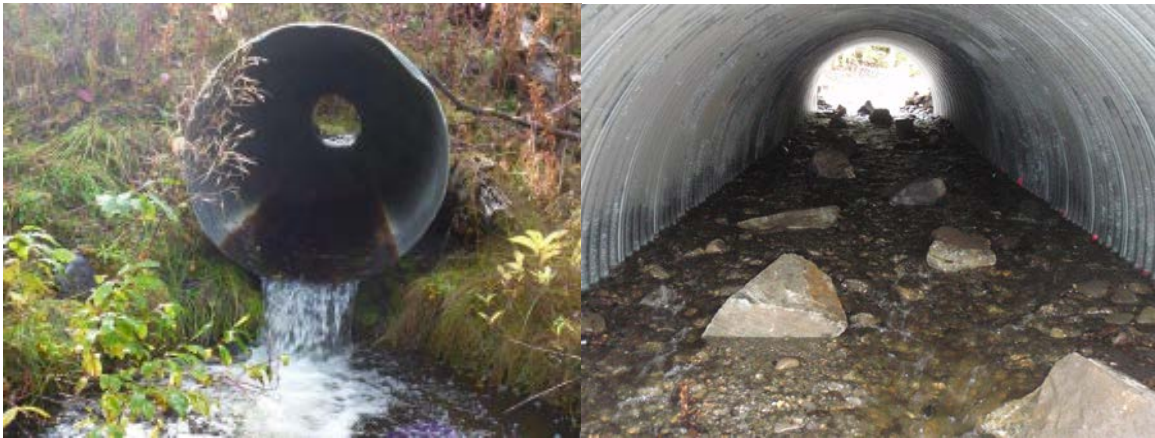
## 8. Kispiox River – Helen Forest Service Road Project

Photo: Kispiox River tributary Site 6 on Helen FSR – before and after

The project objective was to replace two crossing structures (Site 5 and Site 6) that impeded fish passage with two fish-friendly crossing structures that provide for safe fish passage.

The project objective was achieved with the installation of embedded open bottom culverts at both Sites 5 and 6. In tandem with the project, BCTS deactivated a crossing at Site 5b that increased fish access to above Site 5 to 1,300 m.

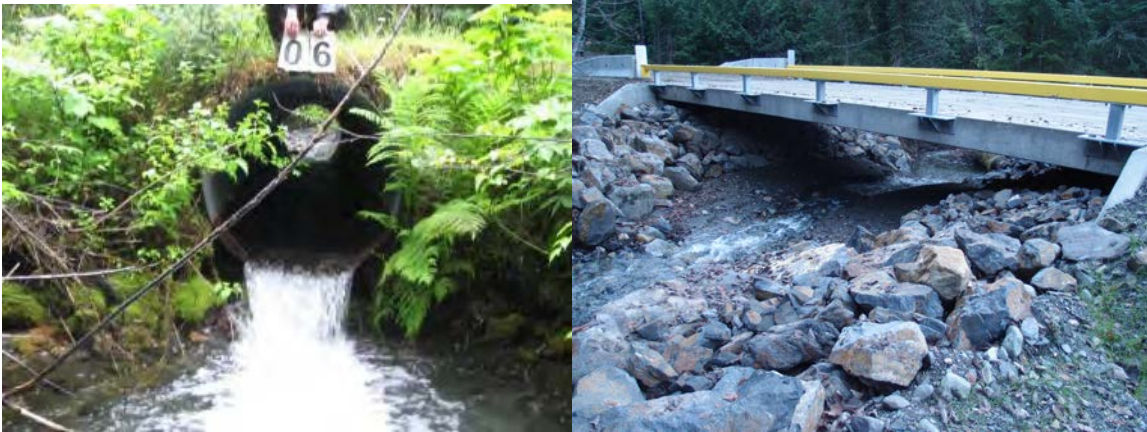
## 9. Cherry Creek – North Fork Forest Service Road

Photo: Tributary to Cherry Creek Crossing – before and after

The project objective was to restore fish passage by replacing an undersized, perched closed bottom culvert on an unnamed tributary of Cherry Creek. The culvert was located on the North Fork FSR in the Okanagan-Columbia area of BC. The culvert was an impassable barrier for fish.

The project objective was achieved with the installation of a clear span bridge. With the removal of the perched culvert and installation of the bridge, the Cherry Creek – North Fork FSR Fish Passage restoration project now provides fish access to at least 500 linear metres of upstream habitat for utilization by *Salvelinus mykiss* (Rainbow trout) and *S. confluentus* (Bull trout). Based on TRIM data, there is the potential for up to 2500 metres of habitat gain.

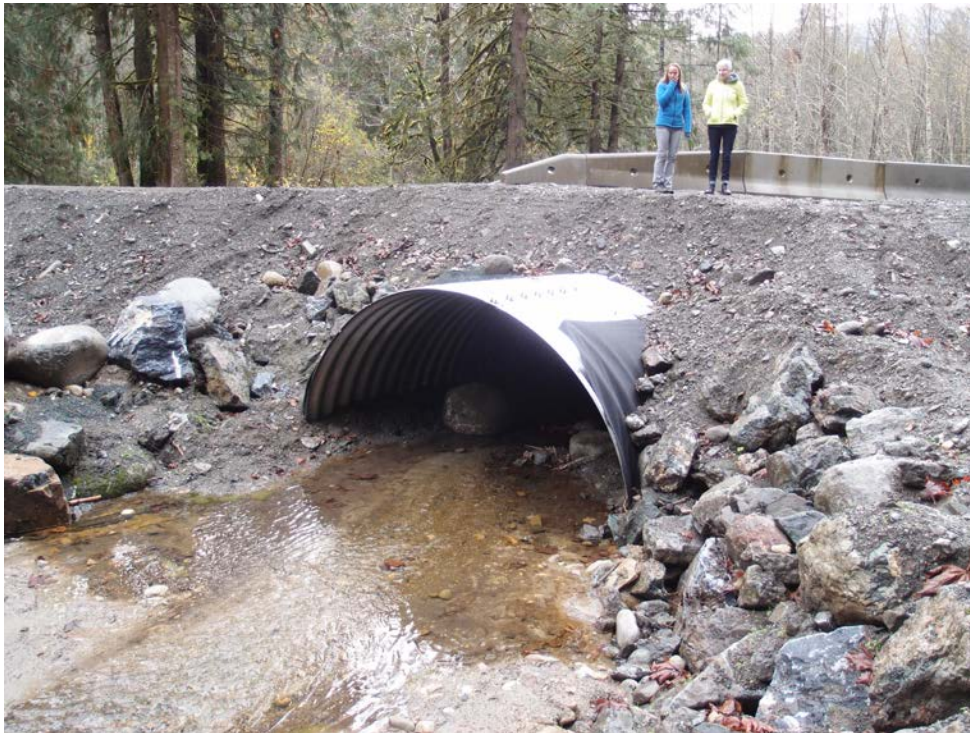
## 10. Bench Forest Service Road Project

photo: Newly installed open bottom arch culvert that provides for safe fish passage

The project objective was to replace a corrugated metal pipe (CMP) on km 4 of the Bench Forest Service Road (FSR) that impedes fish passage with a fish-friendly structure.

The project objective was achieved with the installation of an open bottom arch culvert that provides for safe fish passage. The project also addressed stream flooding of the FSR by raising the road, undertaking bank restoration, restoring thalweg, and restoring riparian area by re-routing the ATV trail to prevent future bank failure

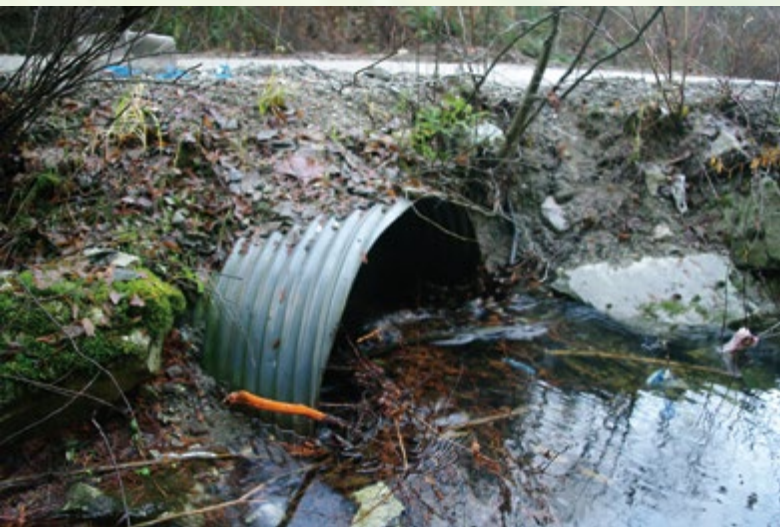
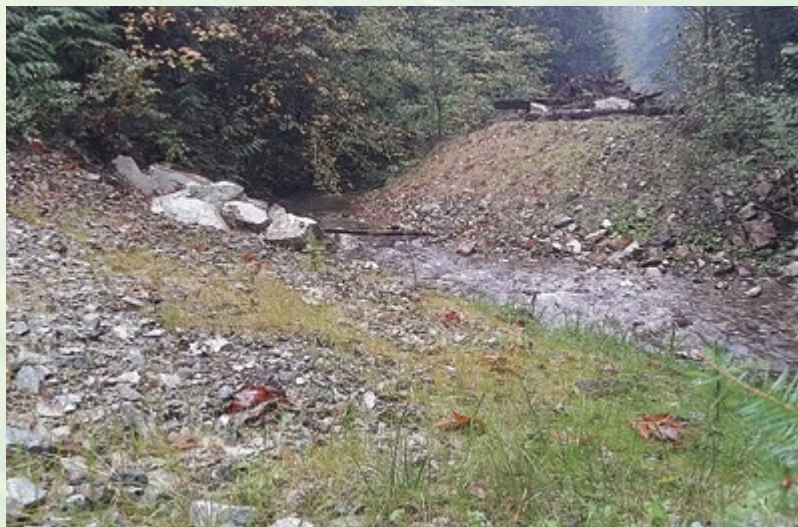
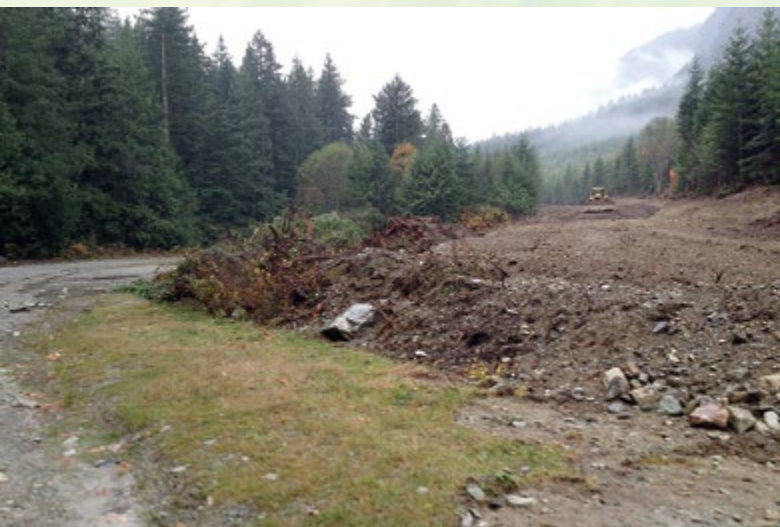
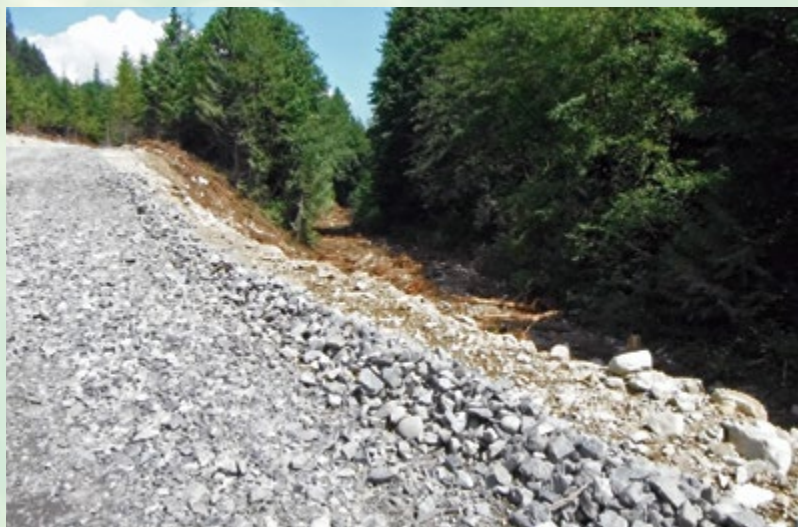
*Construction of the bypass road on the Chehalis FSR. Note the old road at the left of the image, and the bypass road on the right.*

*New bypass road on the left of the image and deactivated forest road on the lower right of the image. This remediation work moved the road away from the stream bed and removed the need for culverts.*

The bypass road was constructed in July 2013 to the appropriate build standards

required for a public road, and all traffic was redirected to this new road. In August of the same year, the two culverts from the old road were removed, and the stream channels at these locations restored. The old road was then deactivated by de-compacting the road bed, top-dressing with slash and other vegetation to improve stability and encourage regeneration, and seeding with grass. Follow-up work in spring 2014 included the planting of 600 trees and additional grass seeding. An informal camping area on the old road section near Elbow Lake was also decommissioned, as it was a source of pollution problems.
