# TEMPORARY ACCESS STRUCTURES: CONSIDERATIONS FOR SITE PLANS AND POST-HARVEST ASSESSMENTS

# FREP

## EXTENSION NOTE #28

Revised January 2014  
October 2013

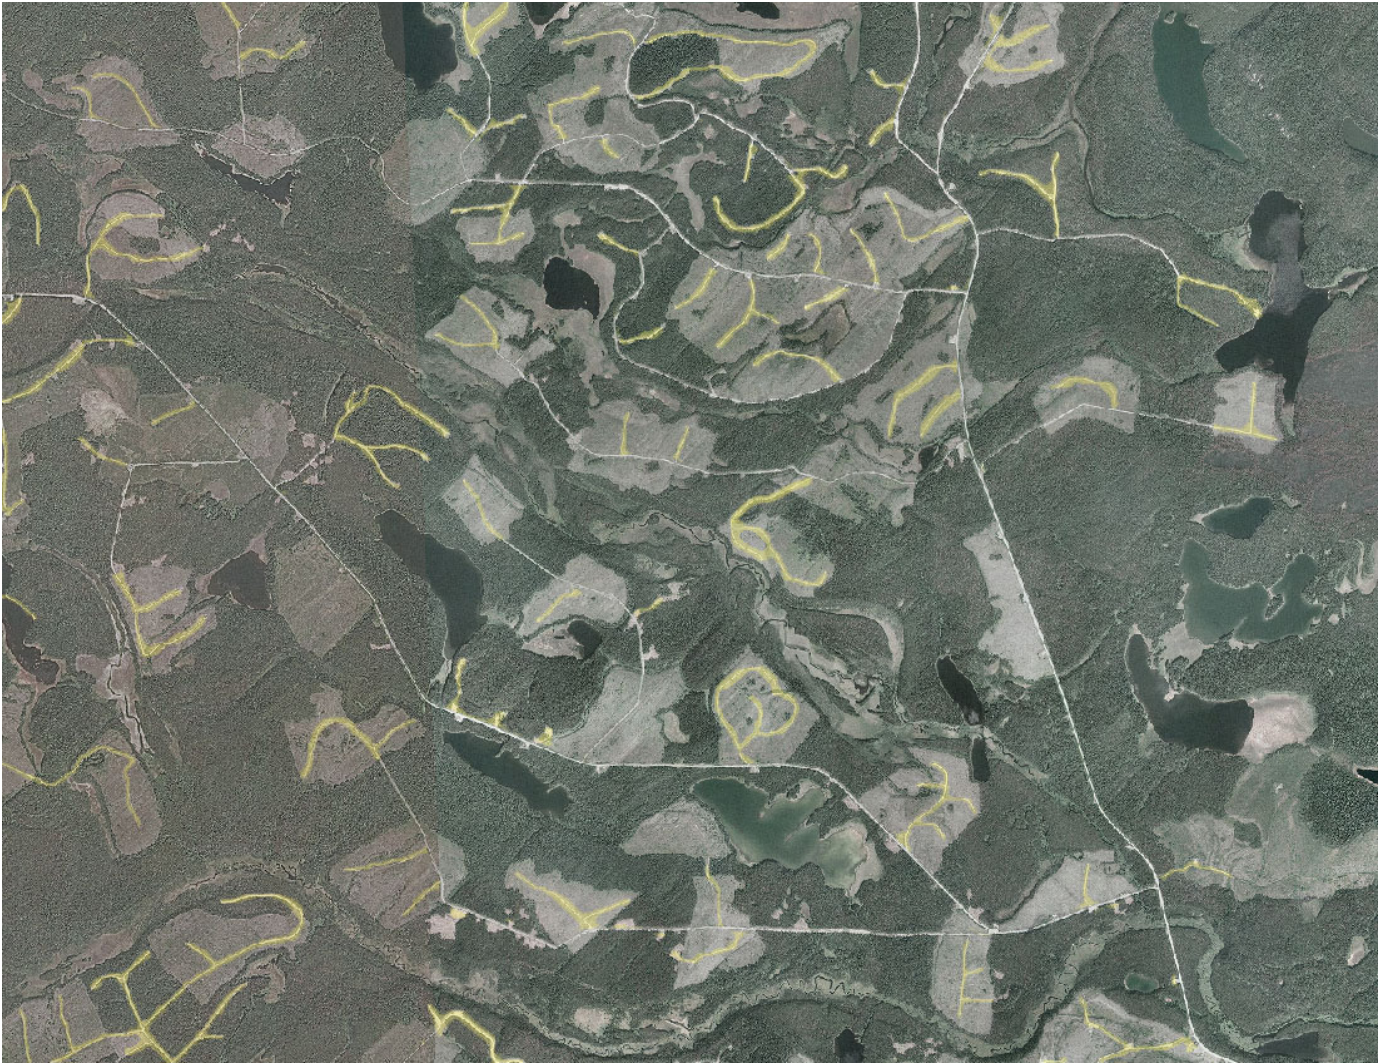
**Figure 1:** This aerial photograph, covering approximately 8500 hectares of intensively harvested low-relief terrain in northern BC, shows unrehabilitated TAS in yellow. The photograph shows 90% of cutblocks contained unrehabilitated TAS (generally roads), this TAS accounted for 1.4% of the overall area and 4.2% of the cutblock area. At this scale, the cumulative effect of accelerated drainage from these roads and the permanent access shown in white, could be significant.

As time passes after deactivation, drainage structures degrade and even deactivated roads can concentrate and accelerate run-off in the same way drainage ditches do. In steep terrain, this can result in landslide failures with significant off-site consequences. In low-relief terrain, increases in the peak flow of major drainage channels is a cumulative impact of road construction (see Figure 1).
