# Findings of Monitoring and Compliance Activities conducted May 13, 2015 at the Cobble Hill Holdings (Lot 23) & South Island Aggregates (Lot 21) sites

Ministry of Environment  
Ministry of Energy and Mines  
July 16, 2015

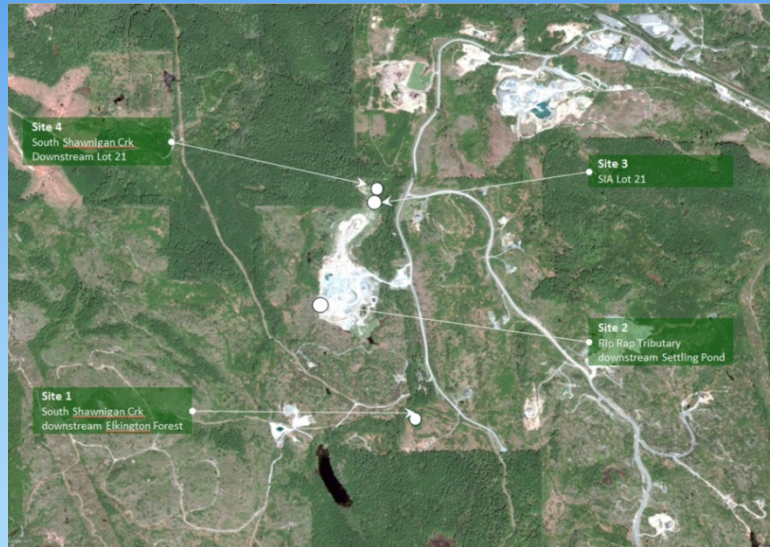
## Receiving Environment – Surface Water & Sediment:

- Tested for metals, chloride & physical parameters
- All WQ results met BCWQ guidelines and draft updated WQ objectives
- Metals results from Shawnigan Cr consistent with data collected by MOE in 2013
- Lot 23 sampling conclusions consistent with those from the permittee, based on 2015 sampling

- Sediments collected and analyzed for grain size, total metals, TOC & PAHs
- Similar results between background site & D/S discharge site
  - Elevated levels of Cr, Fe and Ni reflect natural conditions
- Elevated levels of some metals & PAHs in lower Shawnigan Crk
  - Possibly related to road runoff?
- U/S-D/S differences in Shawnigan Crk may be partially attributable to different particle size composition
  - More fines at downstream site

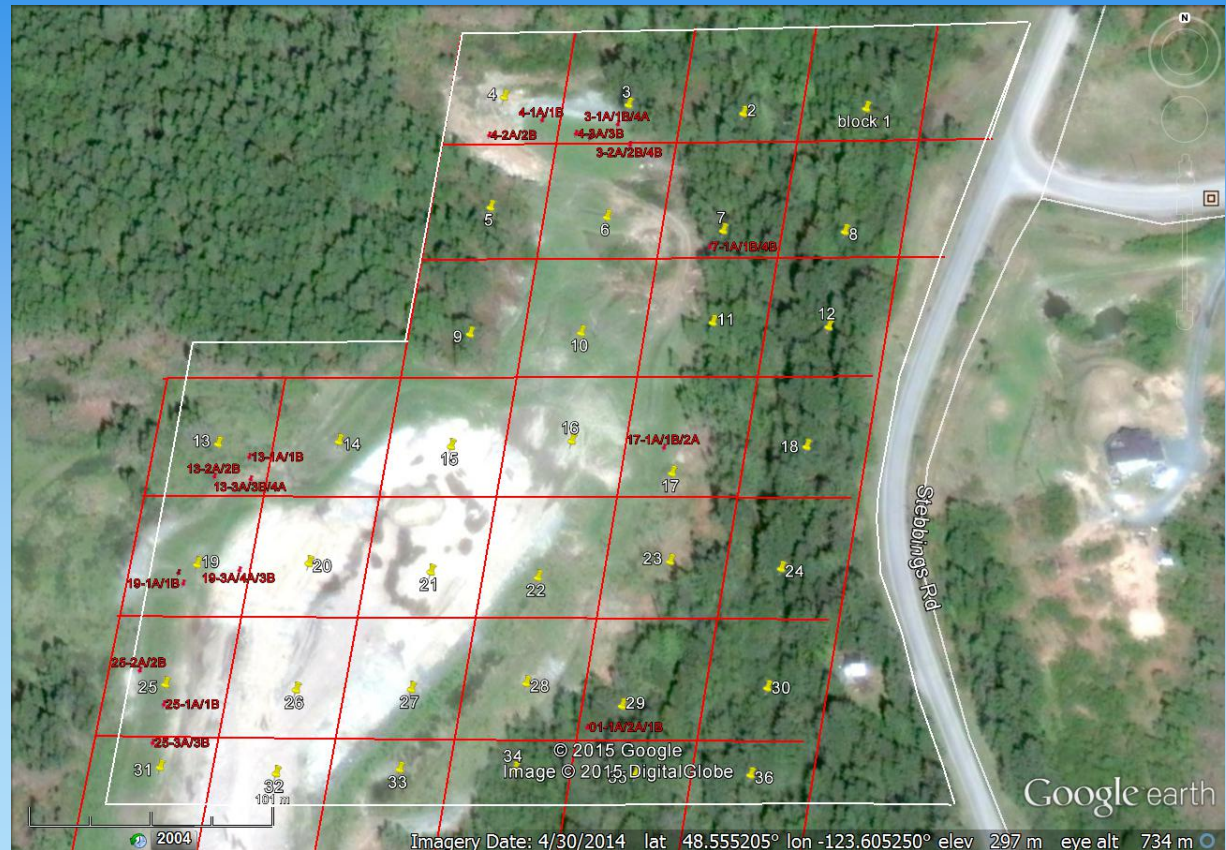
# Approach (Study Design)

- Sample plan based on 50m x 50m grid (sample block)
- 3 random samples from each block
- Surface and shallow (0.5m) sub-surface
- Total of 46 samples including 10 field duplicates

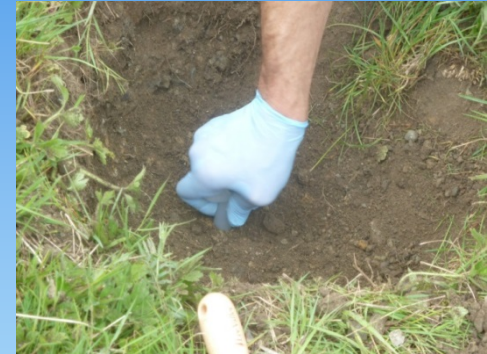
- Sampled for most common substances seen at BCcontaminated sites (metals, hydrocarbons, etc.)
- Analysis done at accredited labs
- Results interpreted by comparing with soil standards listed in CSRSchedules 4, 5 & 7.

## Findings

- Isolated and infrequent locations may marginally exceed relocation standards for Pb & Zn
- No exceedance of standards for protection of health & environment
- No further sampling is warranted
- Recommend that if soil is relocated from the site in the future, assess for metals

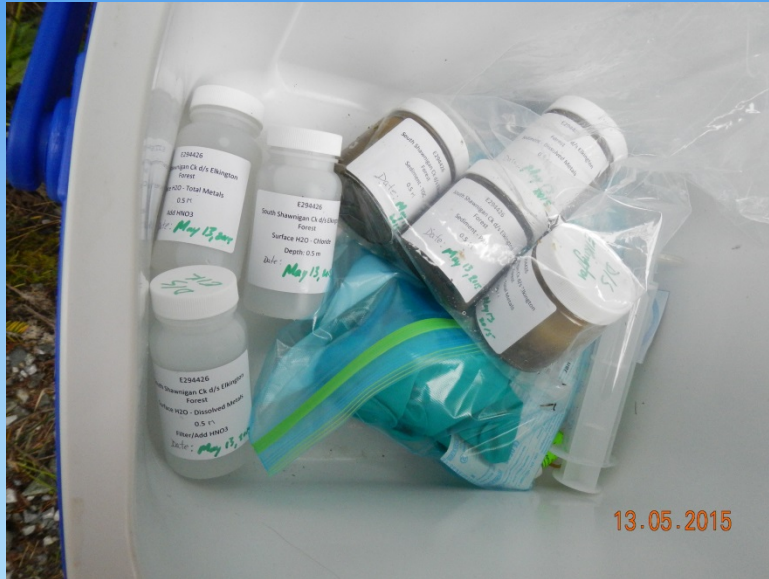
## Surface Water (4 sites)

- All results met BCWQ guidelines/objectives
- Results comparable to background and/or previous conditions
- Conclusions consistent with permittee data

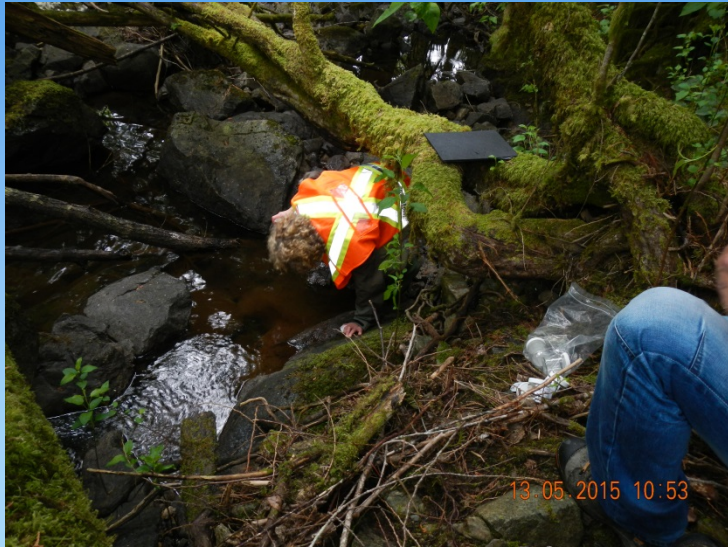
## Sediment

- Similar results between background site & D/S discharge site
- Elevated levels of some metals and PAHs on Shawnigan Crk – possibly related to road runoff
- U/S-D/S differences in Shawnigan Crk may be partially attributable to different particle size composition
