# LOG OF TEST HOLE

TEST HOLE NO.  
**00-1**

CLIENT: Capital Region Housing Corp.  
PROJECT: 280 Burnside Road West  
Prelim. Environmental Assessment  
DATE: May 31, 2000  
FILE NO.: 14-179-2      SCALE: 1:20

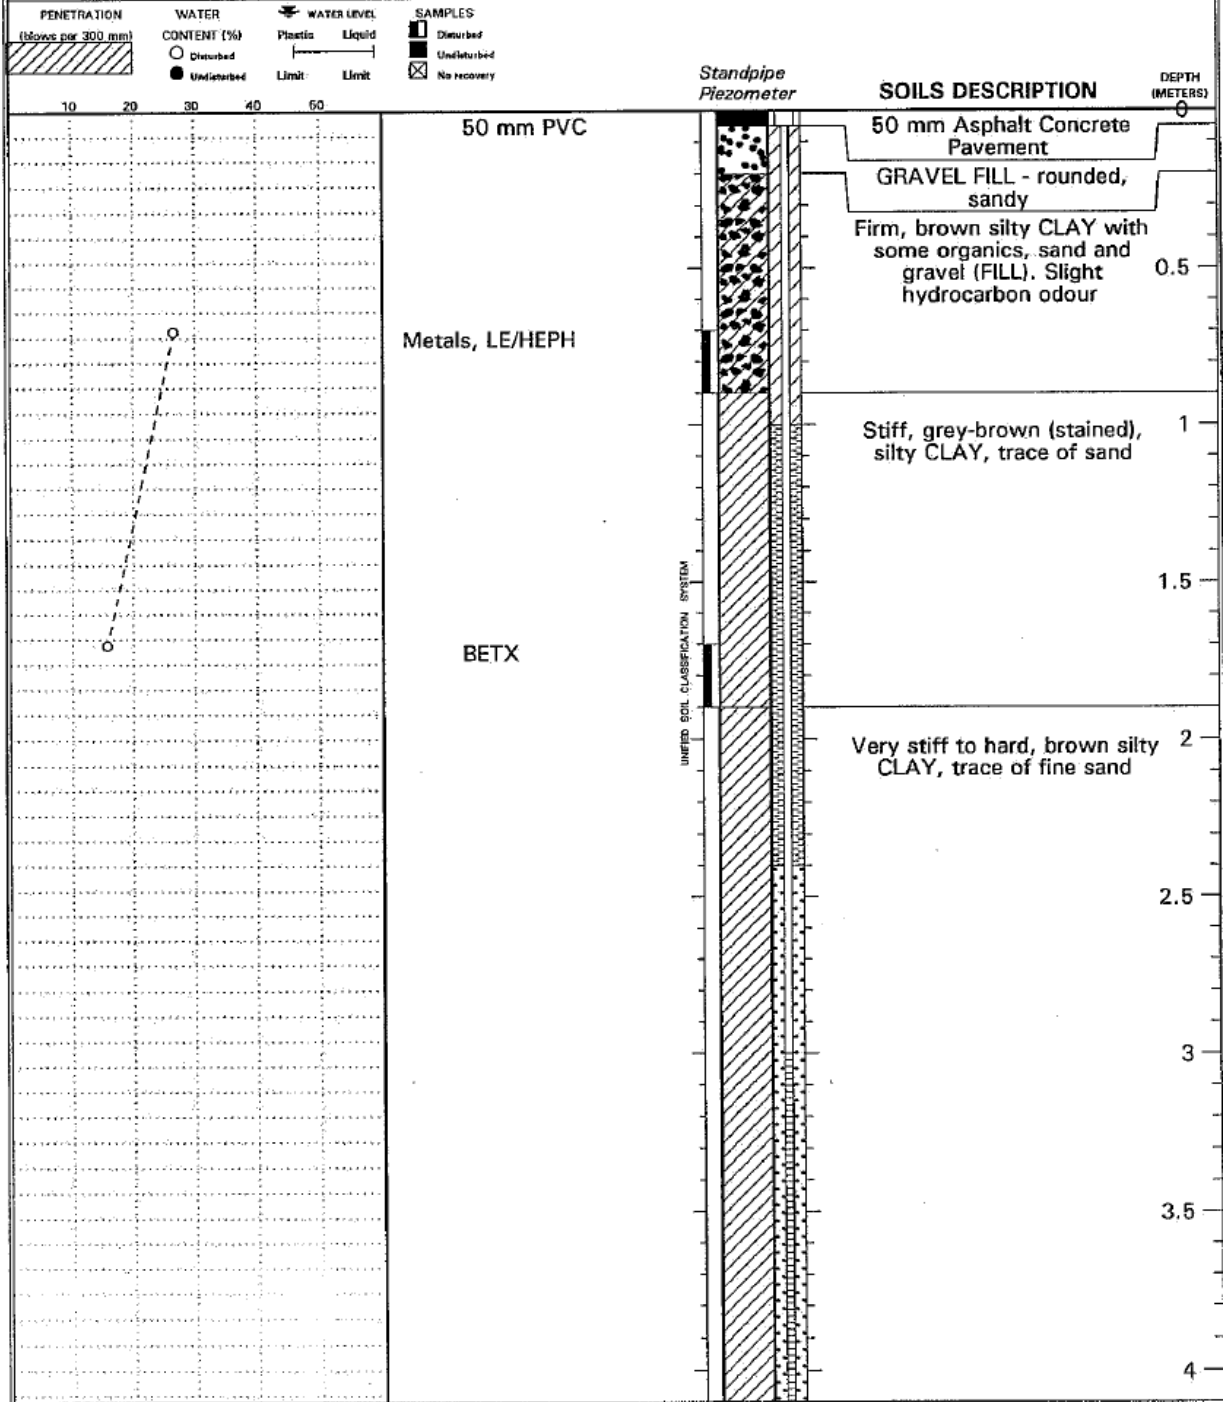
Sheet 1 of 2

LOCATION: Northwest corner  
See Dwg. 14-179-2-1  
TOP OF HOLE ELEV:  
METHOD: Truck-mounted auger  
DRILLING CO.: Drillwell  
INSPECTOR: TJB

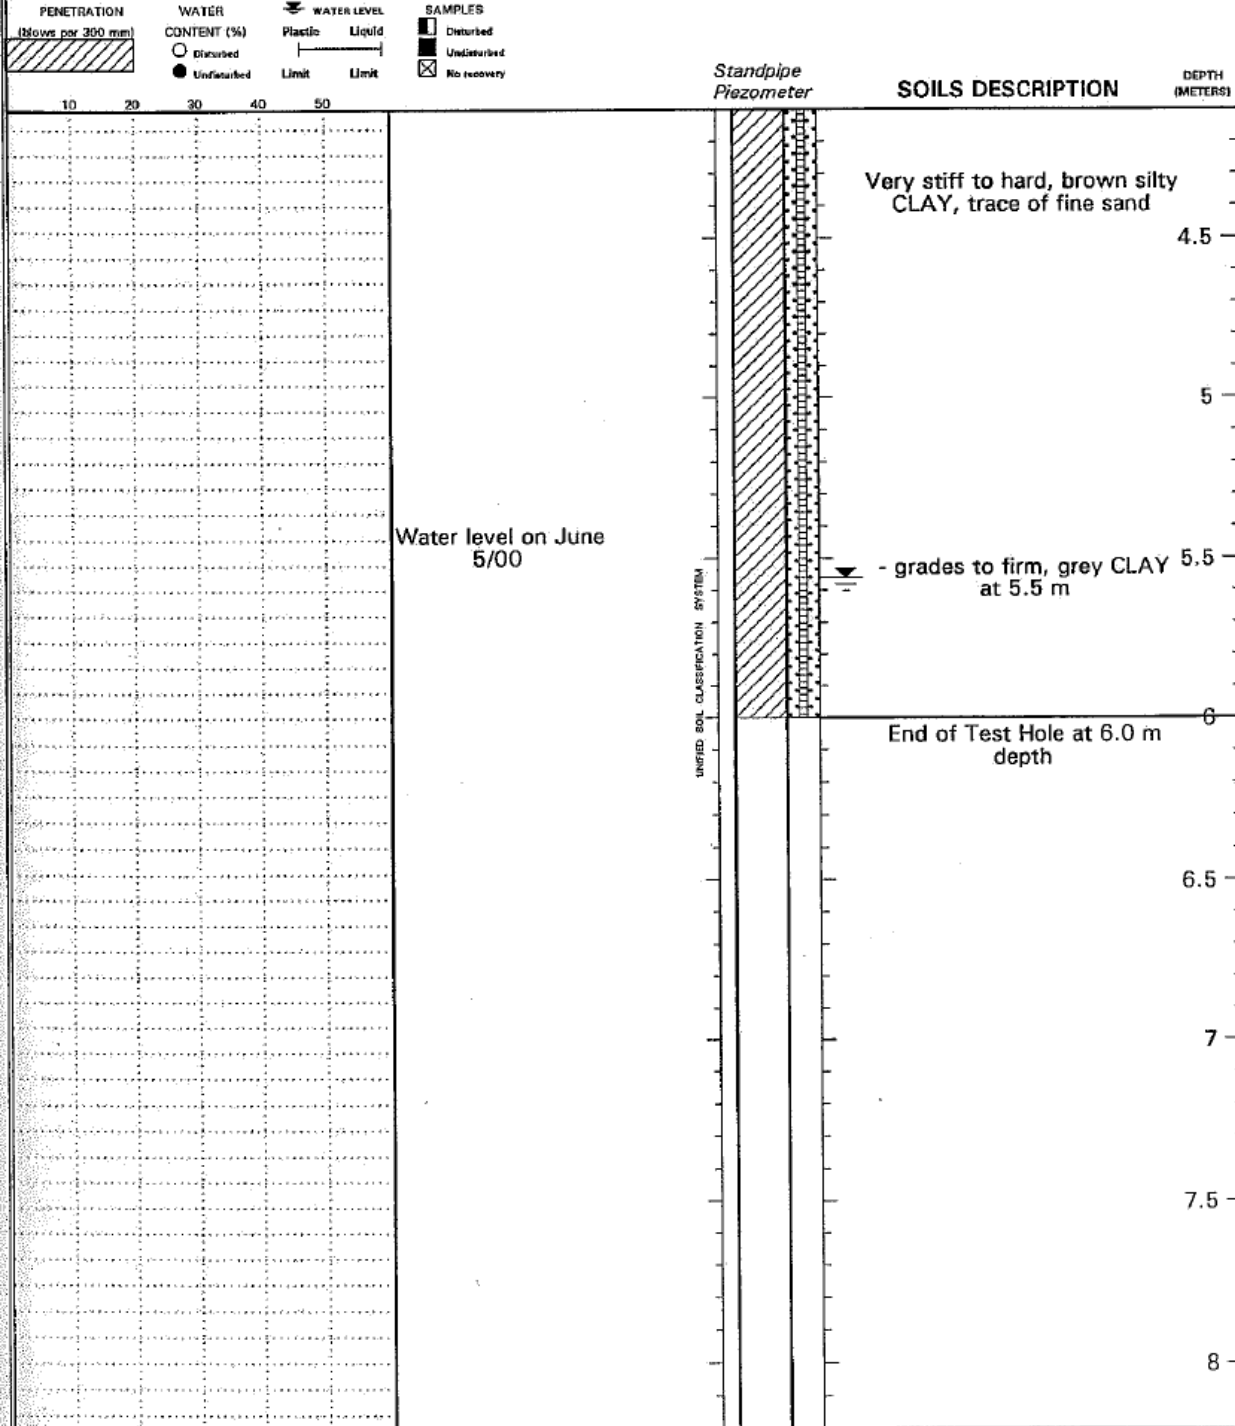
Sheet 2 of 2

LOCATION: Northwest corner  
See Dwg. 14-179-2-1

TOP OF HOLE ELEV:  
METHOD: Truck-mounted auger  
DRILLING CO.: Drillwell  
INSPECTOR: TJB
