WATER QUALITY MONITORING AGREEMENT

WATER QUALITY ASSESSMENT OF Fraser River

AT RED PASS (1984 – 2004)

March 2007

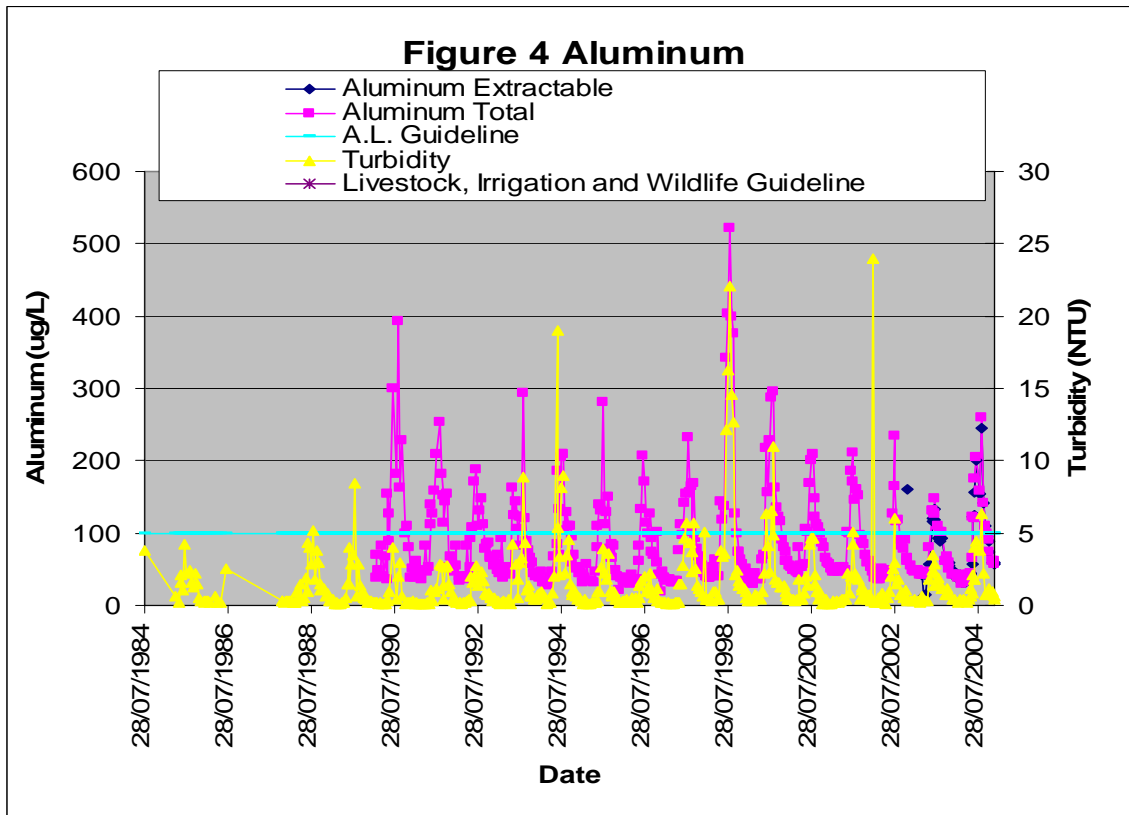
Total aluminum (Figure 4) exceeded the water quality guideline for the protection of wildlife, livestock and irrigation (5 mg/L) once. The highest values occurred in August and September of 1998, concurrent with high turbidity values (see Figure 4), which suggests that the majority of the aluminum was associated with particulate matter and not in the dissolved form. Aluminum is the most common metal on the planet, comprising 7-8% of the earth's crust, so it is not surprising to find that levels vary in proportion to the amount of sediment (turbidity) in the water. However, it is recommended that the concentration of dissolved aluminum be measured in the future to allow a useful comparison with the guidelines for aquatic life and drinking water. No change was noted in total aluminum concentrations over the duration of record.

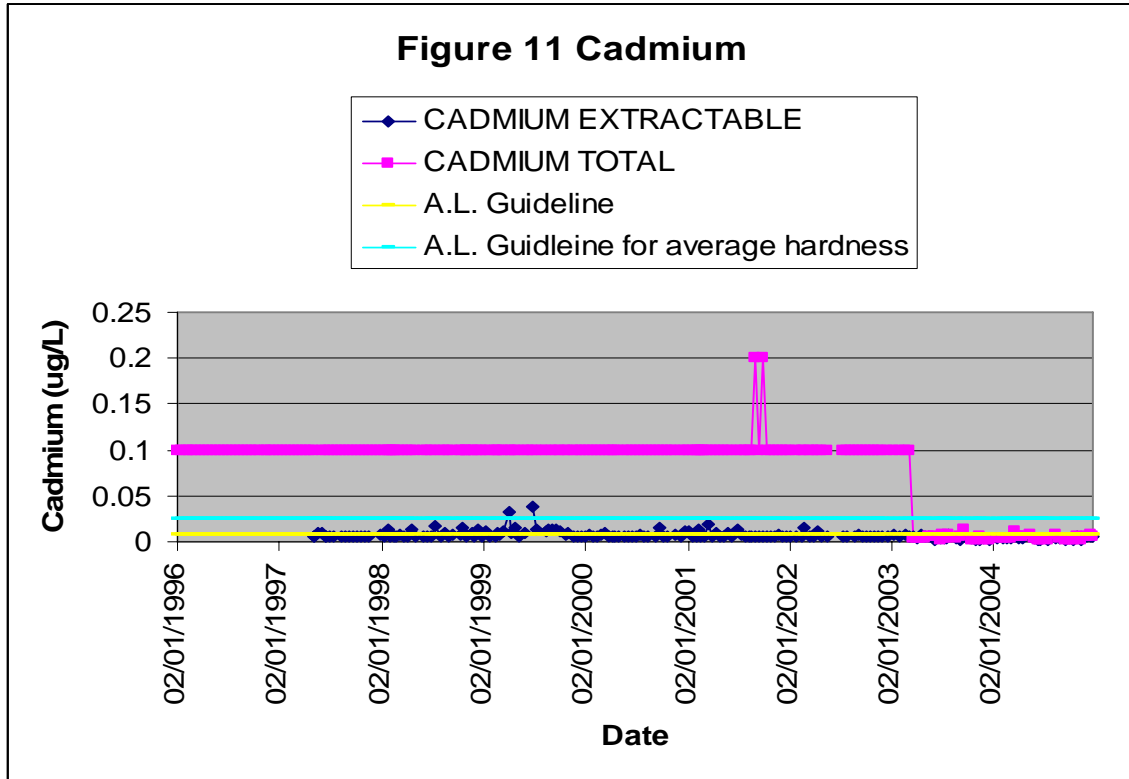
Cadmium concentrations (Figure 11) have been hampered by high levels of detection that have made interpretation of results difficult. Detection limits have improved in 2003

and 2004 to 0.001 µg/L and values usually are less than the guidelines for the protection of aquatic life (0.008 µg/L) at minimum hardness of 20 mg/L and 0.024 µg/L at average hardness of 70 mg/L. No values have exceeded the guideline for the respective hardness since the detection limit has changed. In our analysis, we removed one suspected error/outlier from the data set: a value of 4 µg/L on September 16, 1985 when the level of detection was 1 µg/L.

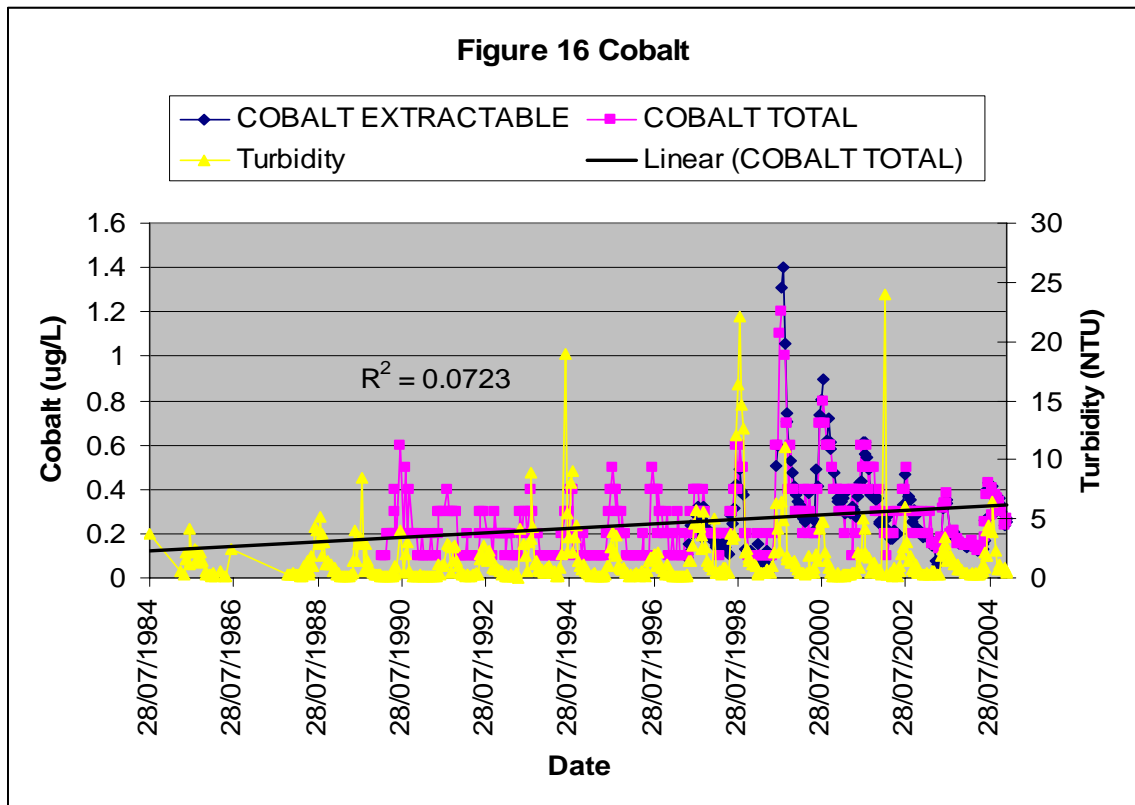
Total cobalt has shown a slight increase during the period of record (Figure 16), although concentrations have not exceeded the B.C. guidelines for the protection of aquatic life (4 µg/L).

- There may be slight increases in cobalt, rubidium, and dissolved nitrogen and dissolved sulphate.
- There appears to be a decreasing trend in lead concentrations and a possible increase in manganese. These trends may be related to the elimination of leaded gas and the use of a manganese-based additive.

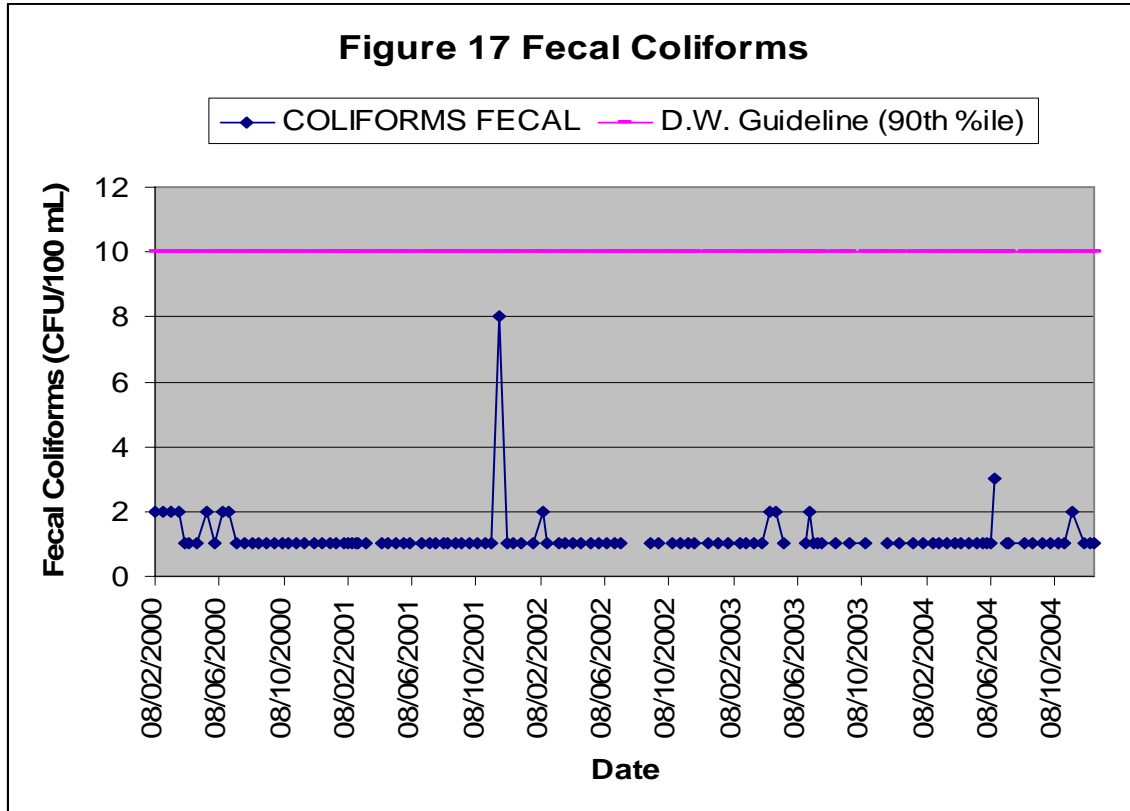
Fecal coliform concentrations have only been measured at Red Pass since early 2000 (Figure 17). All individual values were below the 90th percentile guideline for the protection of drinking water that will receive only disinfection (10 CFU/100 mL). Two suspected errors were removed from the data set: <59 CFU on September 3, 2003 and <13 CFU on November 12, 2003.

- All fecal coliform values were very low, indicating little fecal contamination of the Fraser River was occurring upstream from Red Pass.
- True colour has only been measured at Red Pass since 1997, but all values since that time have been below the aesthetic guideline for drinking water quality.

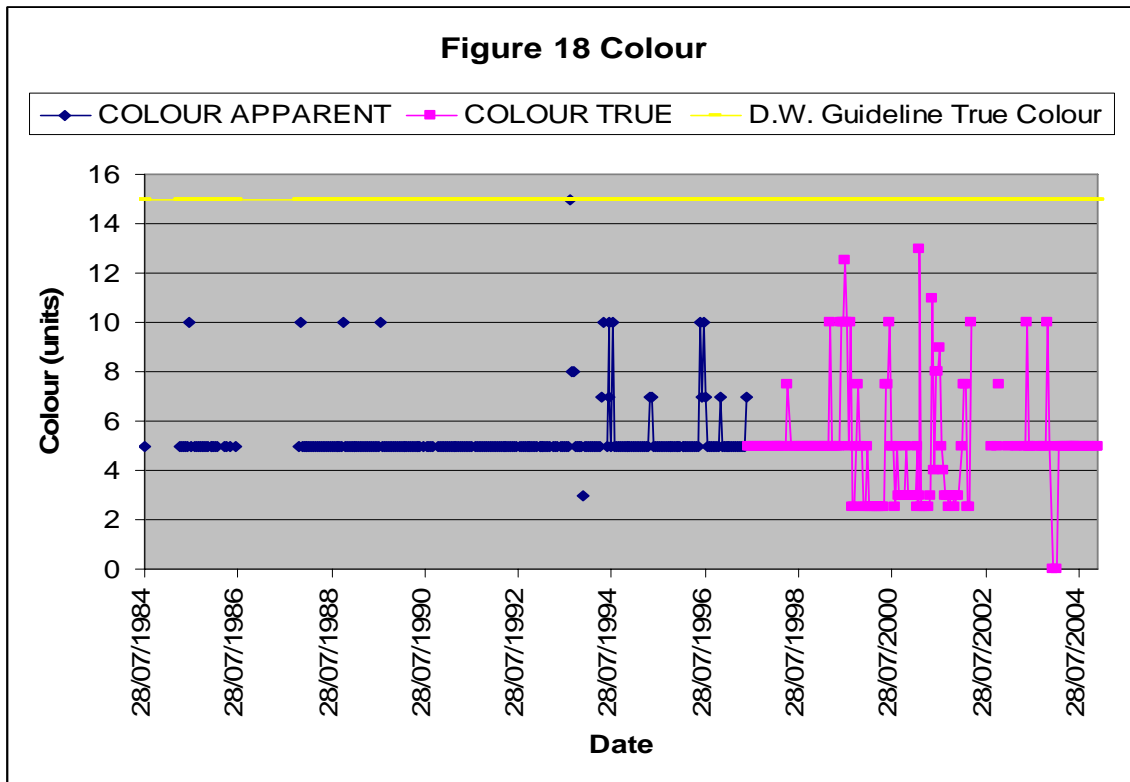
True colour values (Figure 18) are below the aesthetic guideline for drinking water of 15 TCU. All apparent colour values were at or below that guideline.

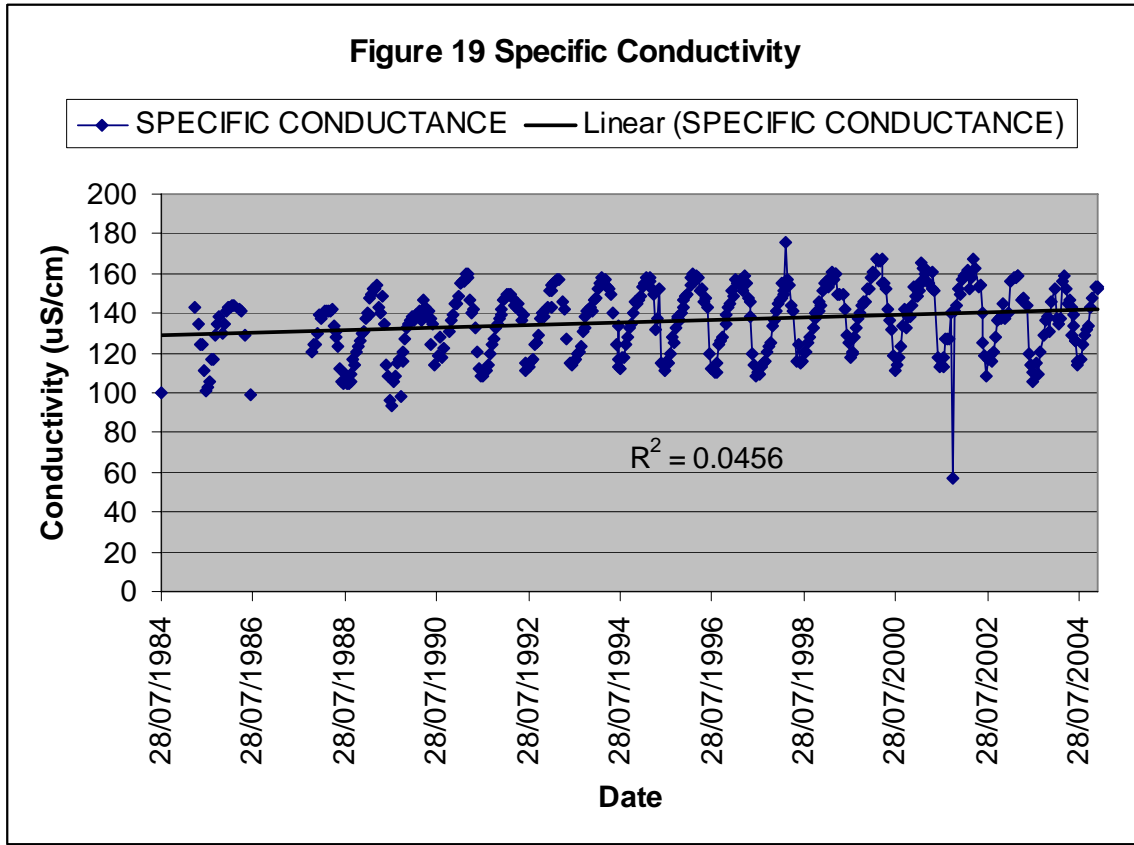
Specific conductivity values (Figure 19) appear to be increasing; however, when the data before 1992 are excluded, there is no increase. All values are well below guidelines values, and this increase is not a cause for concern. Conductivity values generally increase with lower water levels (ions become more concentrated). In our analysis, we removed one suspected error/outlier: 408 µS/cm on April 25, 2001

- Specific conductivity also appeared to be increasing over time, but the levels seem to have remained steady since about 1992. Similar patterns were noted for hardness.

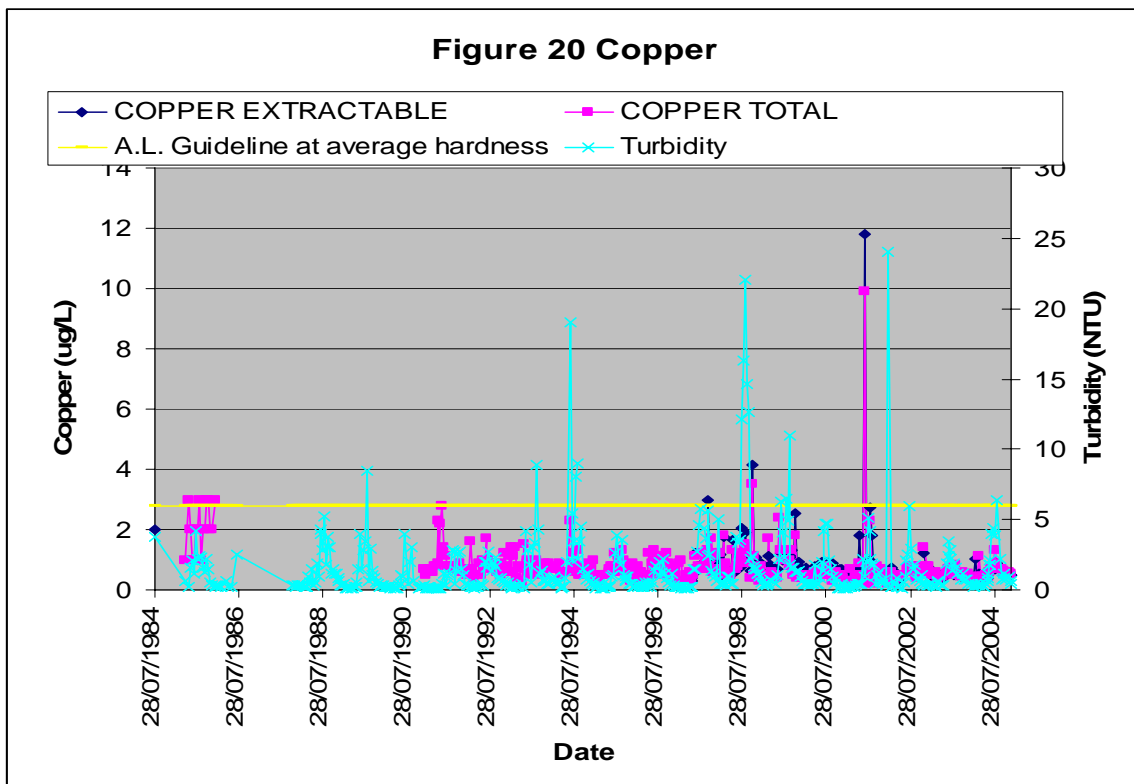
Total copper (Figure 20). The aquatic life guidelines for copper are hardness-dependent. The guideline corresponding to the average hardness was exceeded on only a couple of occasions by individual samples; however, these were related to high suspended solids concentrations. This suggests that much of the copper present at these times was associated with particulate matter which decreases its availability to biota. There does not appear to be any change in total or extractable copper concentrations over time.

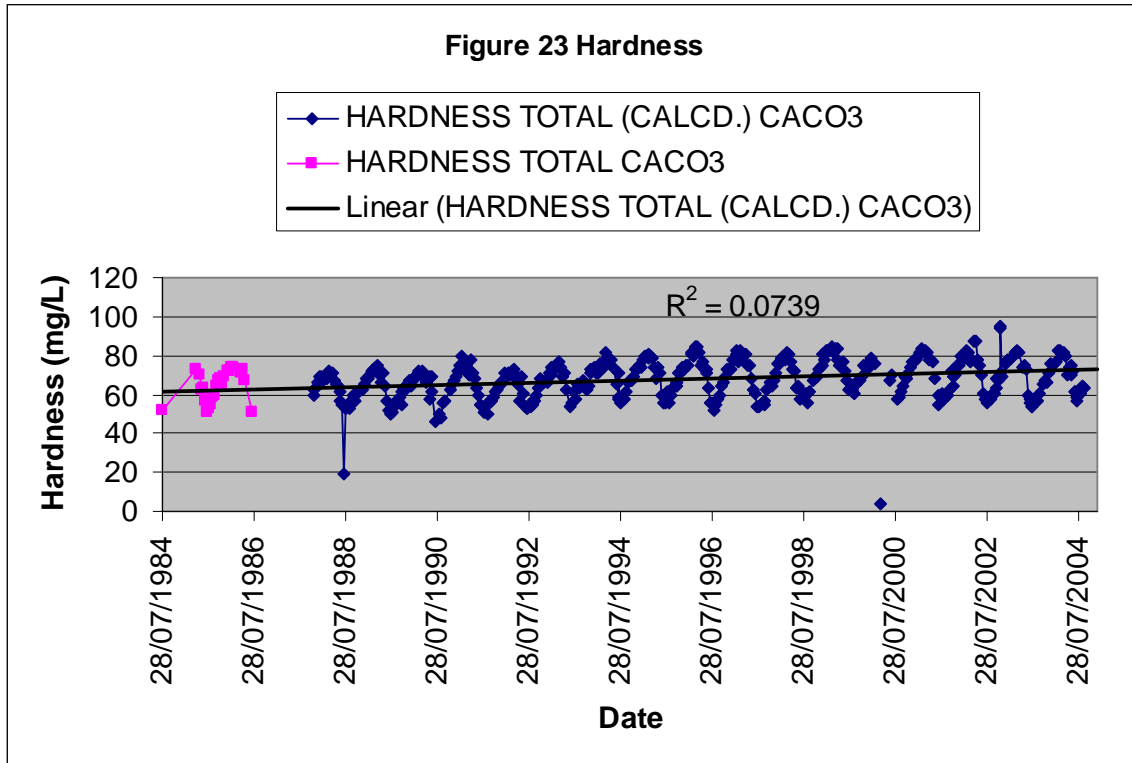
Hardness concentrations (Figure 23) appear to be increasing from the early 1980's; however, when the data before 1992 are excluded from our analysis as we did for specific conductivity, there is no apparent recent trend.

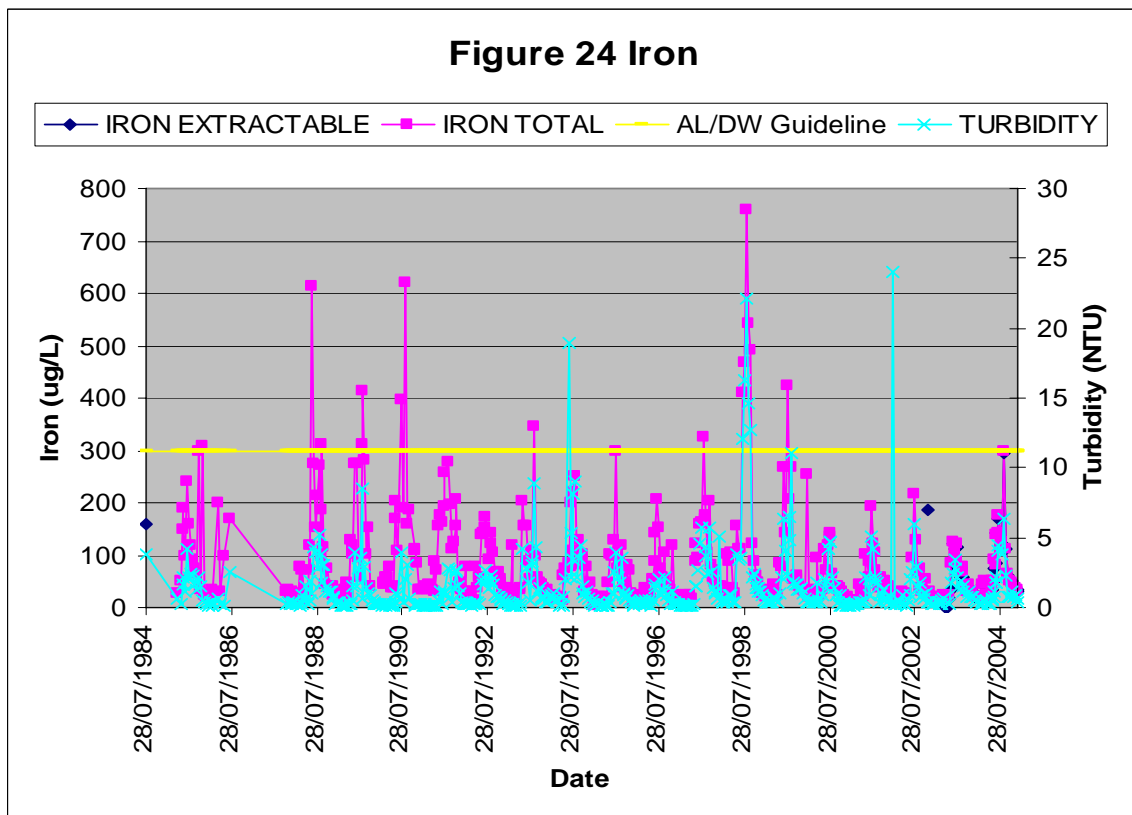
Total iron (Figure 24) concentrations exceeded the aesthetic drinking water and aquatic life guideline of 0.3 mg/L on occasion. These exceedances occurred almost invariably between July and September, when turbidity levels were relatively high. The occasional high concentrations of iron at Red Pass are due to natural sources, as there are no known human sources of iron upstream from this point. There was no apparent change in iron levels over time.

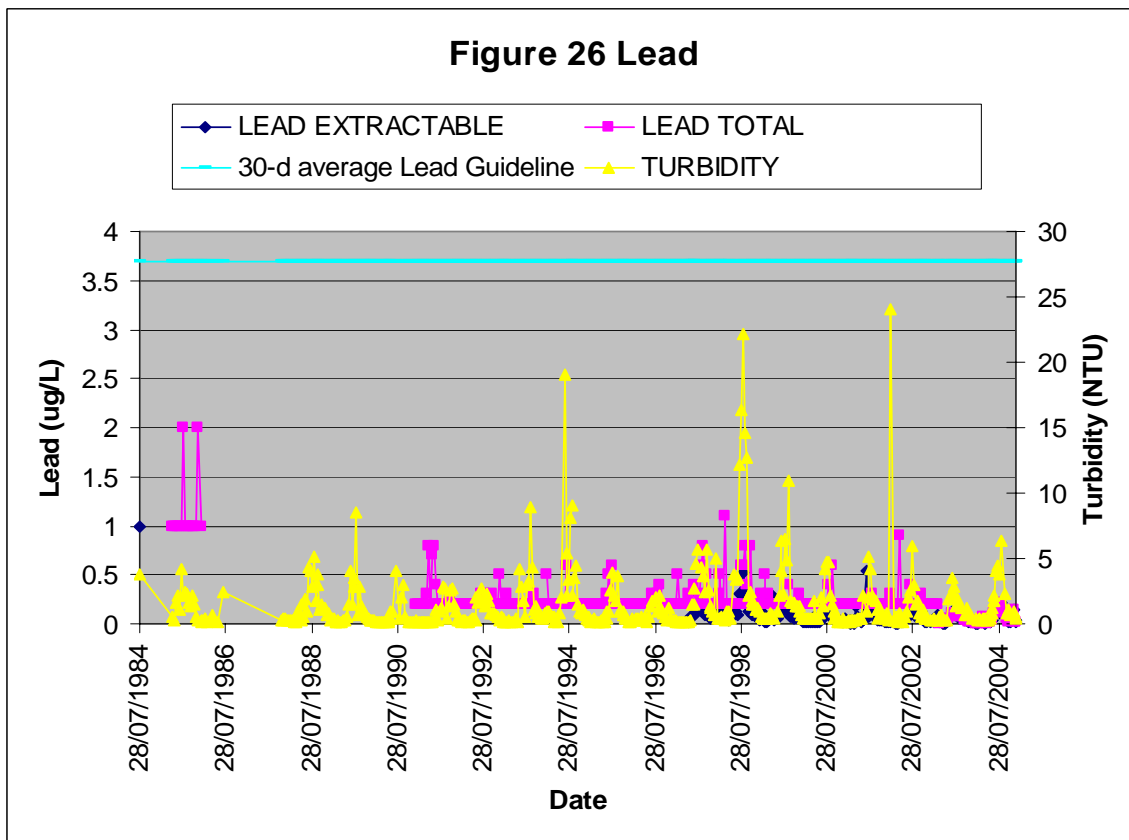
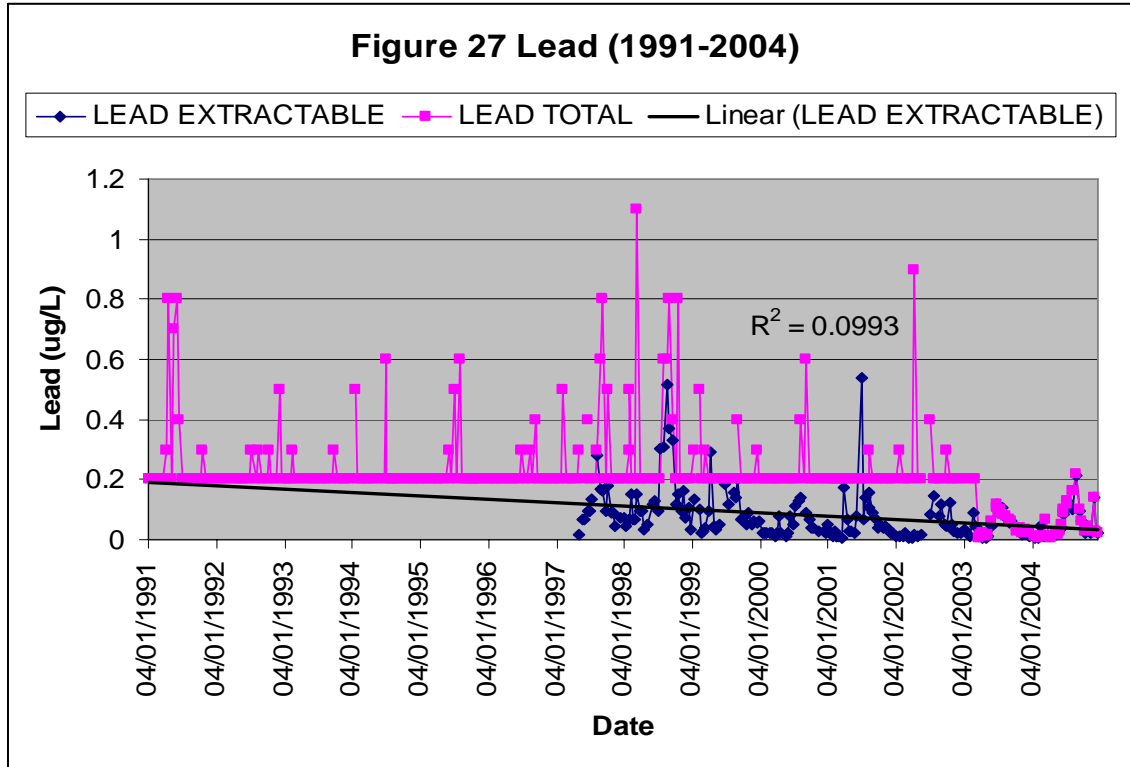
Guidelines for **total lead** (10 µg/L for drinking water and 30-day mean of 3.7 µg/L for aquatic life) were not exceeded by any samples collected between 1984 and 2004 (Figure 26). There appears (Figure 27) to be a trend of lower extractable lead concentrations during the 1991-2004 period. There seems to be some correlation between total lead concentrations and turbidity.

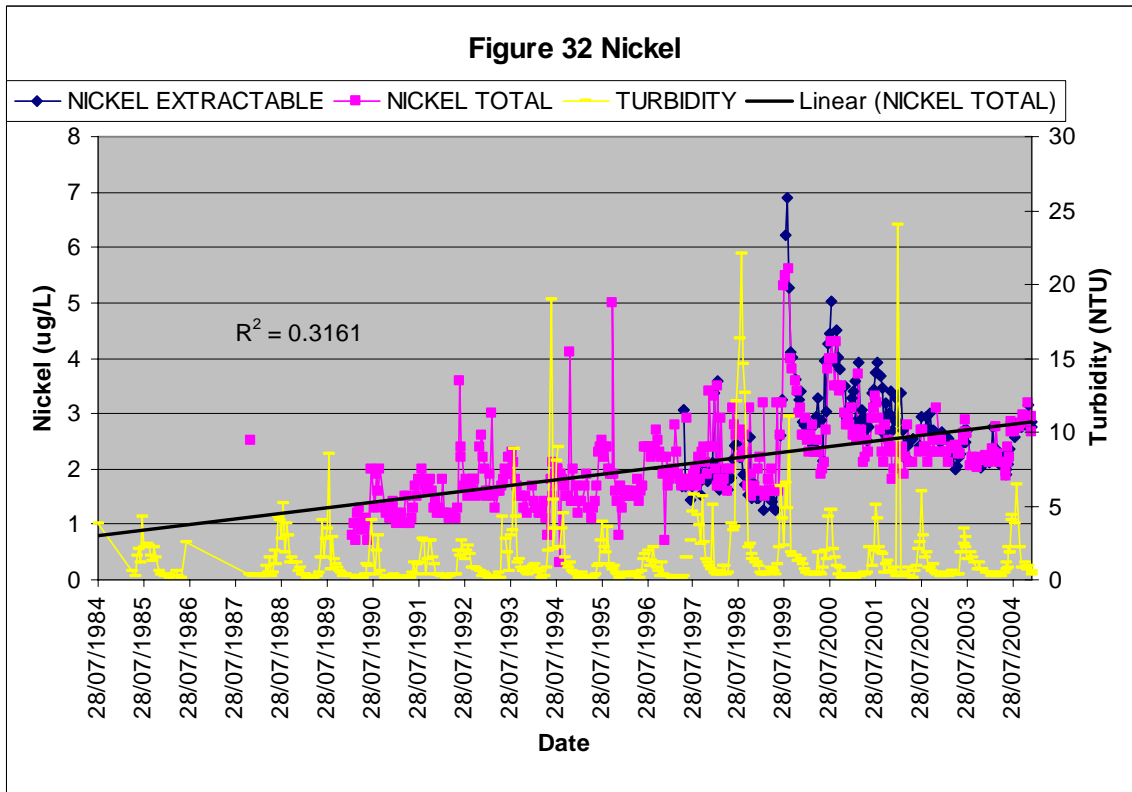
Total nickel values measured at Red Pass during 1990-2004 were considerably below the guideline for the protection of aquatic life of 25 µg/L at a hardness of 0 to 60 mg/L. There appears to have been a gradually increasing trend in total nickel concentrations over time at this site (Figure 32), which has been reduced in scope in the period 1995 to 2004 (Figure 33). However, the levels were well below guidelines and are therefore not of environmental concern at this time. Total and extractable nickel values were similar and did not seem to be correlated with turbidity.

- There was an increasing trend in nickel concentrations since about 1994, although it has been reduced in magnitude in recent years. The cause of this increase is unclear, but concentrations of total nickel remain well below guideline levels for aquatic life.

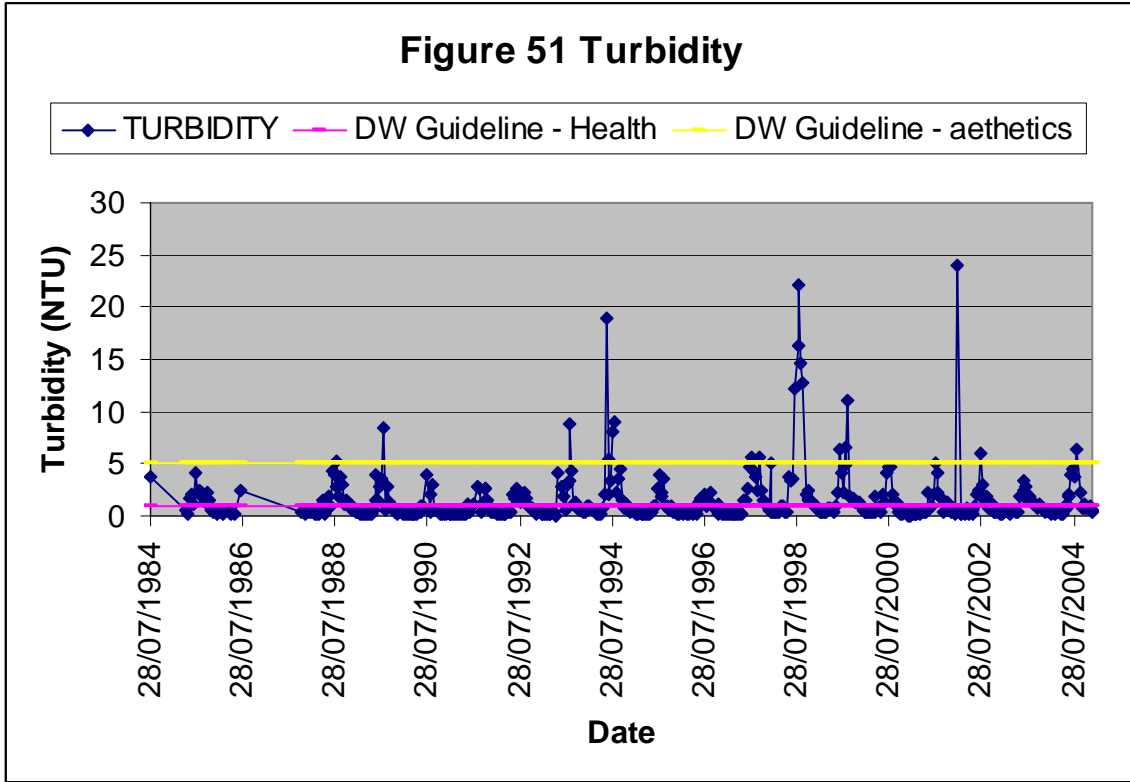
Turbidity values frequently exceeded both the drinking water guideline for health (1 NTU), and occasionally exceeded the aesthetic drinking water guideline (5 NTU) (Figure

51). This indicates that the water would require partial treatment (*e.g.*, filtration) plus disinfection before use as drinking water.

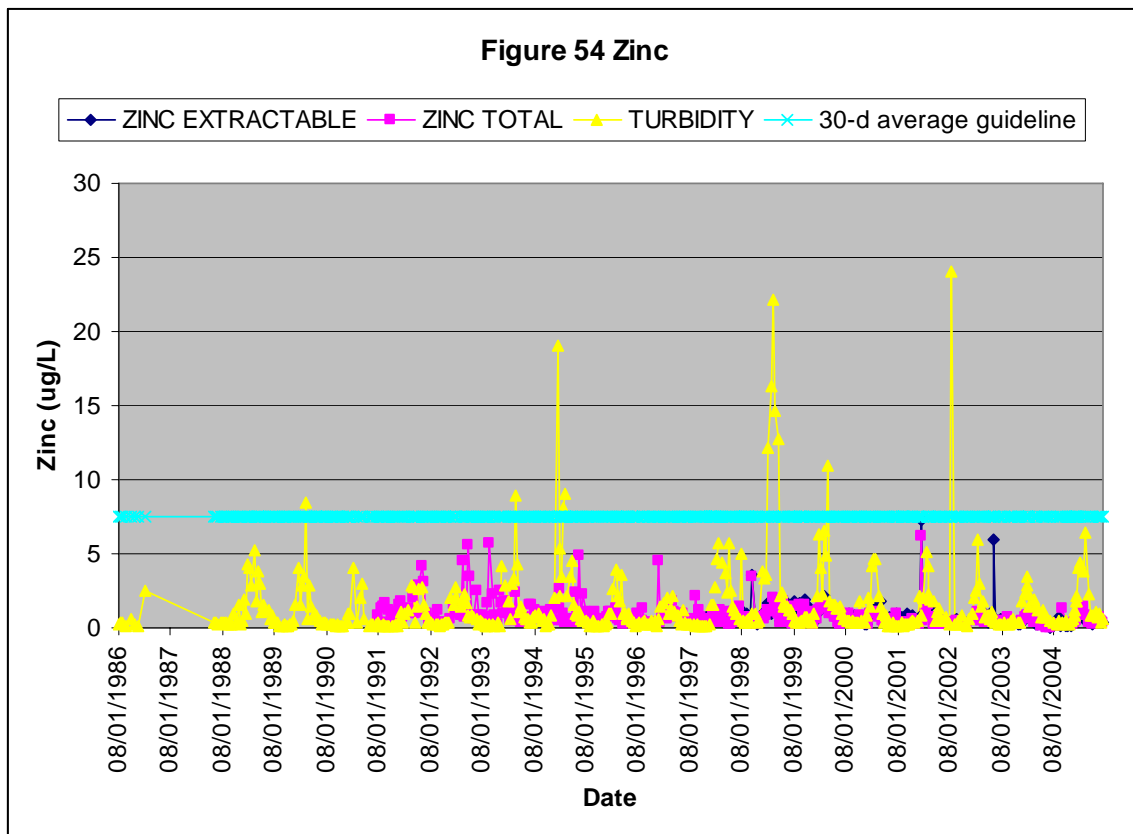
The aquatic guidelines for **total zinc** are dependent on hardness and zinc concentrations appear to be correlated with turbidity events. The aquatic life guideline is a 30-day average of ≤ 7.5 $\mu\text{g/L}$. No individual zinc values have exceeded this guideline over the period of record (Figure 54). It does not appear that zinc concentrations are changing over time at this site. Concentrations of extractable zinc were similar to those of total zinc. There are no known human sources of zinc in the upper Fraser River watershed.
