Assessing Fish Passage at Culverts – the method, its metrics and preliminary findings from over 4,000 assessments.

Richard Thompson, Ministry of Environment , Richard.Thompson@gov.bc.ca

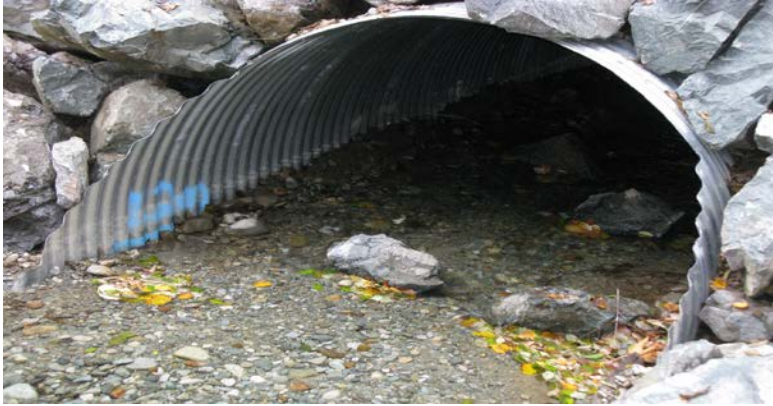
What is Embeddedness? This indicator is a measure of the stream bed material within a culvert (Figure 1). Assessors are asked to determine if a natural stream bed continuously covers the bottom of the culvert and the depth of cover. A culvert with a natural stream bed is assumed to have similar roughness and velocity shadows to allow fish to pass through the culvert as if they were in an undisturbed segment of the stream. The depth of material is an important measure as it relates to the probability of the stream bed being scoured from the culvert exposing the bare culvert which results in velocity increases.

Figure 1: Properly embedded culvert. Streambed is continuous and 40% of culvert diameter.

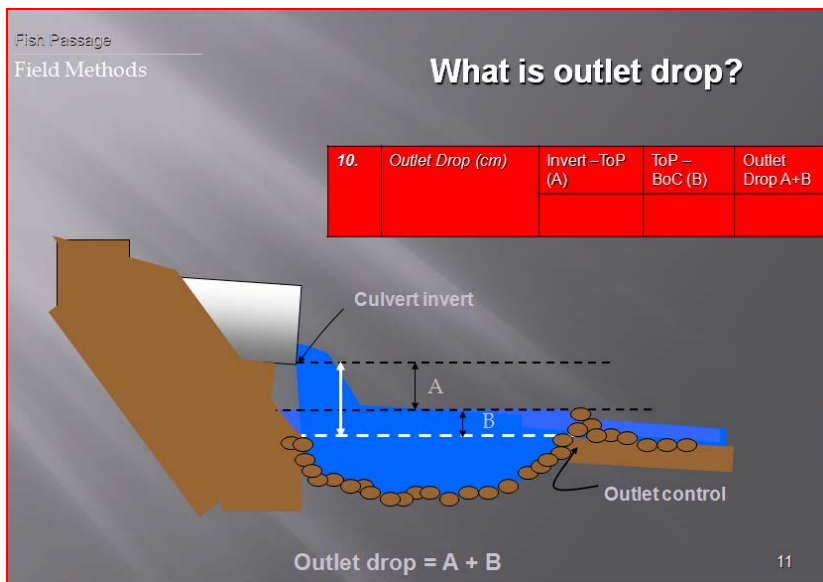
What is outlet drop? Outlet drop is the distance from the invert (bottom) of the culvert to the top of the residual pool (Figure 2). The residual pool is the pool that would remain at the point that water just stops flowing out of the pool. The measurement is made to the residual pool to ensure that the measurement is consistent regardless of the current flow in the stream. Outlet drop is an important consideration as fish have limited ability to jump.

Figure 2. Outlet drop measured from the culvert invert to the top of the residual pool.

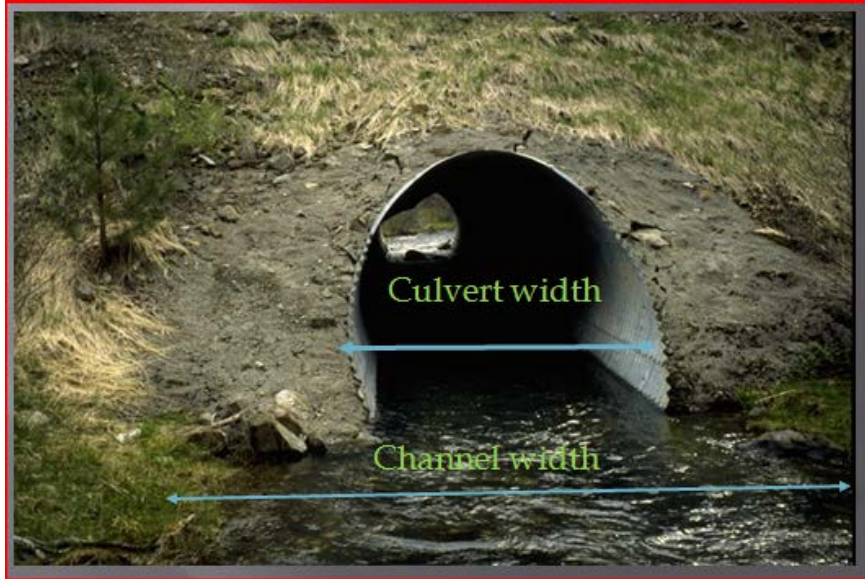
What is stream width ratio? The Stream Width Ratio is simply the ratio determined by stream channel width divided by the culvert width. This ratio is an indication of channel constriction (Figure 3) which results in increased velocities within the culvert.

Figure 3. Stream width ratio.

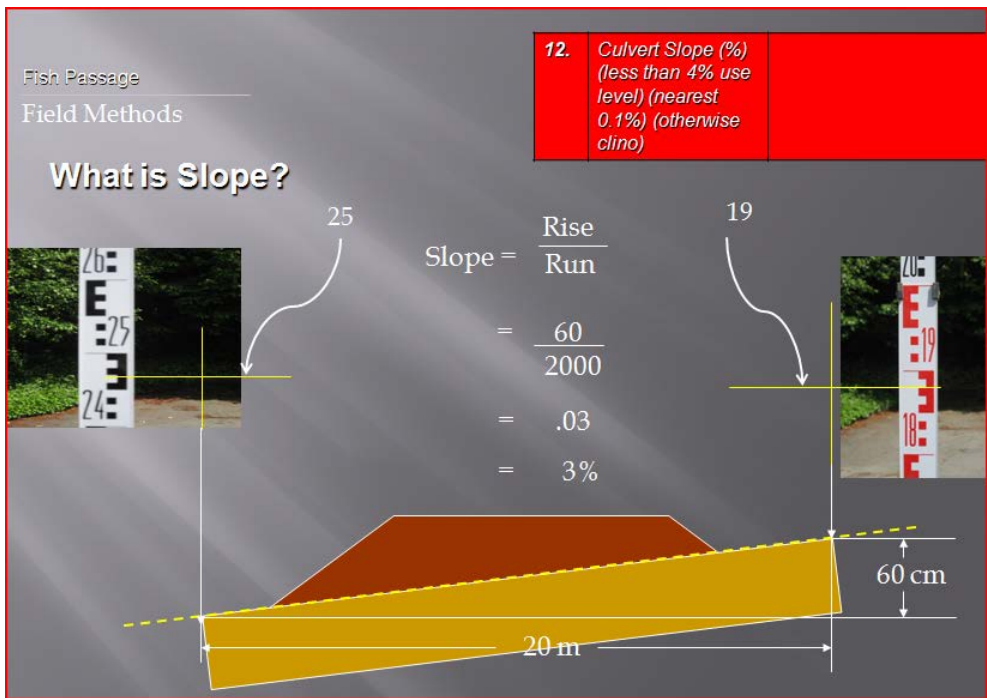
What is culvert slope? This is a measure of the angle of the culvert and is calculated by measuring the difference in elevation from the outlet to the inlet divided by the horizontal distance between the outlet and inlet of the culvert (Figure 4). Flume studies done in Washington State and Manitoba (Powers, 1997.; Kehler 2009) have shown that bare culverts at slopes greater than 1.0 % can be a barrier to juvenile salmonid movement. Because such a small difference in slope can be problematic for fish the current methodology calls for the use of an engineering level to more accurately measure the slope of the culvert where the slope as measured with a clinometers is less than 4%. A common error often made by assessors is to assign too high a level of accuracy to clinometers. Clinometers are typically accurate to plus or minus 2%.

What is culvert length? This is a simple measurement of the length of the culvert from the inlet to the outlet. Fish have limited ability to maintain their highest speed (burst velocity typically 1 to 6 seconds also known as darting speed) This metric is not independent of culvert slope and stream width ratio but recognizes that a longer high slope culvert will be more difficult for a fish to pass than a shorter culvert.

Figure 4: Culvert Slope and length.

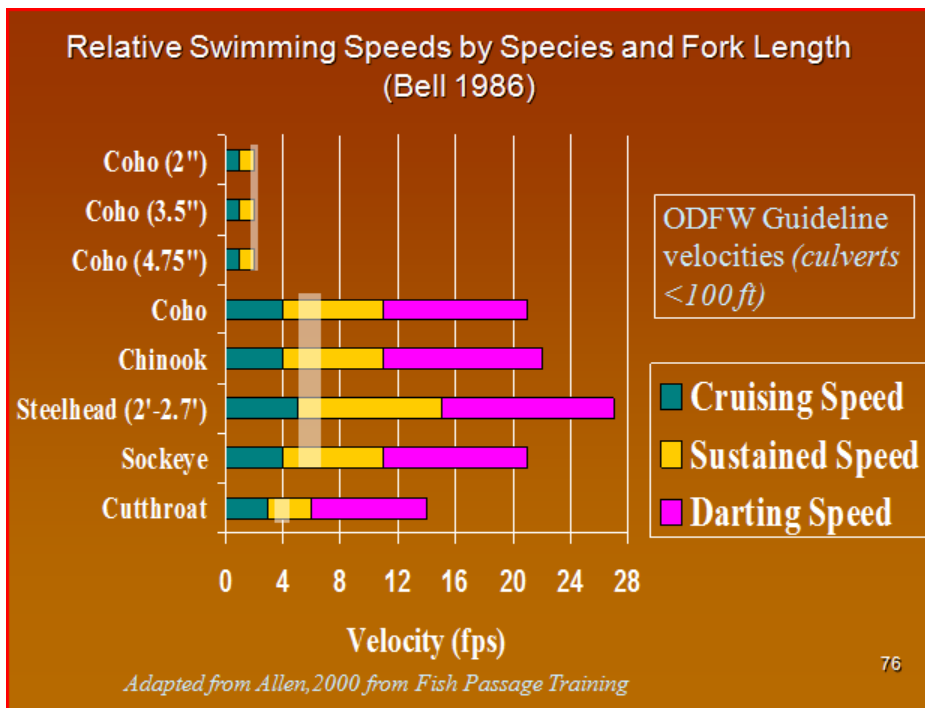
The values associated with each of the indicators in the barrier determination model were developed based on information available on fish swimming ability which is a function of species and size (Figure 5). A juvenile Coho does not have the same swimming ability as an adult Coho similarly an adult Grayling is a weaker swimmer than an adult Steelhead. The indicator scores reflect the best estimation for the passage of a juvenile salmon or small resident rainbow trout.

Figure 5 – Fish Swimming Ability.
