GIS Modelling of Fish Habitat and Road Crossings for the Prioritization of Culvert Assessment and Remediation

Craig Mount, Simon Norris, Richard Thompson, and David Tesch

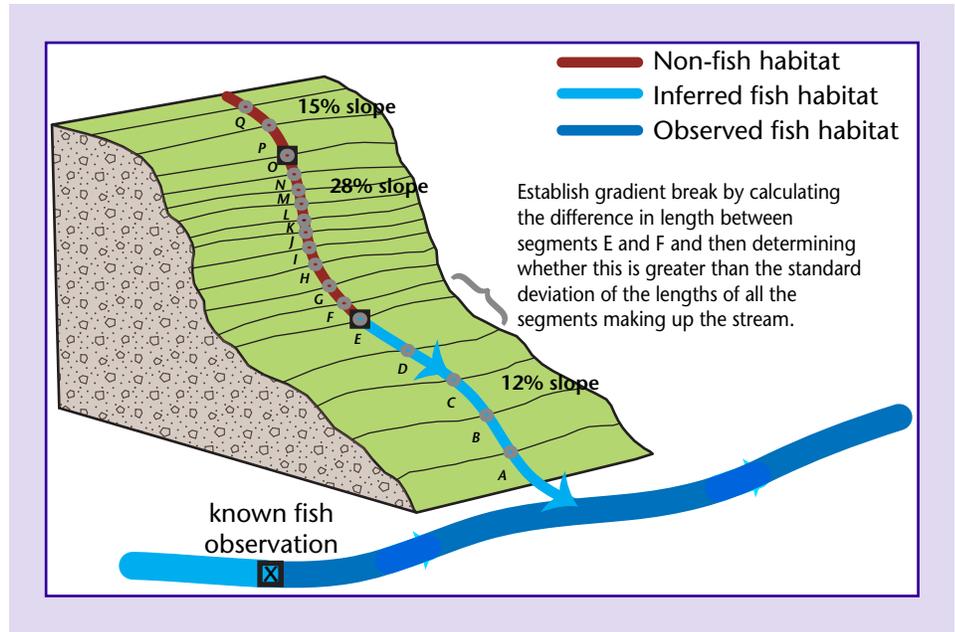
Figure 1. Method used to determine gradient breaks and habitat designation.

Stream gradient segments were created by splitting the FWA Stream Network lines at each intersection with a 20 m contour line (TRIM Contour Lines), thereby creating a highly segmented stream line. The length of these individual segments served as a useful surrogate for slope. In areas of low slope, a larger distance occurs between contours and, as a result, longer segments were generated. Conversely, steeper slopes generated short line segments. A rolling nearest neighbour analysis was employed, whereby the length of each segment was compared to that of its immediate neighbours. Where the difference in the lengths of two adjacent stream segments was greater than the standard deviation of the lengths of all the segments making up the given stream, a significant change in slope is deemed to occur. Breaks in the stream at contour lines were removed except at these identified points, creating the stream gradient segments. Slope of individual stream gradient segments was then calculated using their length and endpoint elevations. This measure of slope was then available as an input to the fish habitat model (see Figures 1 and 2).

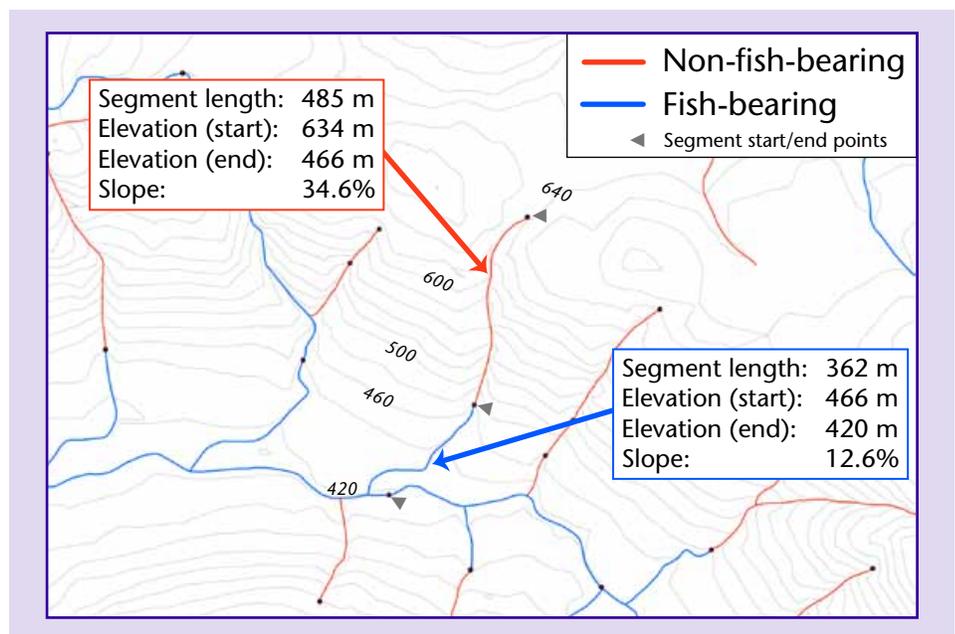
Figure 2. Example of stream segment breaking based on channel gradient. Difference in length of these two adjacent segments (defined by contour crossings) is greater than the standard deviation of all the segment lengths in that stream and therefore a break is generated. The gradient of the stream segment below the break is $x\%$ (fish-bearing), whereas above the break it is $x\%$ (non-fish-bearing).

To model fish habitat, all streams segments downstream of a known Fish Observation Point ($n = 160\ 000$) were considered fish-bearing, and classified as “Fish Habitat – Observed.” Then, starting at the bottom/mouth(s) of the watershed group and working up the Freshwater Atlas Stream Network, streams were classified as fish-bearing until encountering a barrier feature. Segments upstream of any known fish observation but downstream of any barrier feature are classified as “Fish Habitat – Inferred.” Stream segments upstream of barrier features are classified as “Non-Fish Habitat” (See Figure 2).
