Installation of an embedded pipe culvert: Lewis Lake tributary

The Forest Engineering Research Institute of Canada (FERIC) monitored and documented the installation of a closed-bottom corrugated-steel embedded pipe culvert on a newly built section of forest road near Powell River, B.C. Detailed installation procedures and cost information are presented. Suggestions for implementation of future embedded culverts are given.

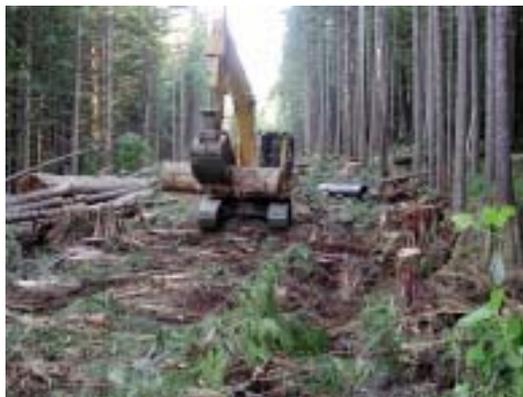
Figure 1. Excavator smoothing the surface of the corduroy trail.

The right-of-way at the stream-crossing site was manually felled one day prior to the embedded culvert installation. The primary excavator prepared access to the crossing site for the articulated truck by clearing the right-of-way, and building a corduroy trail with unmerchantable stems (Figure 1).

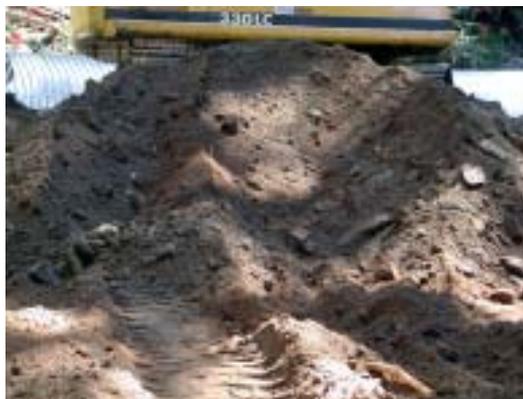
Figure 2. Material for bedding, backfill, and infill was predominantly coarse sand.

The material excavated from the stream channel was endhauled to a spoil site. Culvert bedding, backfill, and infill material were all produced from a nearby cutbank. The material in the cutbank was “weathered/rotten rock” which was easily ripped using the secondary excavator’s digging bucket. The ripped cutbank material was predominantly coarse sand with few cobbles. The riprap was salvaged nearby and also blasted from a nearby bedrock outcrop, and ranged in size from 39 to 112 cm.

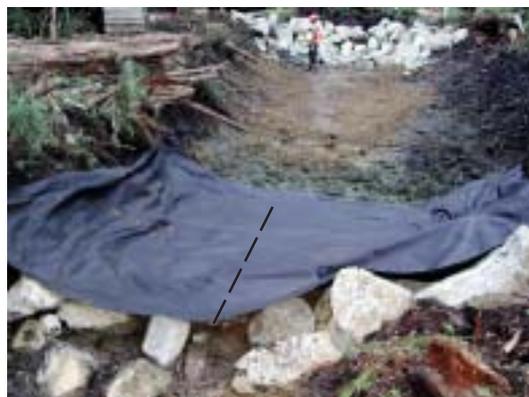
Figure 3. Prepared excavation showing the use of riprap at either end, a layer of bedding material through the length, and geotextile before being cut. Dashed line shows approximate cut line.

A section of non-woven geotextile (approximately 6 m by 4 m) was placed near the outlet area of the prepared excavation (Figure 3). The purpose of the geotextile was to act as a barrier to fine soil movement along the outside edges of the culvert. The geotextile was cut near its centre, parallel to the stream, in preparation for raising and tying it around the culvert. The cut did not extend all the way through the length of the geotextile; the geotextile was in one piece.

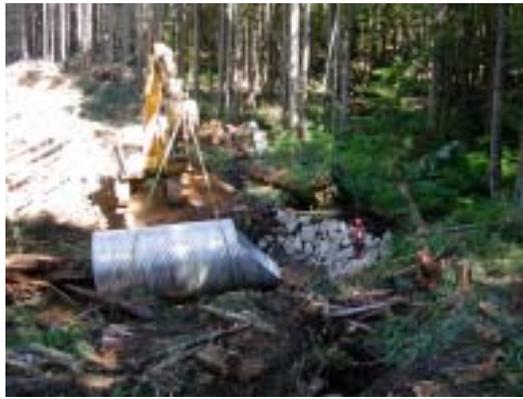
Figure 4. Lifting straps were used to carry the inlet section of the culvert.

- Appropriate lifting straps should be used to lift large culverts during delivery and installation. In this case, chains were used at first to lift and move the culvert but did not offer the proper support during lifting, so a short delay occurred while waiting for a set of straps to arrive.

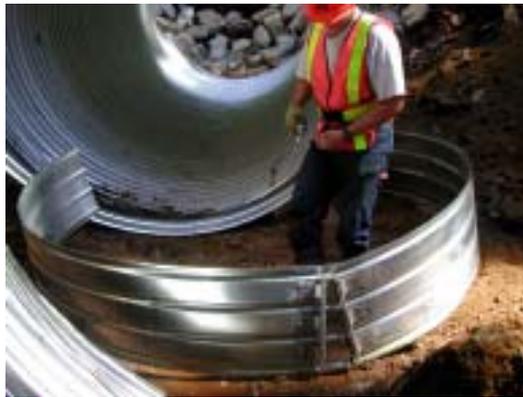
Figure 5. Two sections of the three-piece coupler being loosely joined together.

The excavator lifted one end of the placed culvert section so that one of the three sections of the coupler could be placed below the culvert. The remaining two sections of the coupler were joined loosely together (Figure 5) and placed on top of the first culvert section. The excavator used one lifting strap to lift and drag the second section of the culvert towards the first section (Figure 6). The second lifting strap was left fastened to the outlet end of the culvert and re-attached to the excavator during final alignment. Once the two culvert sections were abutted and aligned, the coupler was bolted together. An impact gun worked well to tighten shorter bolts around the coupler. A deep socket attachment was not available for the longer bolts so these were tightened by hand. Securing the two culvert sections together with the coupler took approximately 1.5 h.

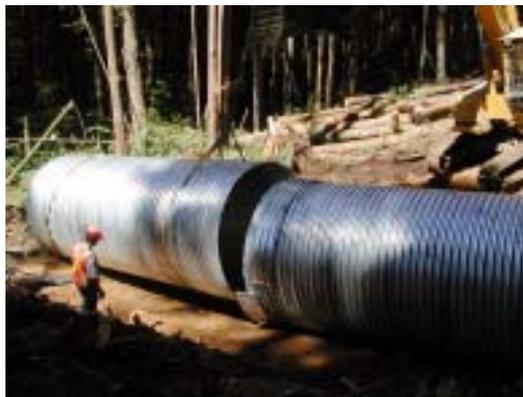
Figure 6. Second section of the culvert being dragged towards the first section using a single lifting strap. Notice the section of the coupler below the culvert.

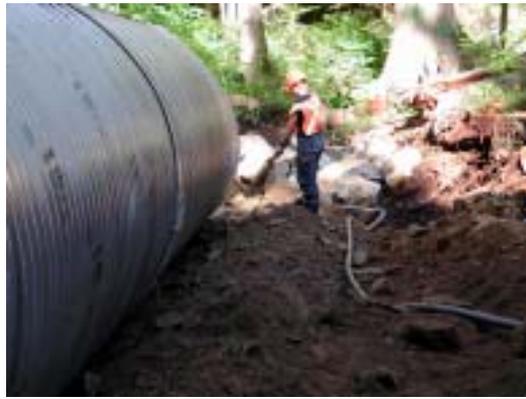
Figure 7. Forest worker using pumped water to force backfill material below the haunch of the culvert.

The initial backfill lifts were forced below the culvert (haunch area) by using the hose to direct pumped sump water (Figure 7). The forest worker compacted the backfill material in this area with her boots. The backfill lifts near and above the haunch area were compacted using a single 534-kg plate compactor. Pre-compacted lifts were approximately 30 to 40 cm deep. Each delivered lift was raked flat in preparation for compaction by the plate compactor. The excavator lifted the plate compactor from one side of the culvert to the other, as needed (Figure 8).

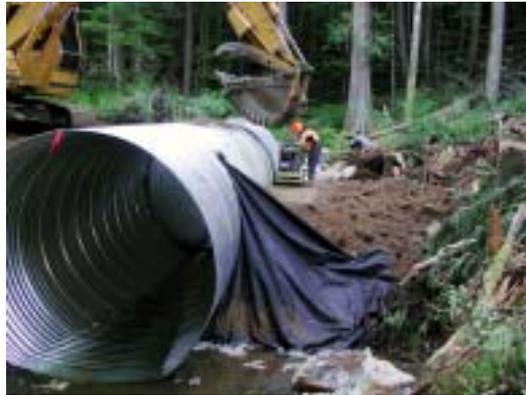
Figure 8. Forest worker attaching plate compactor to excavator's bucket hook in preparation for lifting it to the other side of the culvert. Notice the geotextile tied over the top of the culvert.

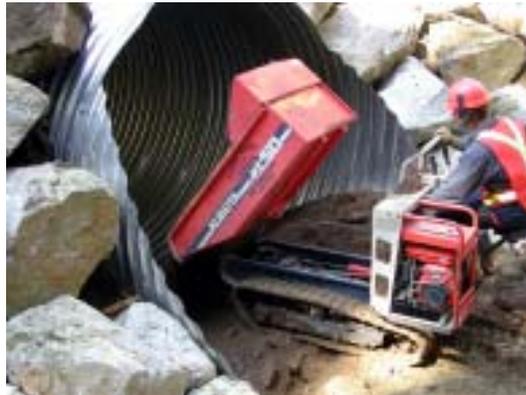
Figure 9. Wheelbarrow delivering infill material near the inlet of the culvert.

The delivery of infill material started once the backfilling and compaction were completed. A motorized tracked self-dumping wheelbarrow delivered material within the culvert (Figure 9). The wheelbarrow was placed in the inlet area (staging area) by the excavator, which then loaded the

wheelbarrow. The wheelbarrow delivered the first layer of infill material starting at the inlet and worked its way towards the outlet. This allowed the wheelbarrow to deliver material in front of itself while creating a flat travel surface. This layer was approximately 30 cm deep. Once the initial layer was completed, the wheelbarrow delivered material to the desired height starting at the outlet and working back towards the inlet. The culvert was filled to 40% of its diameter (108 cm deep) during the second pass.

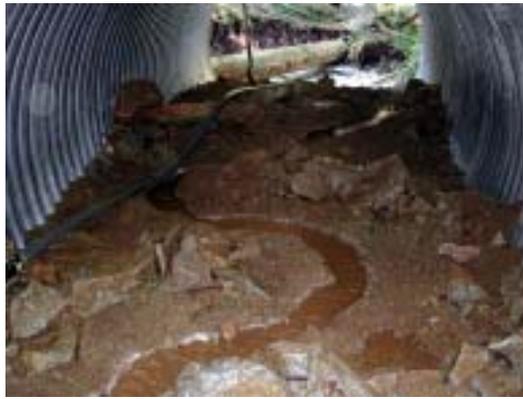
Figure 10. Final simulated streambed surface showing meandering low-flow channel between rock spurs.

and to dig a shallow meandering low-flow channel. The rock spurs projected towards the centre of the culvert from alternating sides to create a meandering channel during low water flows (Figure 10). The spurs and the randomly placed aggregate offer areas of lower water velocity (velocity shadows), which serve as resting areas for fish passing through the culvert.

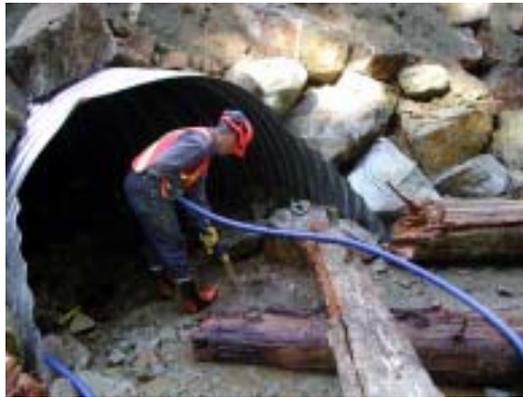
Figure 11. “Washing” the staging area near the inlet of the culvert. Note the large woody debris.

The excavator delivered some infill material to the surface of the staging area and in the same area placed large woody debris along the streambed surface. The staging area was “washed” with pumped water (Figure 11). After the initial washing phase, the hose was positioned near the inlet and left alone, allowing pumped water to continue flowing through the culvert.

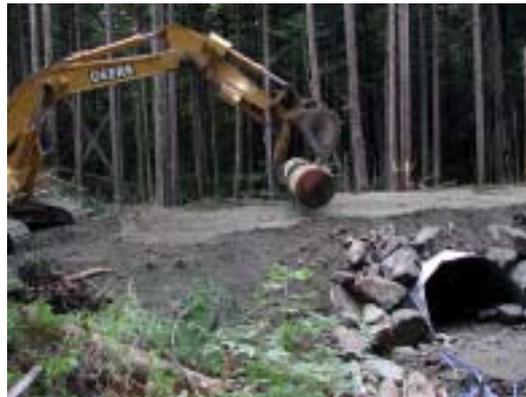
Figure 12. Excavator preparing road surface above the installed embedded culvert.

The excavator built the road up to its final grade. Fill material was delivered by the truck and the excavator used a log to prepare a flat surface. The road length associated with the installation extended approximately 15 m on either side of the culvert. The finished road width measured between 6.0 and 6.1 m. The final road grade was prepared with the lowest area away from the culvert location, to keep road surface runoff from directly entering the stream.

The survey equipment was used during this time to check the gradient of the installed culvert, which measured 6.7%. The height of fill above the culvert was 98 cm (Figure 12). The gradient of the simulated streambed through the culvert was 6.8%.
