Re: Non-compliance Advisory Letter, Permit 7866, Port Edward

NRIS Photo Record

Authorization: PE-7866	Client Name: Aero Trading Company Ltd.
NRIS IR#: 79739	Site Inspection Photos: February 7, 2018

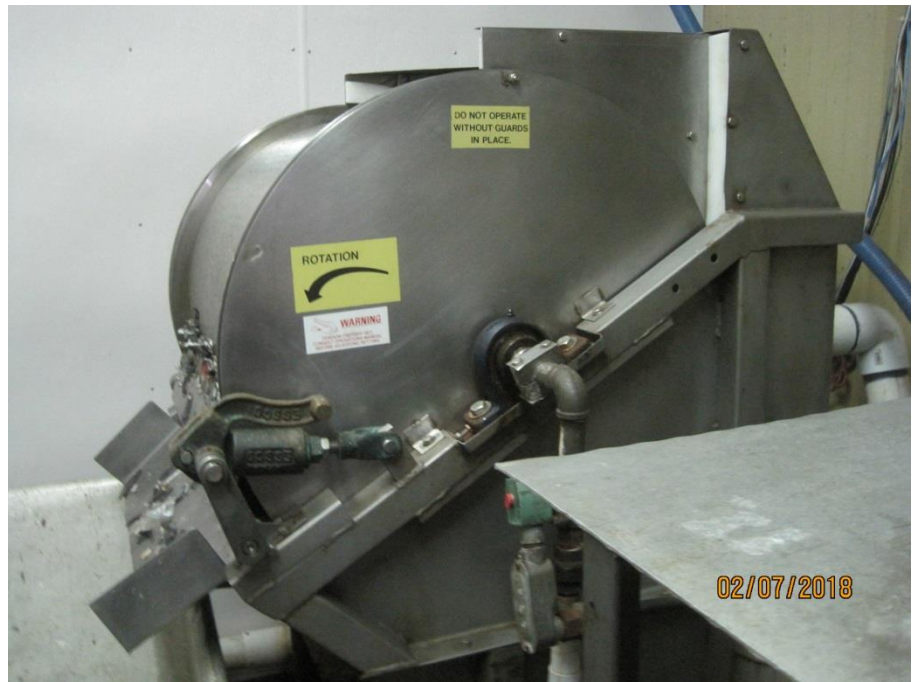
Details/Findings:	The Officers observed authorized works including floor drains, a collection sump, coarse floor screens, a No.25 mesh fine screen facility, and an outfall located as shown on Site Plan A at the time of the inspection. The facility uses a rotary drum screen for screening of effluent prior to discharge (Photos 1 and 2).
Compliance:	In
Actions to be taken:	No action required.
Requirement Description:	2. GENERAL REQUIREMENTS, 2.1 Effluent Volume and Plant Production 2.1: The permittee shall record once per month on a day that is representative of the normal operation the volume of waste flow in m3/day and the tonnage (or kg) or each fish species processed per month.
Details/Findings:	The Permittee reported the total monthly volume of waste discharged per month and the tonnage of each fish species processed per month for 2016 and 2017. The Facility processes salmon, herring, halibut, black cod, and cod.

Photo 1 – No.25 mesh fine screen facility, using a rotary drum screen.

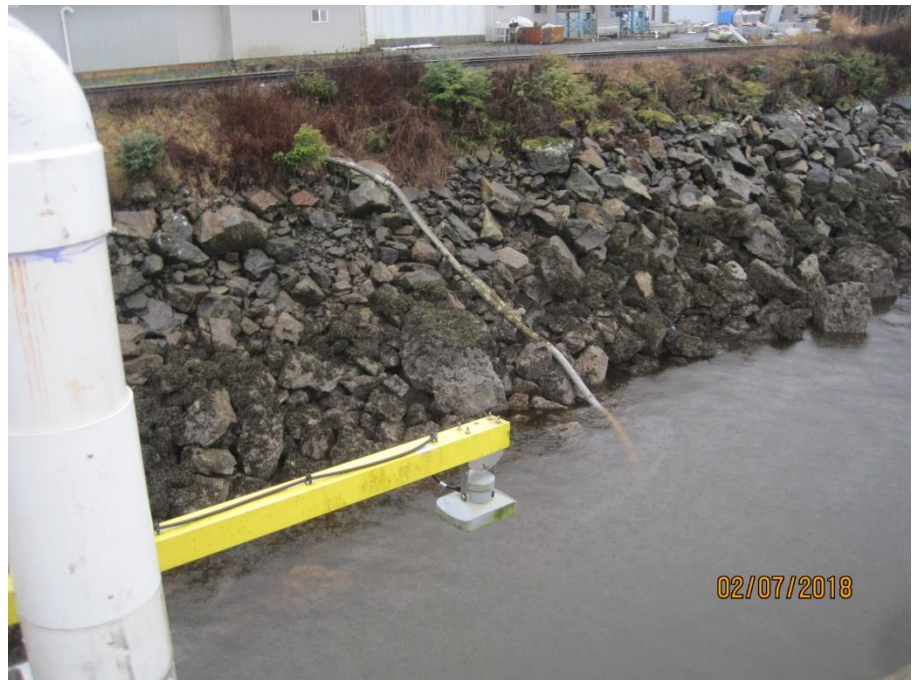
Photo 2 – Effluent outfall pipe.
