Re: Non-compliance Advisory Letter, Permit 8220, Prince Rupert - Seal Cove

NRIS Photo Record

Authorization: PE-8220	Client Name: Canadian Fishing Company
NRIS IR#: 80010	Site Inspection Photos: February 8, 2018

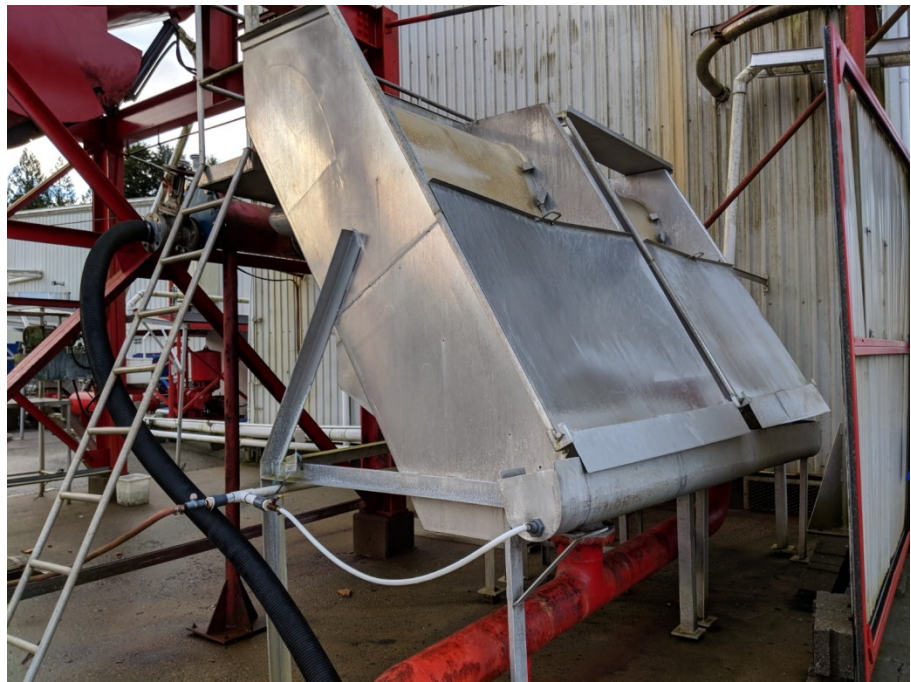
Compliance:	In
Actions to be taken:	No action required.
Requirement Description:	<p>1. AUTHORIZED DISCHARGES, 1.1</p> <p>1.1.2: 1.1 This subsection applies to the discharge of effluent from a fish processing plant to Seal Harbour, Prince Rupert. The site reference number for this discharge is E220186.</p> <p>1.1.2 The characteristics of discharge shall be typical of fish processing effluent treated by a number 25 mesh fine screen.</p>
Details/Findings:	The Facility was not processing fish at the time of the inspection so compliance with this requirement could not be determined. The Officers observed a series of two wedge wire screens with 25 mesh fine screening at the time of the inspection that are used for effluent treatment (Photo 1).
Compliance:	Not Determined
Actions to be taken:	No action required.

Photo 1 –
Number 25 mesh
fine screening
facilities.
