Utility Trucks on Mine Sites

Utility vehicles are essential tools for completing tasks in heavy-duty industrial environments. A recent dangerous occurrence involving a utility truck highlighted several safety considerations around the use of mobile equipment on mine sites.

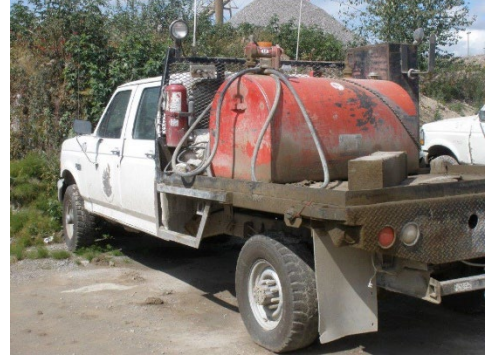
In early 2022 on a BC mine site, an incident occurred where a utility truck started rolling downhill after being parked by the driver. The driver, who was outside of the vehicle at the time of the incident, was severely injured while attempting to regain control after it started to roll away. The utility truck, unattended and out of control, travelled across an active haul road before stopping at an embankment. The vehicle was later inspected and was found to have a buildup of mud on the transmission and parking brake cable, and a second parking cable was completely separated. However, the event of the runaway vehicle was not a single occurrence, nor was the issue of the buildup of material rendering the parking brake unusable.

1. **Maintenance:** Vehicle maintenance should be performed regularly to ensure vehicles are safe and functioning normally. The type of use, site conditions, and environmental factors may impact a vehicle's function and safety systems. Consider increasing maintenance intervals for vehicles with increased use and wear.

2. **Pre/Post Inspections:** Operators should perform pre-and post-trip vehicle inspections and be trained to recognize when a component or safety system is not functioning correctly.

3. **Safe Work Procedures:** Staff operating vehicles should be aware of the procedures for securing vehicles. Consider additional methods to ensure the vehicle is secure, not solely relying on the transmission or brakes.

5. **Vehicle Modifications:** No modification or bypass of a safety feature or normal operating system should be done. If the system is not operating correctly, it should be removed from service until it is repaired.
