# Hazard Alert

## Lightning Strikes

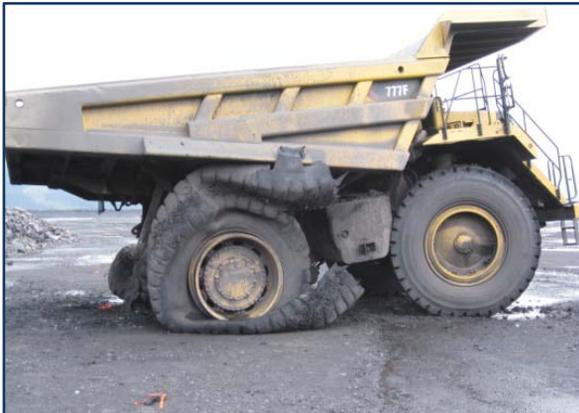
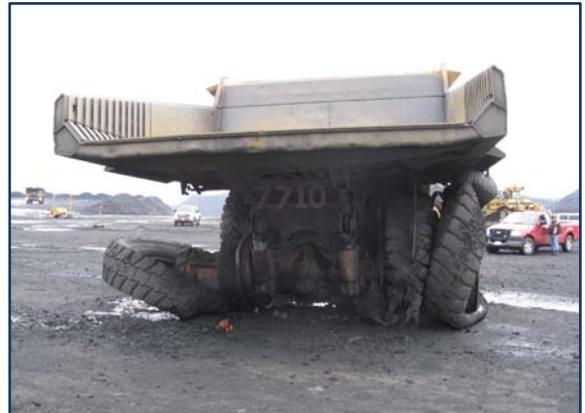
*This haul truck was struck by lightning while parked at a dump. The truck's rear tires were blown off and propelled some 250 metres. All four rear tires were perforated and detached from the wheels of the truck.*

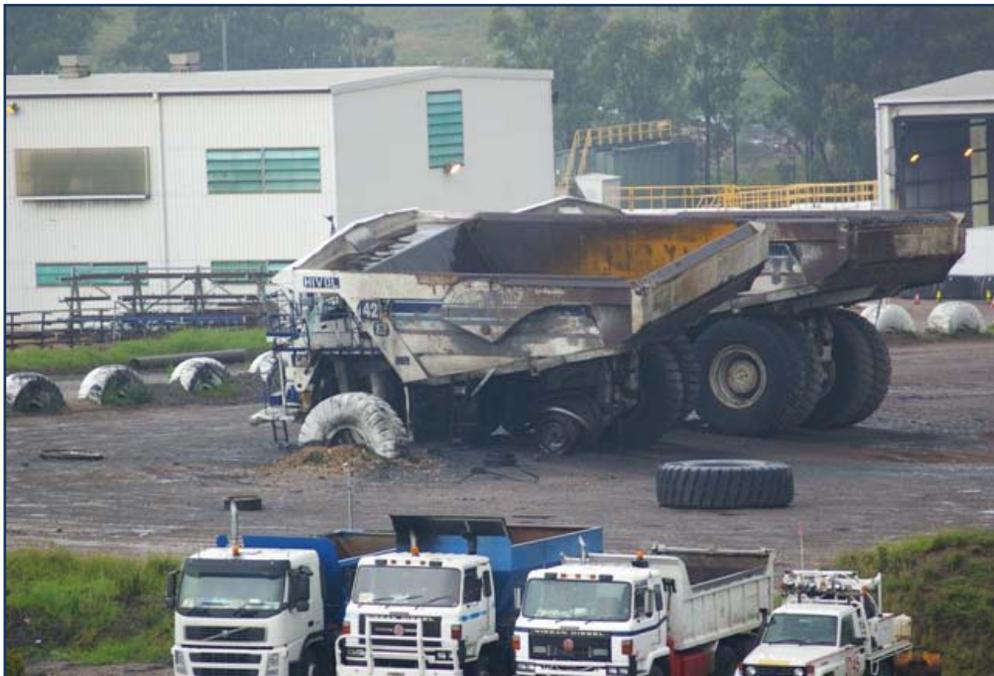
*The tension created on the wheel had a force of approximately 270 kilonewtons (equivalent to 27,532 kilograms of weight). This force was strong enough to break 57 1-inch grade 10.9 bolts fastening the flange to the wheel.*
