MINISTRY OF TRANSPORT AND INFRASTRUCTURE

ISLAND RAIL CORRIDOR CONDITION ASSESSMENT

TRACK CONDITION ASSESSMENT

MARCH 13, 2020

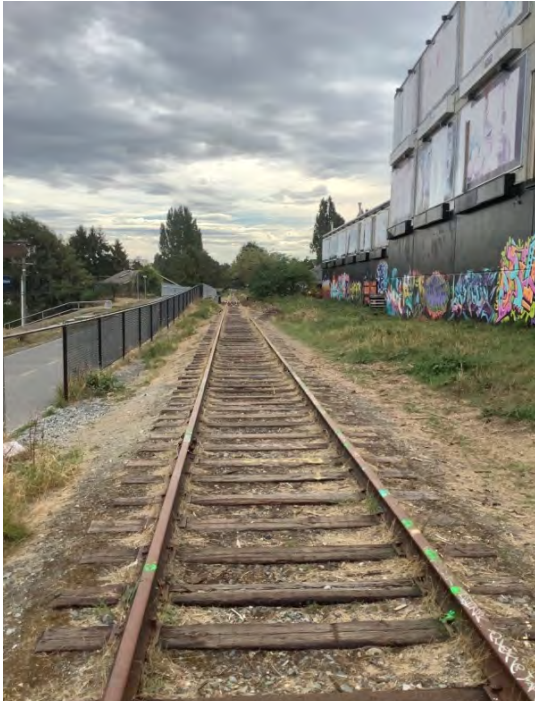
Figure 4: Victoria to Langford - Typical Road Bed

The surface condition of the Victoria to Langford segment of the Victoria subdivision was determined to be in a fair condition. There was no warping or dips in the track profile noted while on site. There were no major cross level concerns observed while inspecting the subdivision via hi-rail.

During a wet site inspection, no significant drainage issues along the corridor were observed. In some locations however, local ponding between the cribs was noted. This is due to fines and vegetation fouling the ballast void spaces, consequently inhibiting drainage.

It is understood, by discussions with and evident on site, that SVI have a Pest Management Plan (PMP) in place to combat vegetation in the corridor. However, from the site visits, it was observed that vegetation on the corridor is still prevalent within and around the right of way. The condition of the vegetation impact ranges from poor in some areas to good in others. Typically, in the Victoria to Langford segment the condition of the vegetation is considered fair.

Figure 4 shows a typical example of the road bed between Victoria and Langford

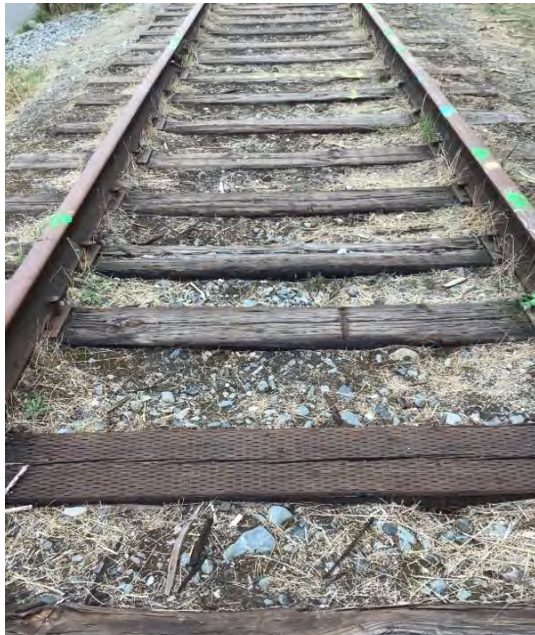
Figure 5: Victoria to Langford - Typical Track Structure

Along the Victoria and Langford corridor the ballast was generally observed to be crushed pit run gravel fouled with fines and generally in a poor condition for the length of the corridor. The ballast cribs were noted to be full along most of the corridor with some sections empty or only partially full. The ballast shoulder was observed to range from fair (present but incomplete) to poor (no shoulder).

The rail condition along the Victoria to Langford segment of the corridor was determined to be generally fair with between 6-10mm of head loss in the inspected zones. There was a mixture of predominantly standard joint bars with a few sections of angled joint bars connecting the rails. The condition of the joint bars was considered to be good if the joints were connected by standard joint bars and poor if they were connected by angled joint bars. There were no significant rail defects noted while onsite, however it should be understood that only a portion of the overall segment was inspected on foot.

The spikes, anchors and tie plates are in poor condition on the Victoria to Langford segment. The tie-plates used across the segment, are all single shoulder and should be upgraded to double shoulder plates in the restoration phases.

Wooden ties are used throughout the length of the corridor. It was observed on site during the inspections that between 44% and 55% off these ties were defective.

Figure 5 shows a typical example of the track structure between Victoria and Langford

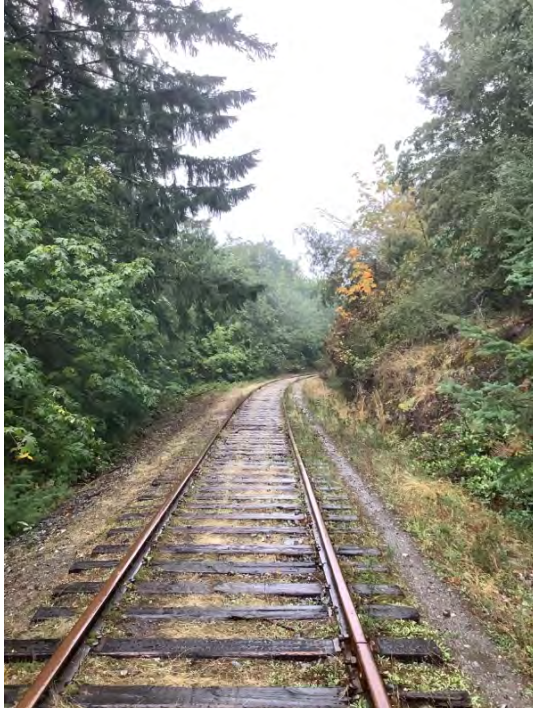
Figure 7: Langford to Duncan - Typical Road Bed

The surface condition for the Langford to Duncan segment of the Victoria subdivision was noted to be in a fair condition. There was no warping or dips in the track profile noted while on site. There were no major cross level concerns observed while inspecting the subdivision via hi-rail

During a wet site inspection, no significant drainage issues along the corridor were observed. In some locations however, local ponding between the cribs was noted. This is due to fines and vegetation fouling the ballast void spaces, consequently inhibiting drainage.

Figure 7 shows a typical example of the road bed between Victoria and Langford

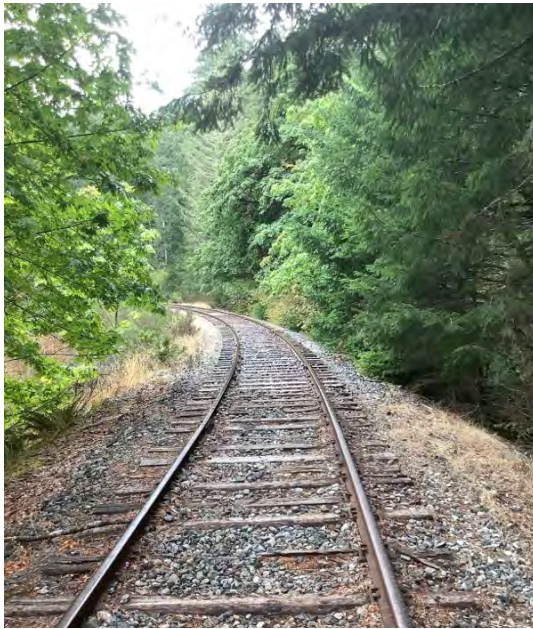
Figure 8: Langford to Duncan - Typical Track Structure

The spikes and anchors are in fair condition on the Langford to Duncan segment. The tie-plates used across the segment are considered in poor condition, due to all inspected locations being single shoulder and should be upgraded to double shoulder plates in the restoration phases.

Figure 8 shows a typical example of the track structure between Langford and Duncan

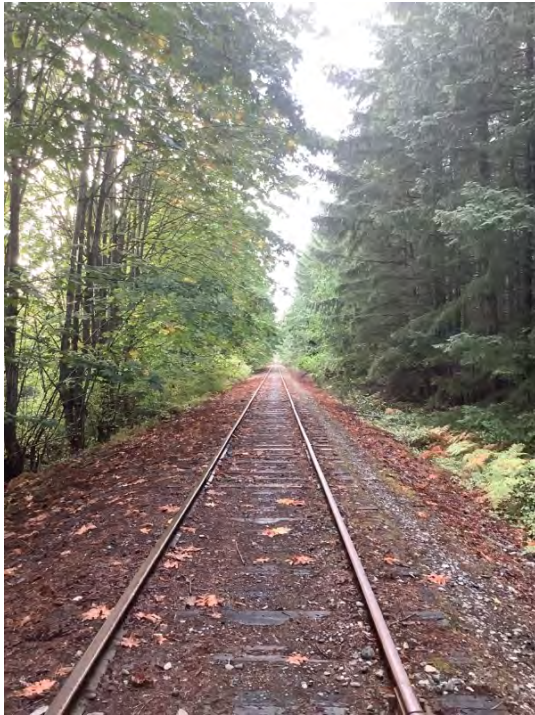
Figure 10: Duncan to Nanaimo - Typical Road Bed

Figure 10 shows a typical example of the road bed between Duncan to Nanaimo.

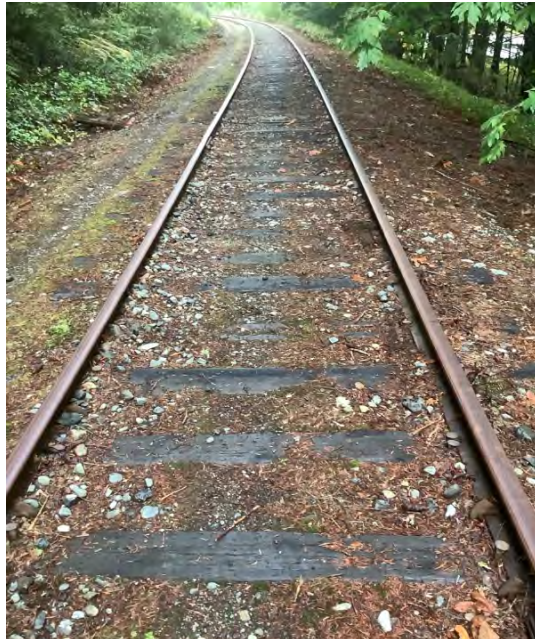
Figure 11: Duncan to Nanaimo Typical Track Structure

Figure 11 shows a typical example of the track structure between Duncan and Nanaimo

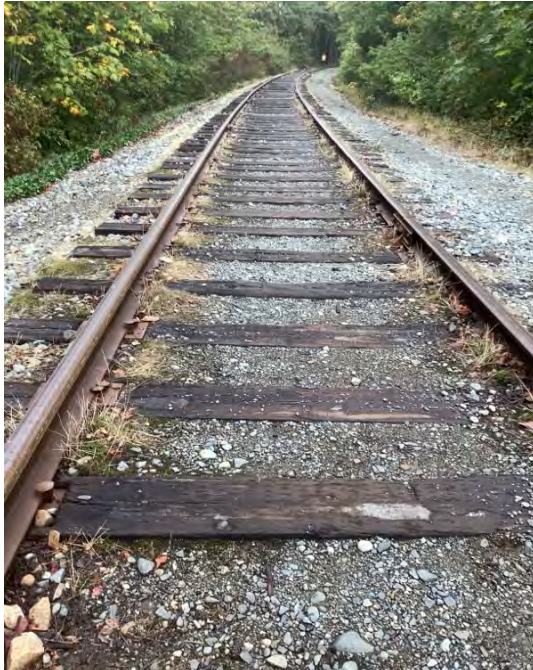
Figure 13: Nanaimo to Parksville - Typical Road Bed

Figure 13 shows a typical example of the road bed between Nanaimo to Parksville.

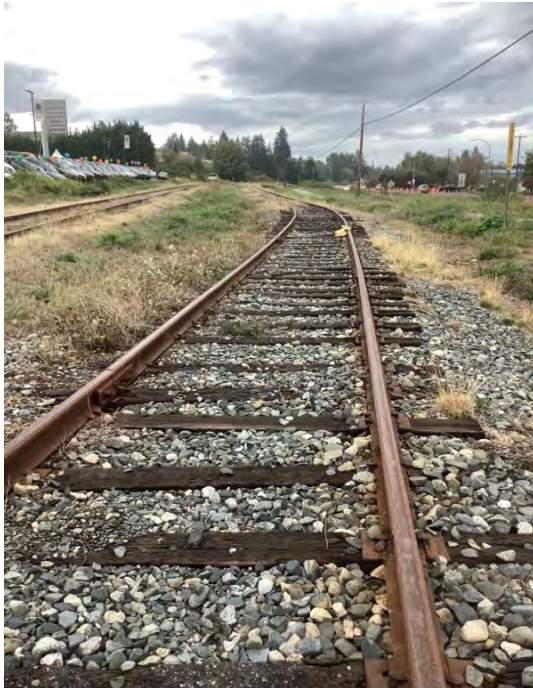
Figure 14: Nanaimo to Parksville - Typical Track

Figure 14 shows a typical example of the track structure between Nanaimo and Parksville.

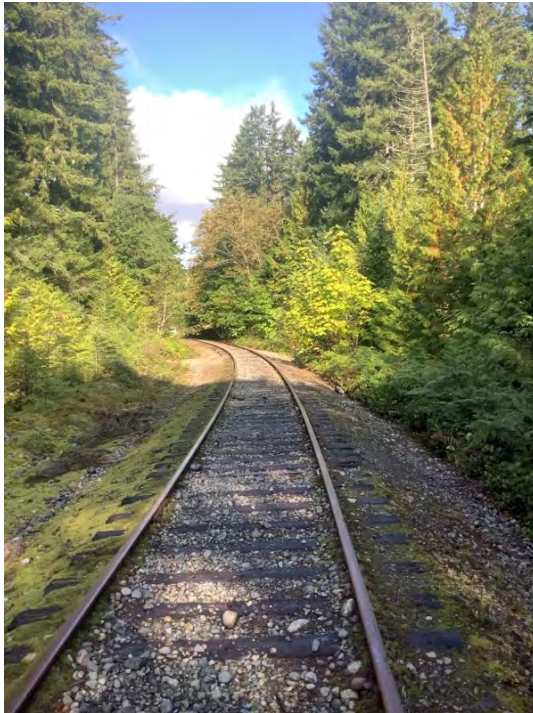
Figure 16: Parksville to Courtenay - Typical Road Bed

Figure 16 shows a typical example of the Track road bed

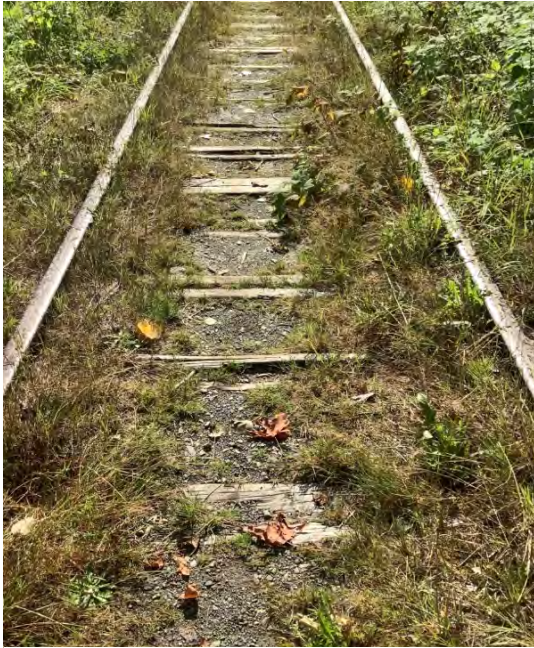
Figure 17: Parksville to Courtenay - Typical Track Structure

Figure 17 shows a typical example of the track structure between Parksville and Courtenay

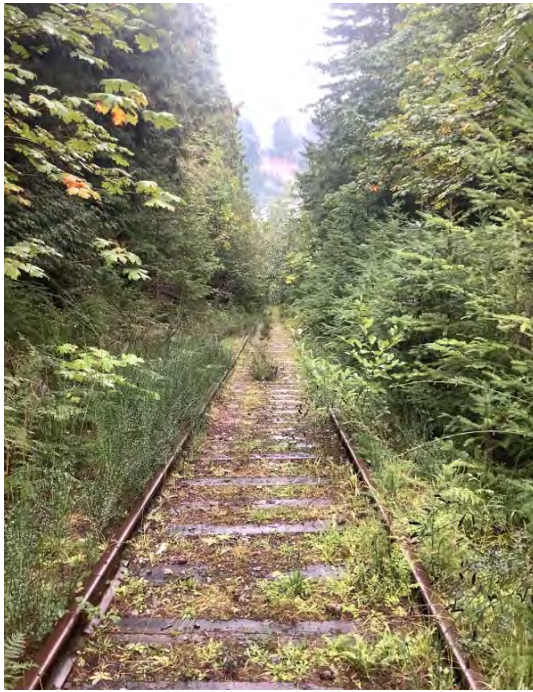
Figure 20: Parksville to Port Alberni- Typical Track Structure

Figure 20 shows a typical example of the track structure between Parksville and Port Alberni.

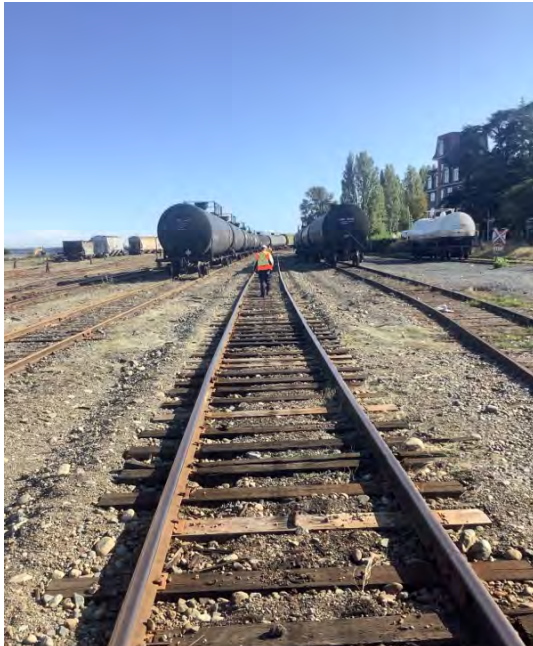
Figure 23: Wellcox Yard - Typical Track Structure

Figure 23 shows a typical example of the track structure within Wellcox yard.

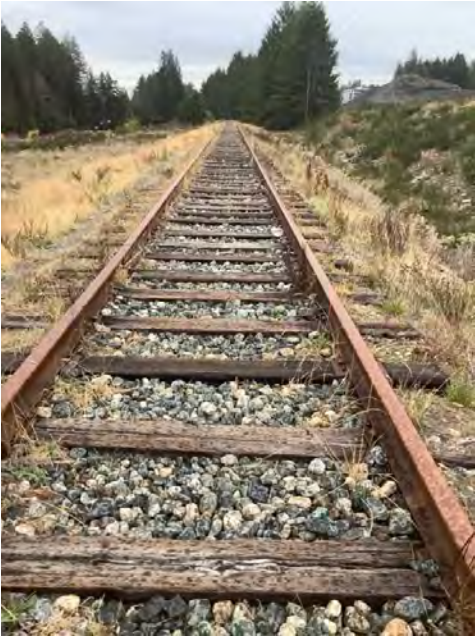
<p>Ballast Photo</p>

Joint Bars Type Standard	Tie-Plates Type Single Shoulder	Number of Tie Defects 155	Ballast Type Pitt run gravel	Ballast Description Fouled	Are the ballast Cribs full? Yes	Gauge (in) 56.50
Joint Bar Condition Fair	Tie-Plate Condition Poor	Spike/ Anchor Condition Fair	Ballast Condition Fair	Shoulder Condition Fair	Surface Condition Fair	Vegetation Condition Fair

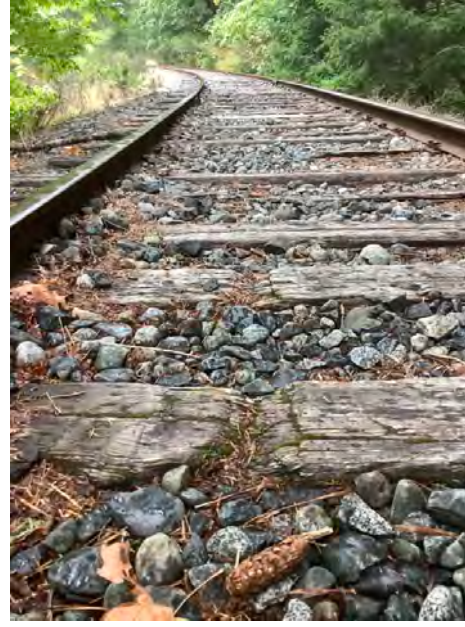
Tie Photo

Cut ties from derailment. Replaced ties yellow ties have double shoulder plates. Single Shoulder plates everywhere else.

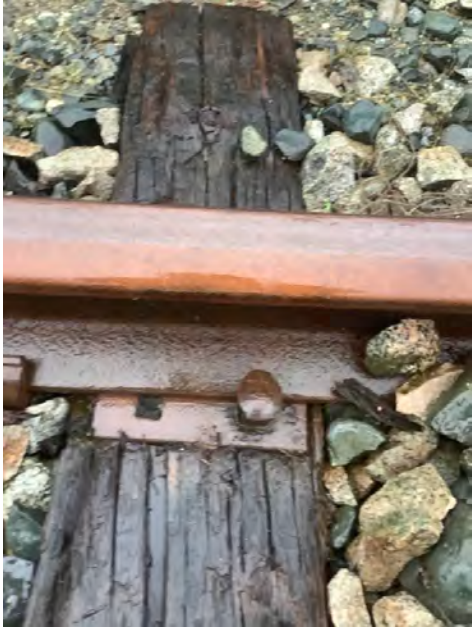
Tie-Plates Photo

General Tie and Gauge Comments
Poor Condition

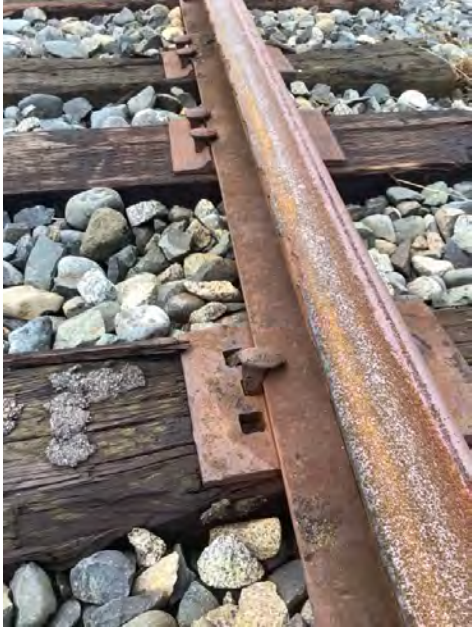
Tie-Plates Photo

Double shoulder plates on replaced ties.
Track head loss gauge doesn't work ok 80lb

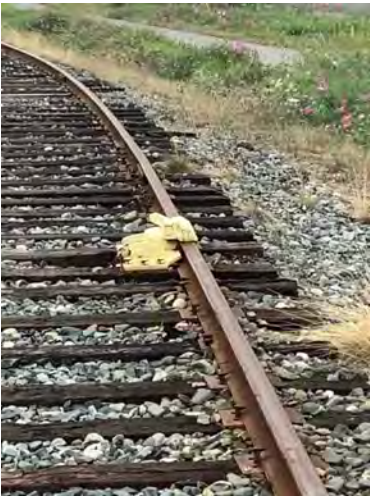
Additional Photo 1 Description
Derail

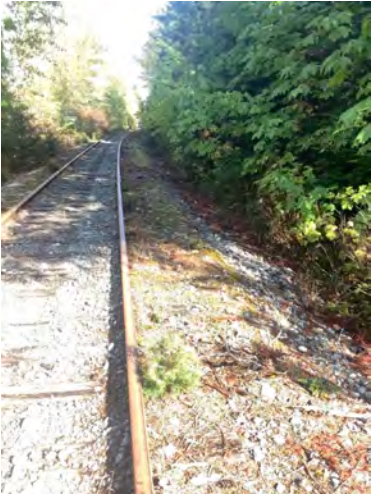
<div>Additional Photo 1</div>

Additional Photo 1 Description
Good shoulder

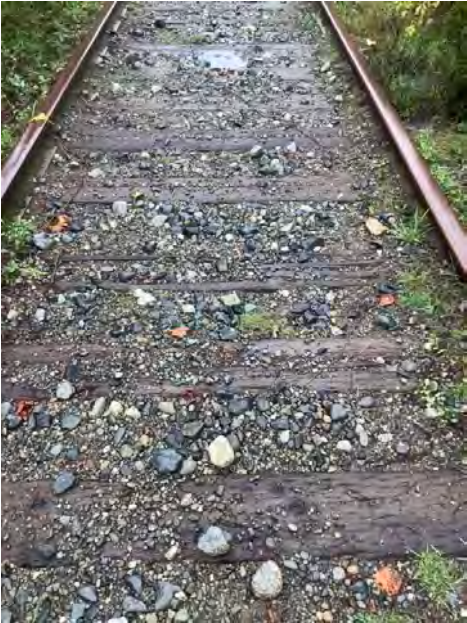
Tie Photo

General Tie and Gauge Comments
Defective ties 75/200

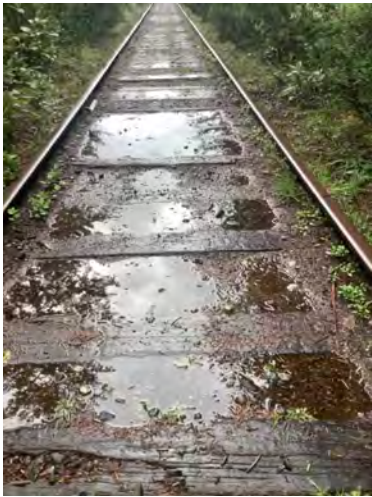
Additional Photo 1 Description
Non draining ballast

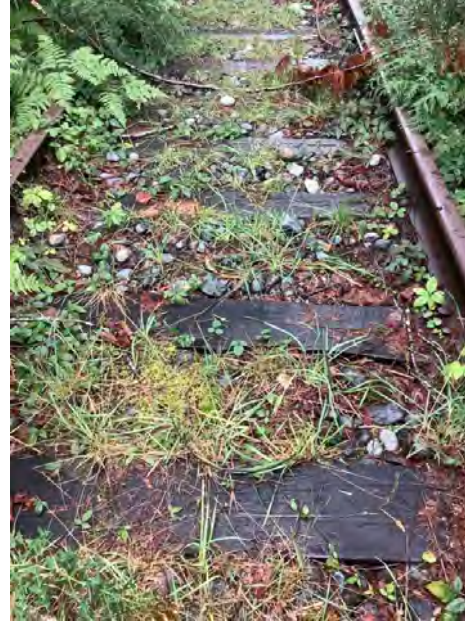
Tie Photo

General Tie and Gauge Comments
Defective ties 71/170

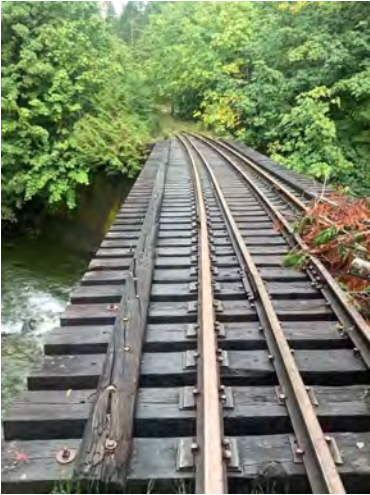
<div>Additional Photo 1</div>

Additional Photo 1 Description
Bridge

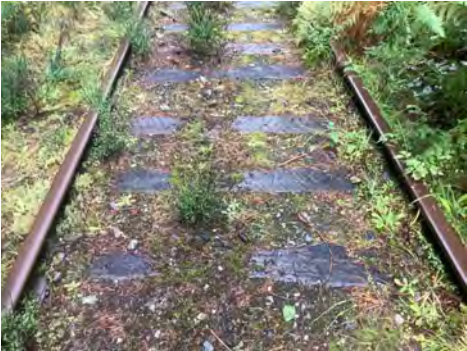
Tie Photo

General Tie and Gauge Comments
Defective ties 40/200

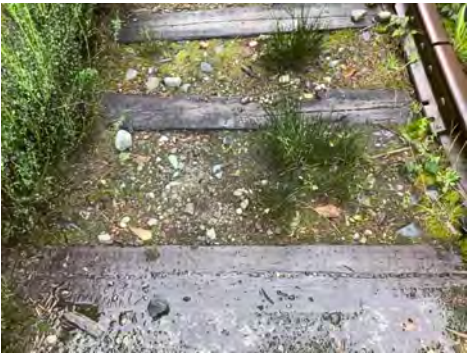
Tie Photo

General Tie and Gauge Comments
Defective ties 45/200

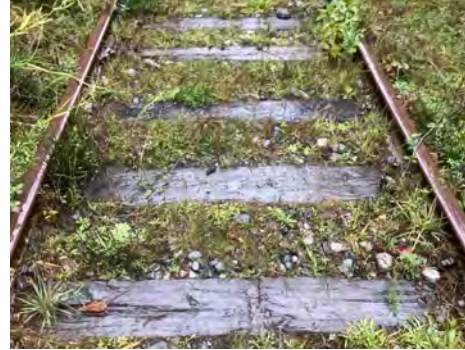
Tie Photo

General Tie and Gauge Comments
Defective ties 40/200

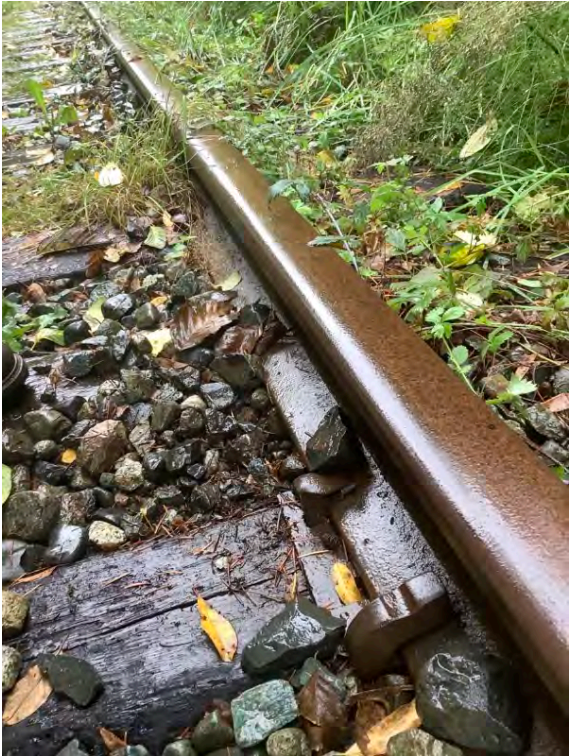
Rail	Rail Defect Photo 1	Rail Defect Photo 2	Rail Defect Photo 3
Left Rail

Rail	Rail Year Rolled	Metal Type	Weight (lbs)	Length (ft)	Headloss Estimate (mm)	Flange Estimate (mm)	Rail Condition	Comment
Left Rail		Not Observed	85		9	1	Fair	Track condition in this section is fair. Requirements are not as high here. Just take care of vegetation.

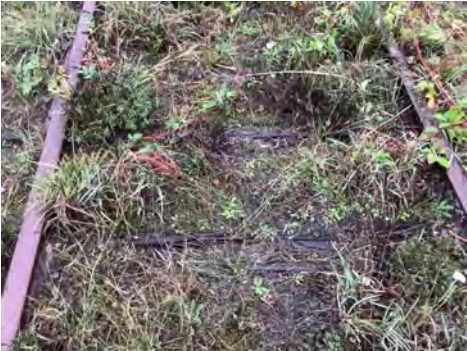
Tie Photo

135/200 defective. Hard too see ties because of vegetation.
Port Property.

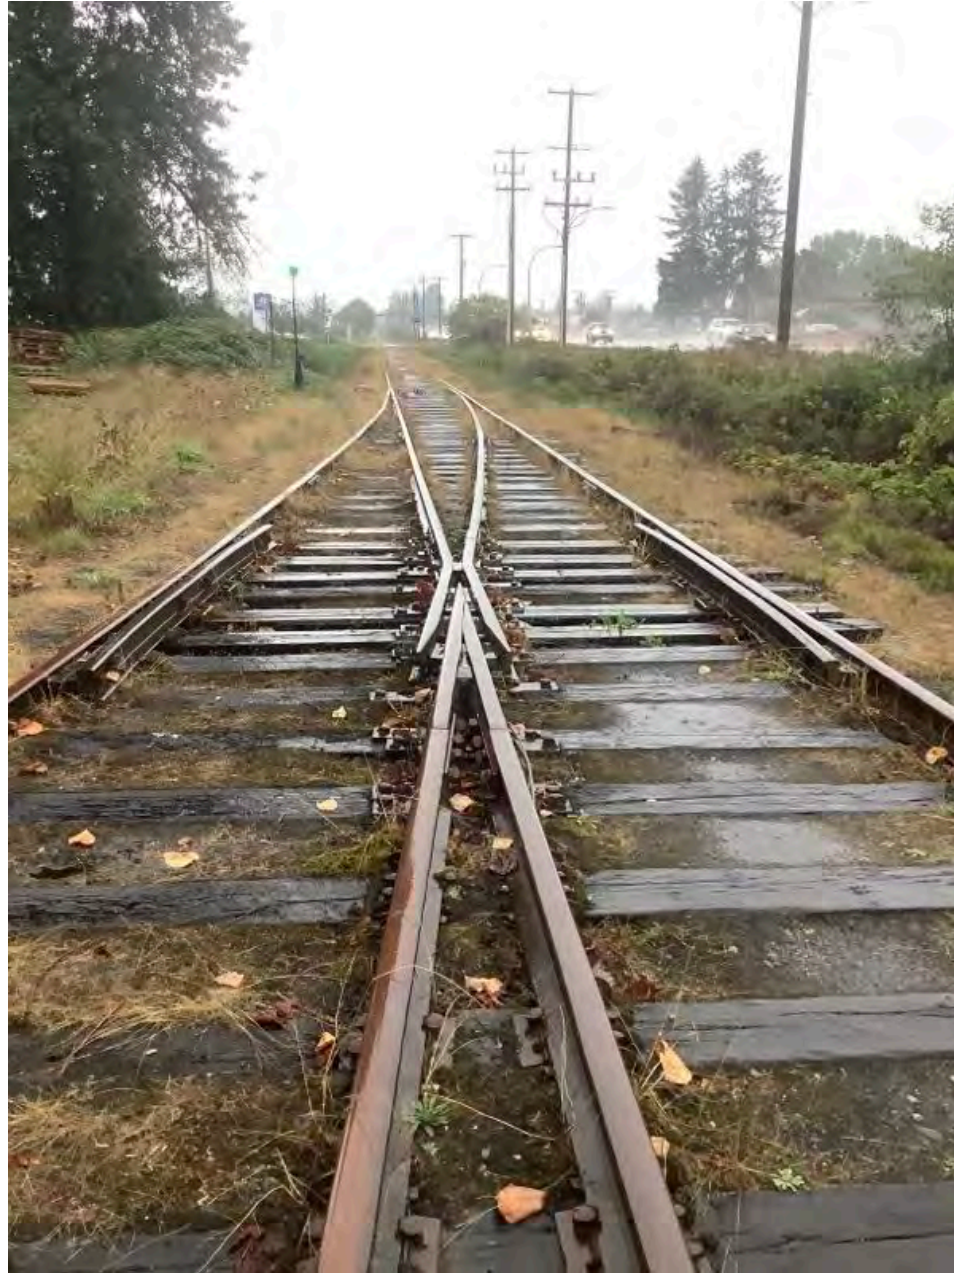
Turnout Photo

Component	Condition	Comment
Ties	Poor	No Comment
Anchors	Fair	No Comment
Ballast	Poor	No Comment
Guard Rails	Fair	No Comment
Frog	Fair	Chip
Closure Rails	Fair	No Comment

Adjustable rail braces in fair condition

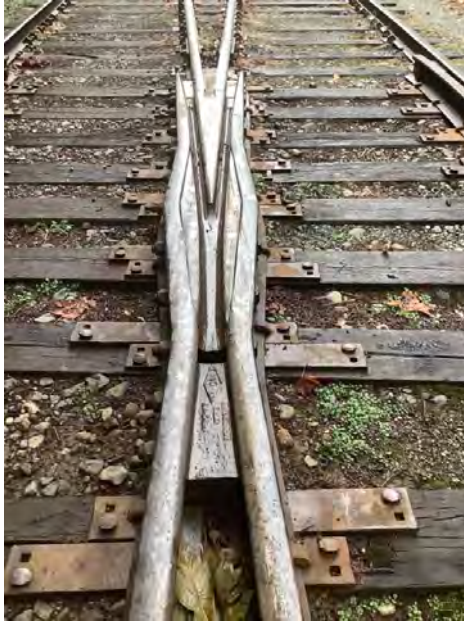
Additional Photo 1 Description
Frog

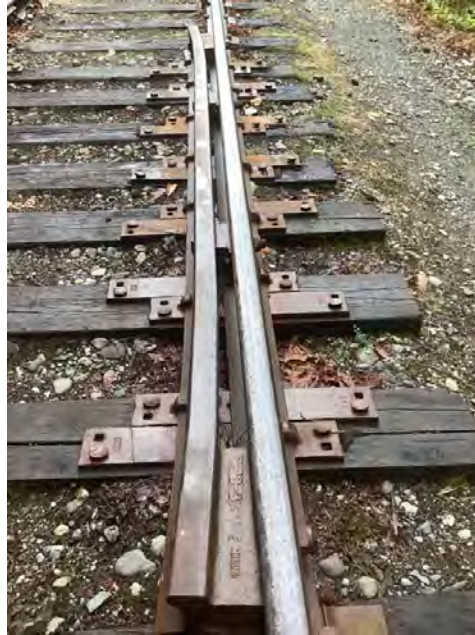
Additional Photo 2 Description
Guard Rail

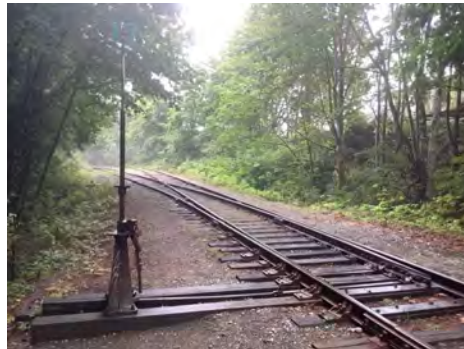
Additional Photo 3 Description
Switch Stand

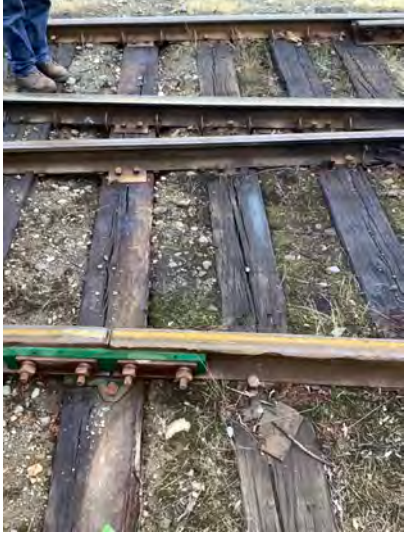
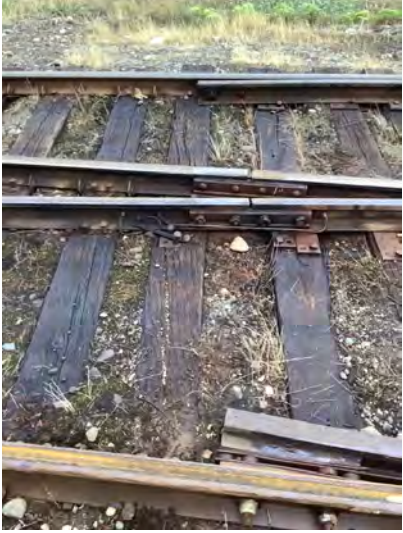
Component	Condition	Comment
Closure Rails	Fair	Curve closure Head loss 10 Flange 0
Guard Rails		No Comment
Ties		No Comment
Anchors		No Comment
Ballast		No Comment
Frog		No Comment

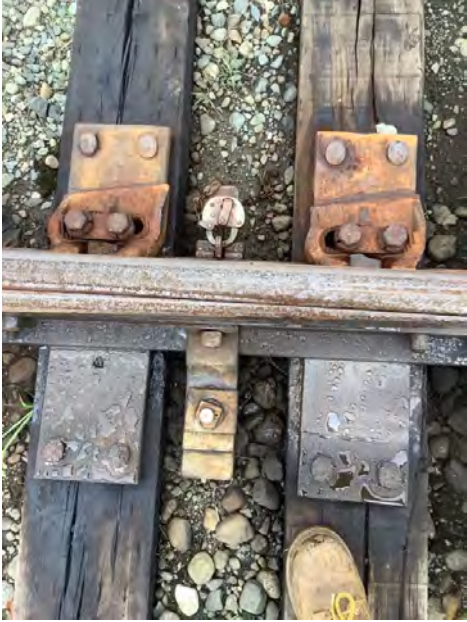
<p>Additional Photo 1</p>

<p>Additional Photo 1 Description Switch point lock.</p>

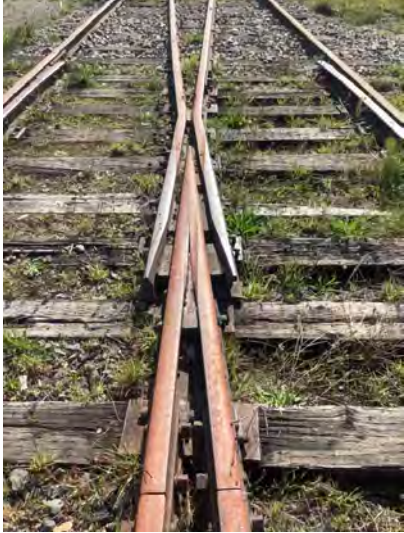
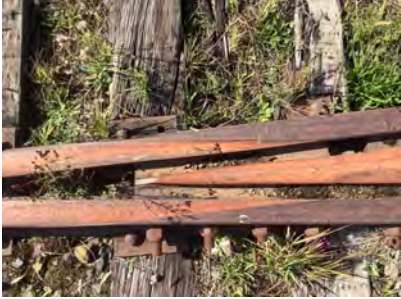
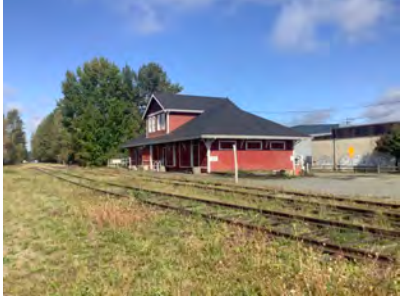
Component	Condition	Comment
Ties	Good	Switch ties in good condition.
Ballast	Poor	Poor through PS Diverging side beyond TO good ballast
Anchors	Fair	No Comment
Frog	Fair	85 lb no 9
Guard Rails		Not Observed
Closure Rails		Not Observed

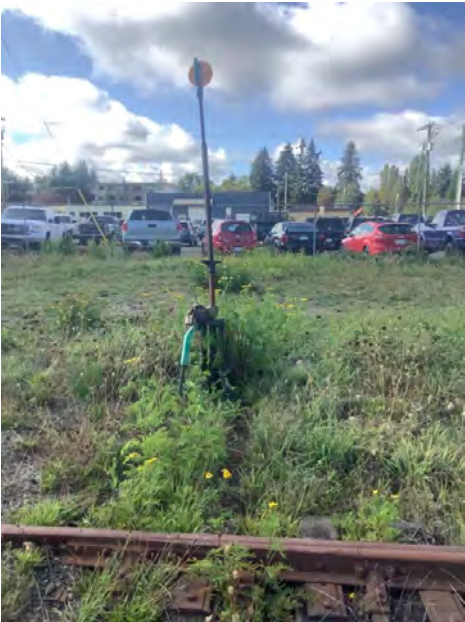
Additional Photo 1 Description
Switch stand

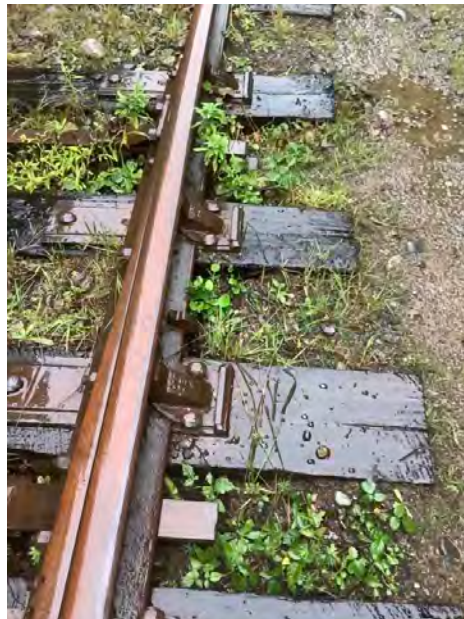
Additional Photo 3 Description
Rail braces are rigid spiked.

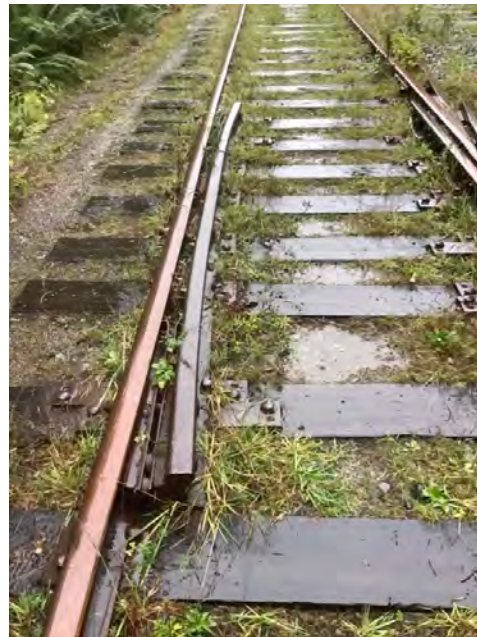
Additional Photo 4 Description
Guard rail

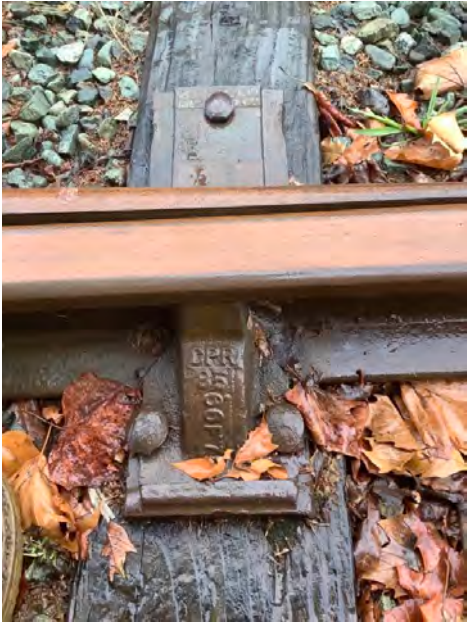
<p>Additional Photo 1 Description Old style spike and plates.</p>	<p>Additional Photo 2</p>

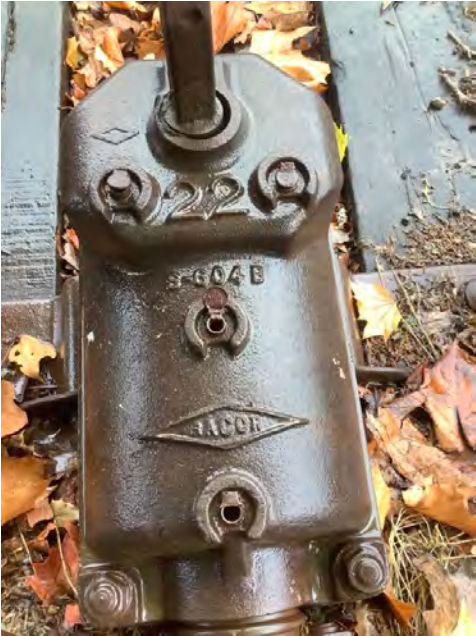
<p>Additional Photo 2 Description Switch stand</p>

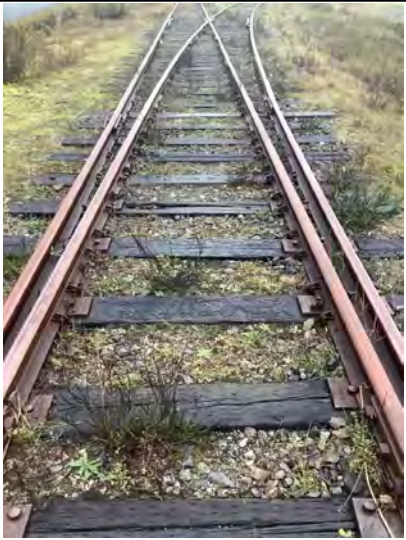
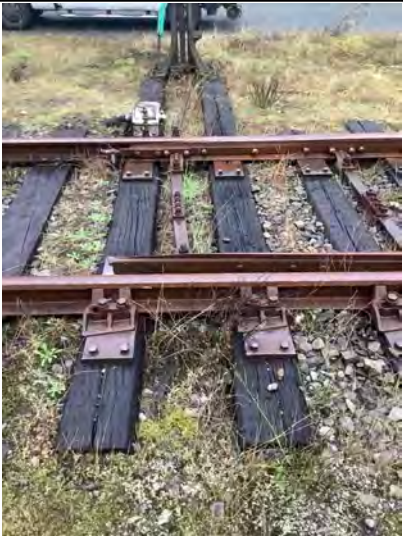
Component	Condition	Comment
Ties	Fair	Will need 40% new switch ties
Ballast	Poor	Pitt run gravel Fouled
Closure Rails		No Comment
Frog	Fair	Bolted rail frog
Anchors	Fair	Not Comment
Guard Rails	Fair	No Comment

Overall fair condition other than switch ties. Need to realign frog to fix gauge.

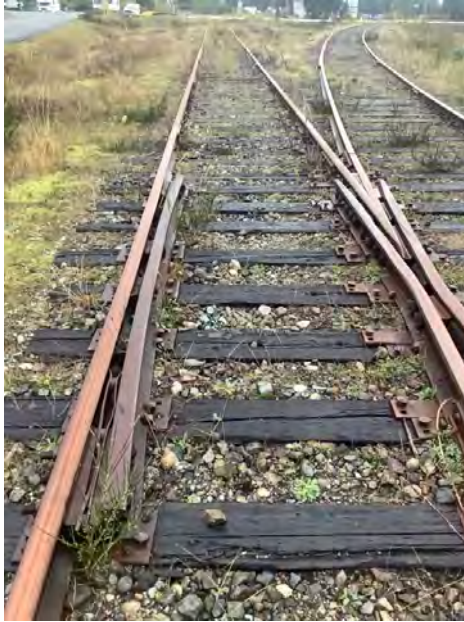
Additional Photo 1 Description
Guard rail through

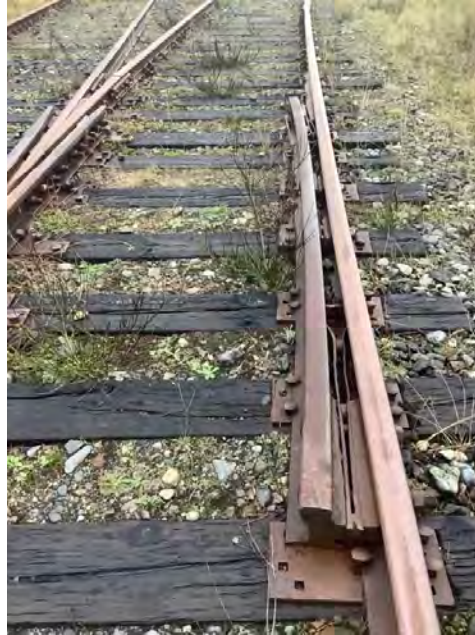
Additional Photo 2 Description
Diverging gourd rail

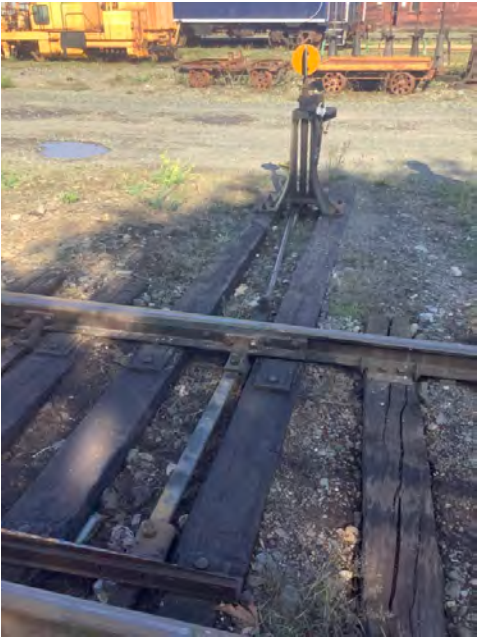
Additional Photo 2

Standard hand throw switch stand
