BI-WEEKLY STATUS REPORT

Cobble Hill Landfill Closure

PROJECT # : PRJ18074	File #: 18074- BWR-71
REPORT #: 73	Date: July 30, 2020
SHA REPRESENTATIVES: Dr. Tony Sperling, P.Eng. Scott Garthwaite Carly Wolfe, EIT	Owner: Cobble Hill Holdings Ltd. Contractor: Allterra Construction Ltd.

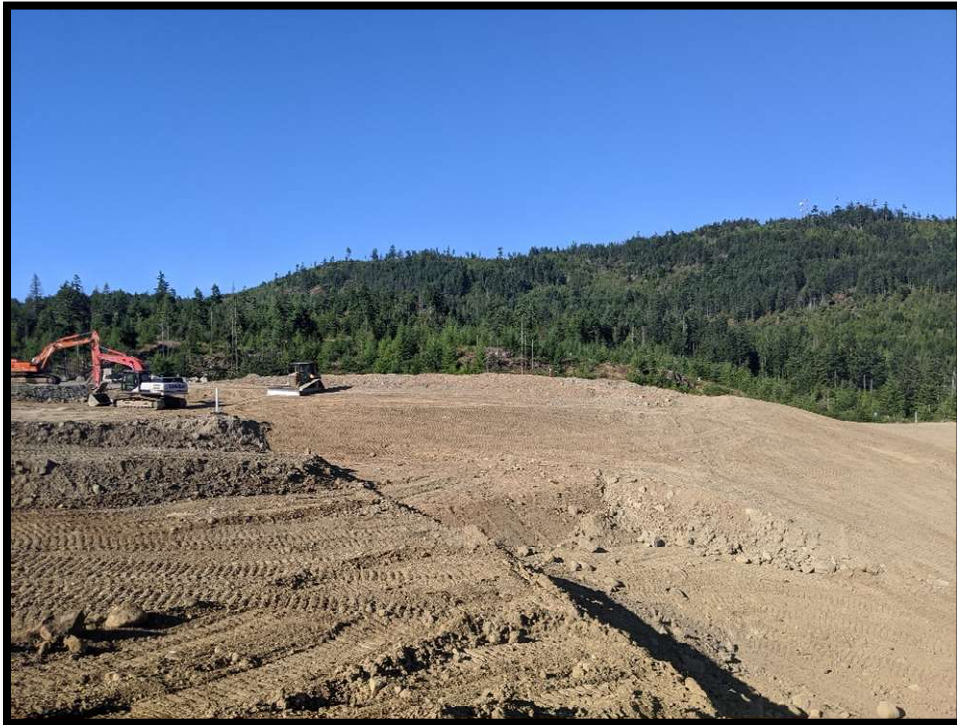
Picture # 1: Looking west towards the east side of the PEA prior to relocating previously stockpiled material around on site.

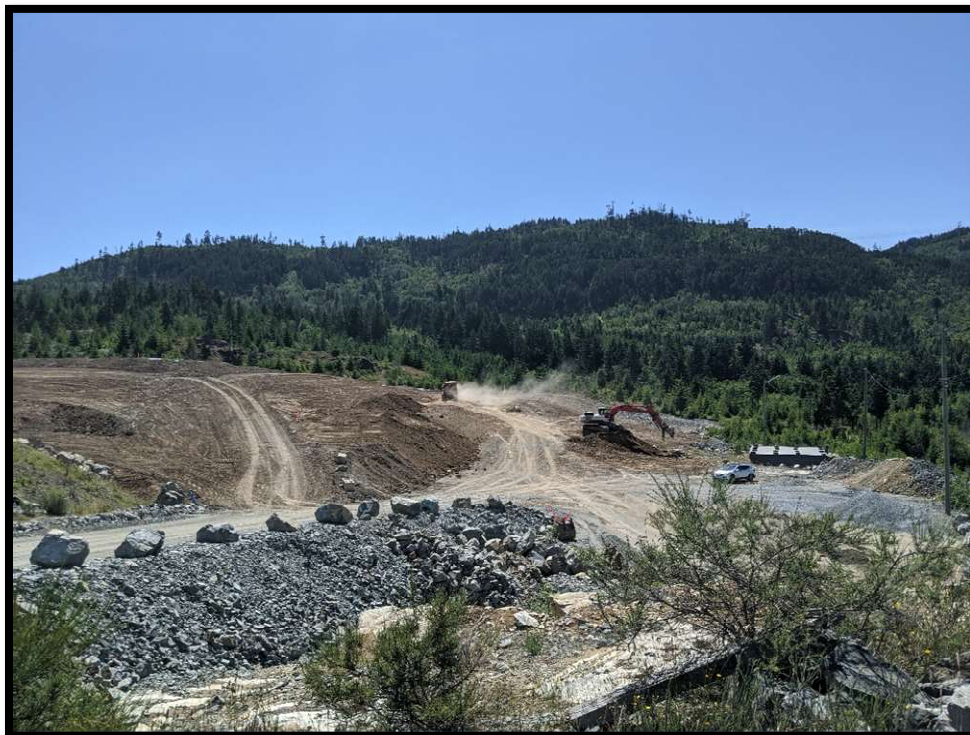
Picture # 2: View of the contractor relocating previously stockpiled material from the northern side near the Leachate Facility.

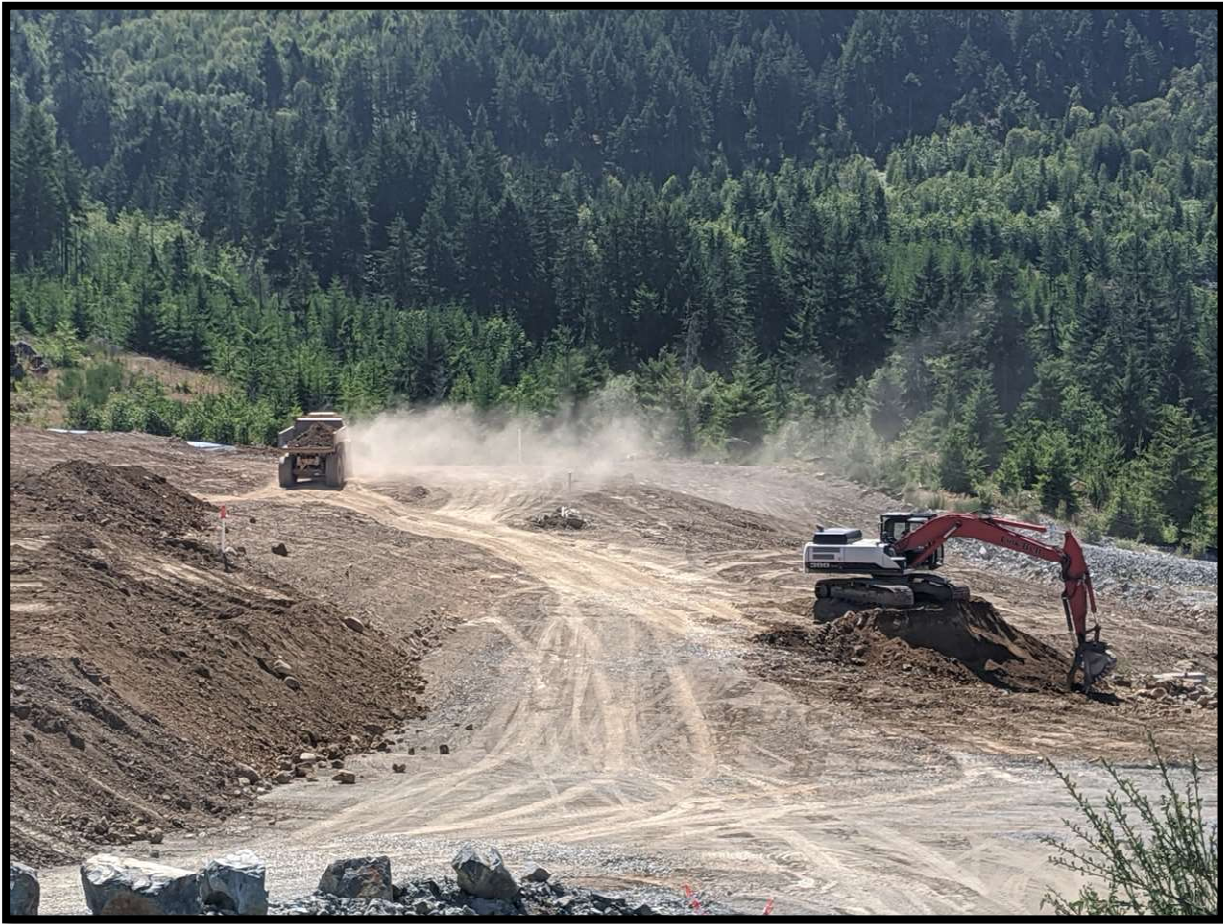
Picture # 3: View of the contractor continuing to move material previously stockpiled near the Leachate Facility. Previously stockpiled material was relocated closer to the northeast corner of the PEA throughout the day.

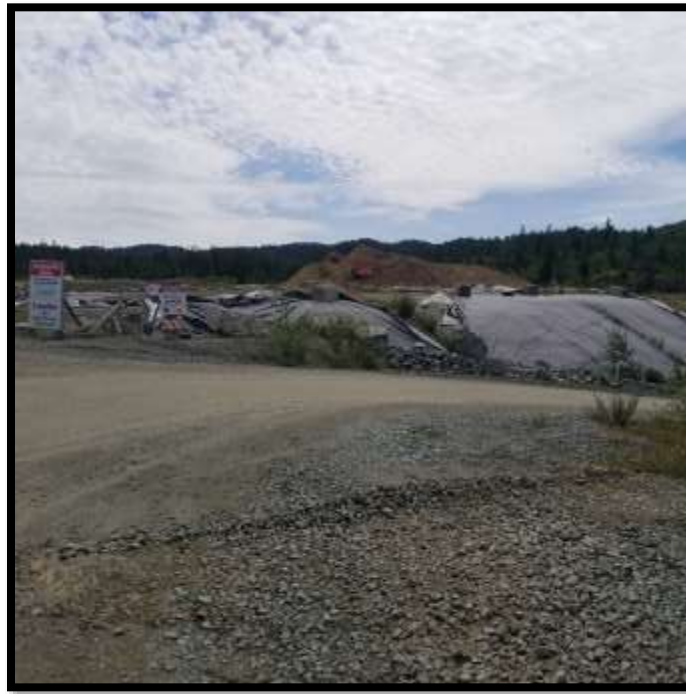
Picture # 1: Stockpile Location - South Stockpile

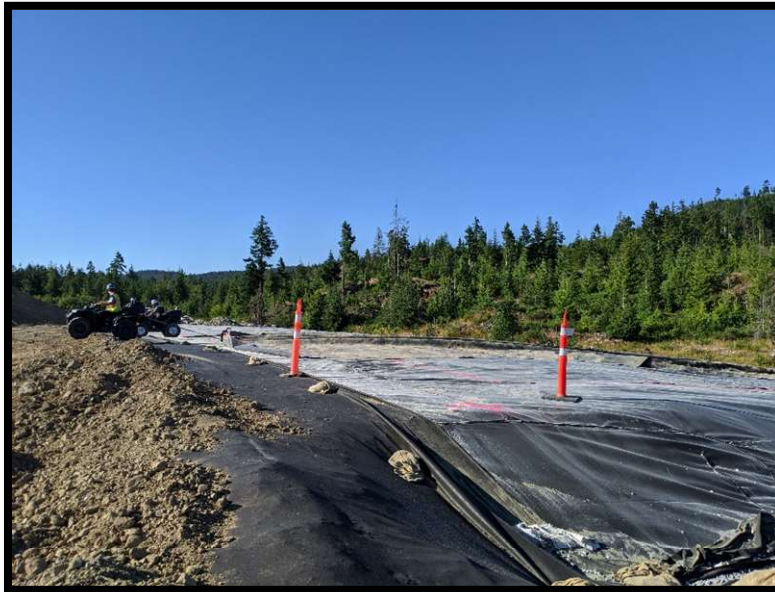
Picture # 1: Contractor began using quads to initially peel back the PEA membrane. The membrane was cut along three sides and peeled back in a single piece.

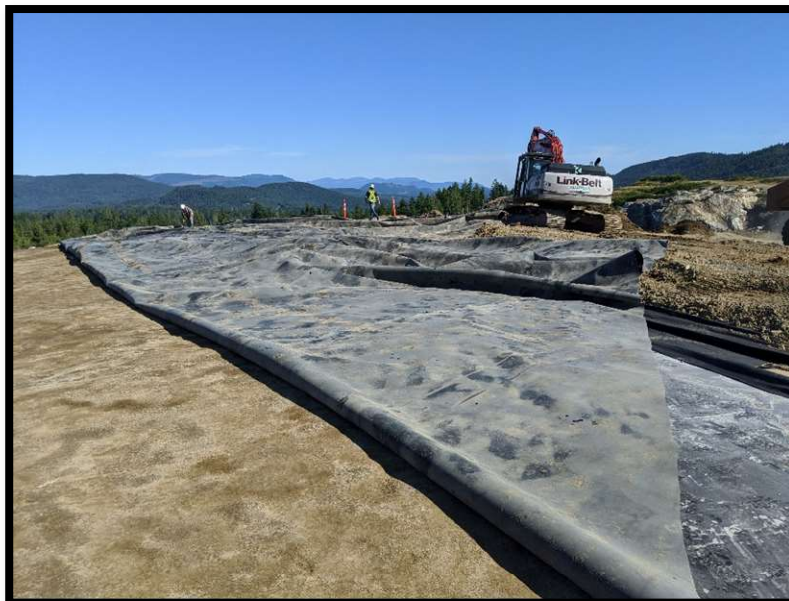
Picture # 2: Once the liner was within reach, an excavator was used to peel back the remaining portion of liner. The edge of the liner was sandwiched between two pieces of 4x4 and pinched together using the excavator thumb and bucket. The excavator then walked back until enough of the PEA had been exposed.

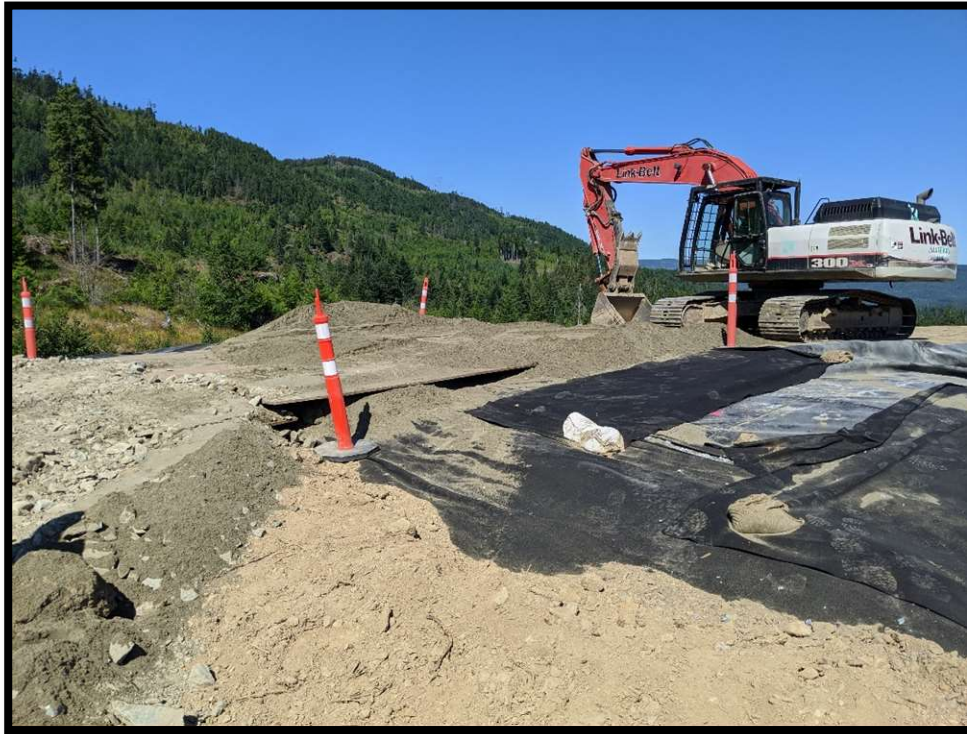
Picture #5: Sand bedding and road plates were used to create a bridge for hauling onto the exposed portion of the PEA.

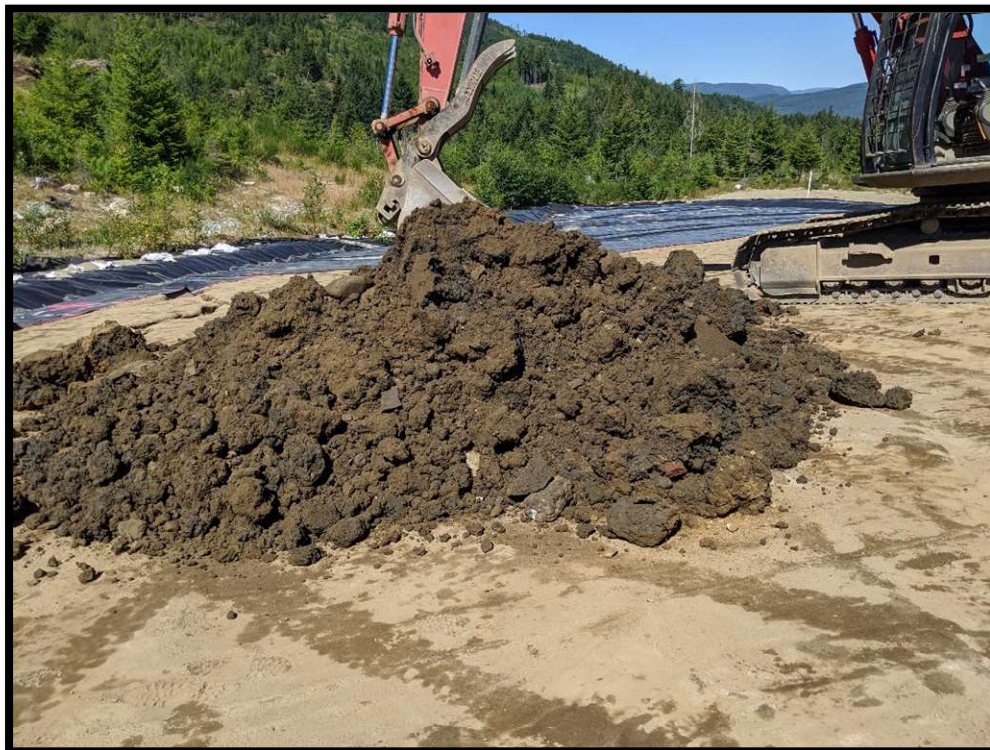
Picture #6: Previously stored on-site contaminated material was transferred to the exposed portion of the PEA. Hauling of the on-site contaminated material occurred throughout the day.

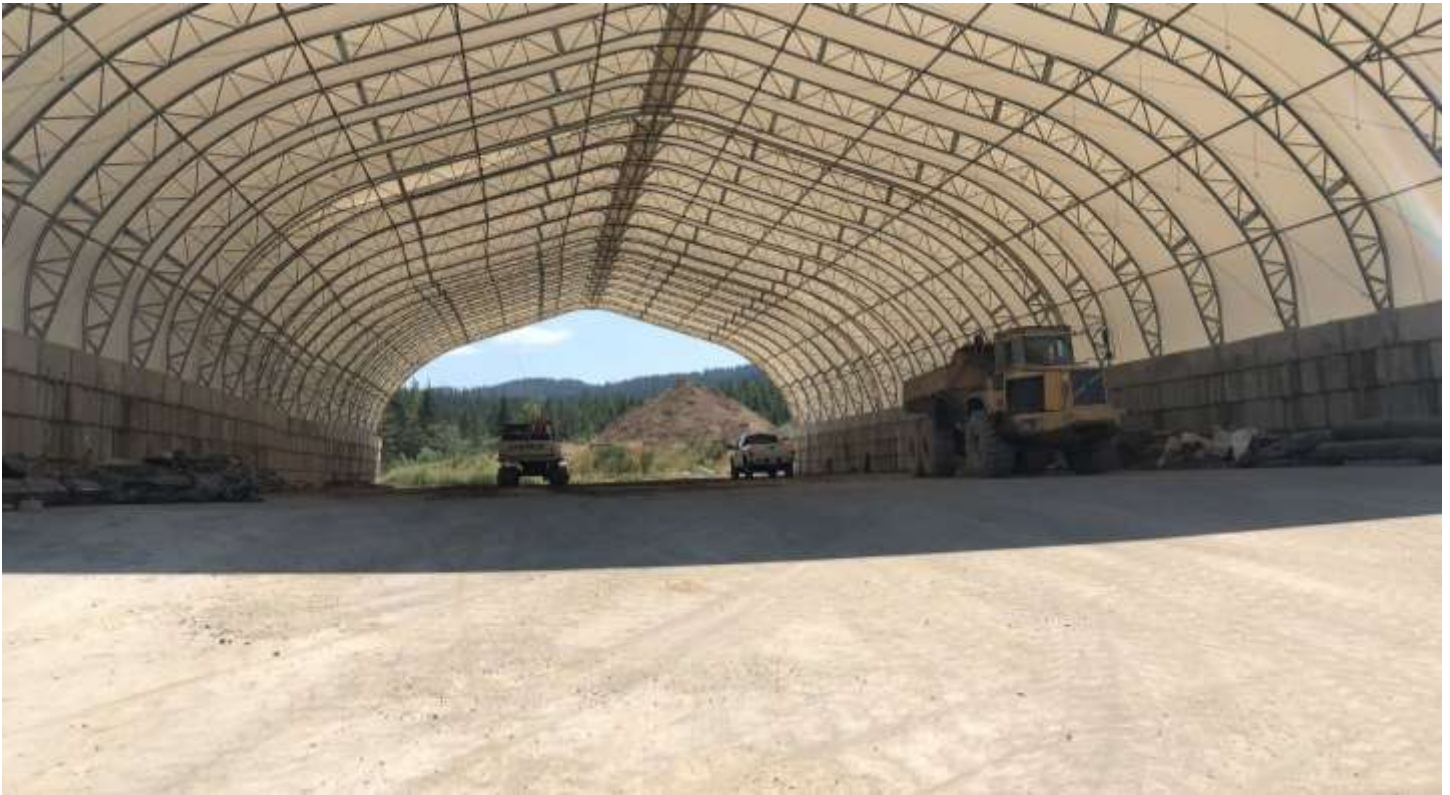
Picture #7: Waste soils completely removed from SMA.

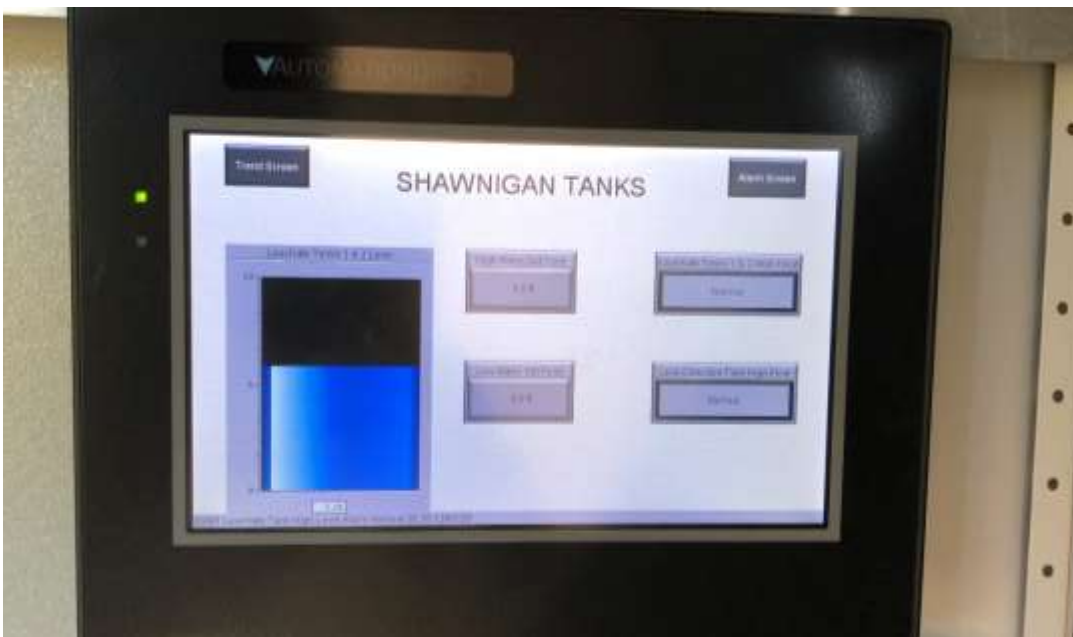
Picture #8: Leachate tank reading 7.05 ft.

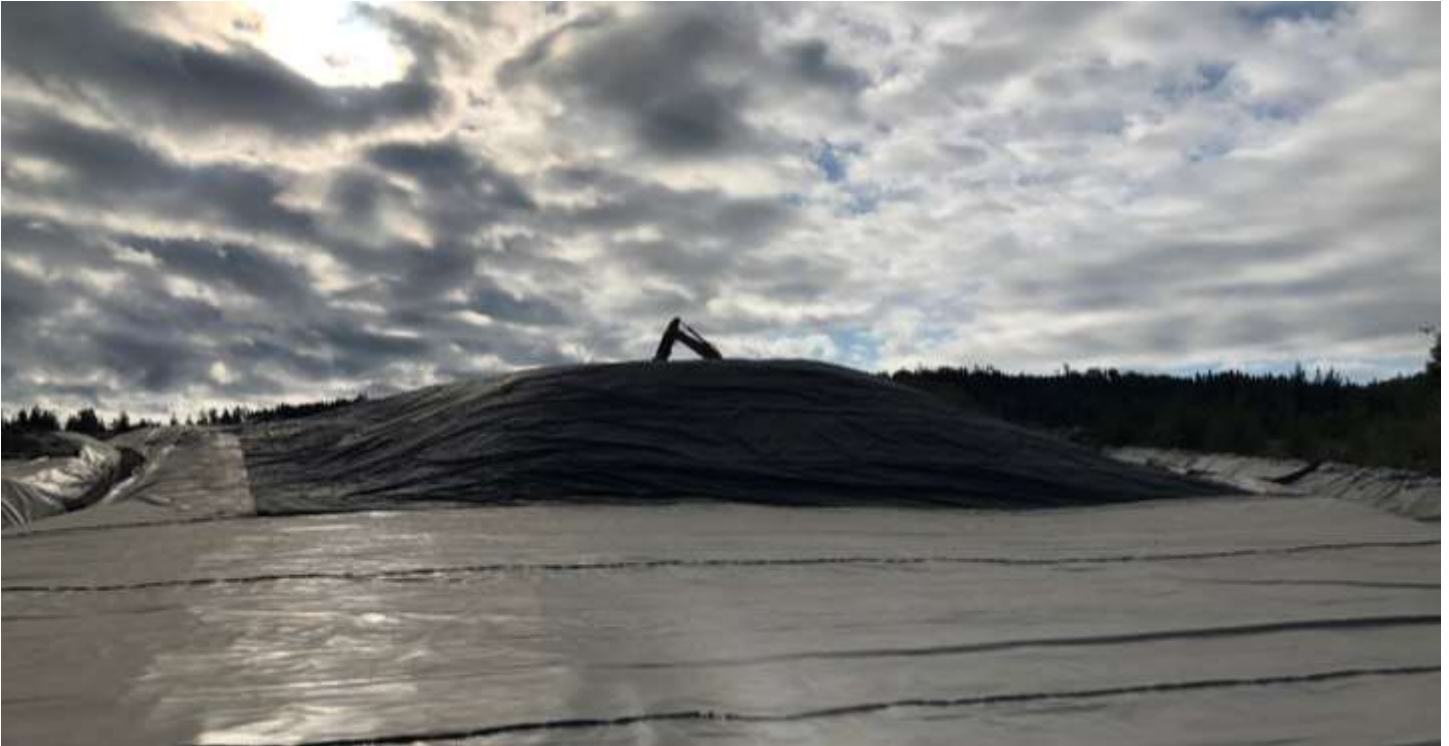
Picture # 5: 12 oz. geotextile deployed on crest of PEA (looking east). The geotextile was tucked under the existing geomembrane by 0.5 m.

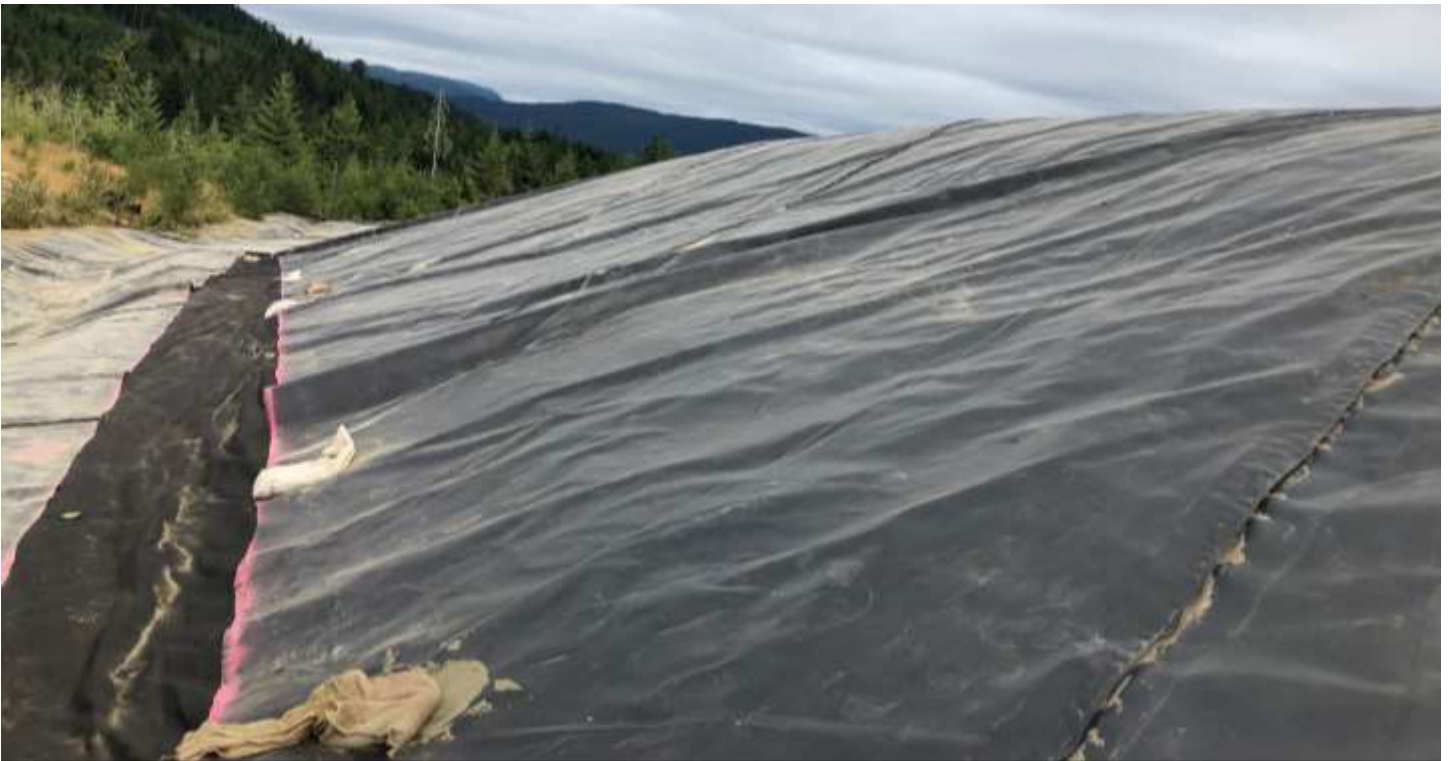
Picture #8: Gap between geomembrane after pulling back over crest of PEA.

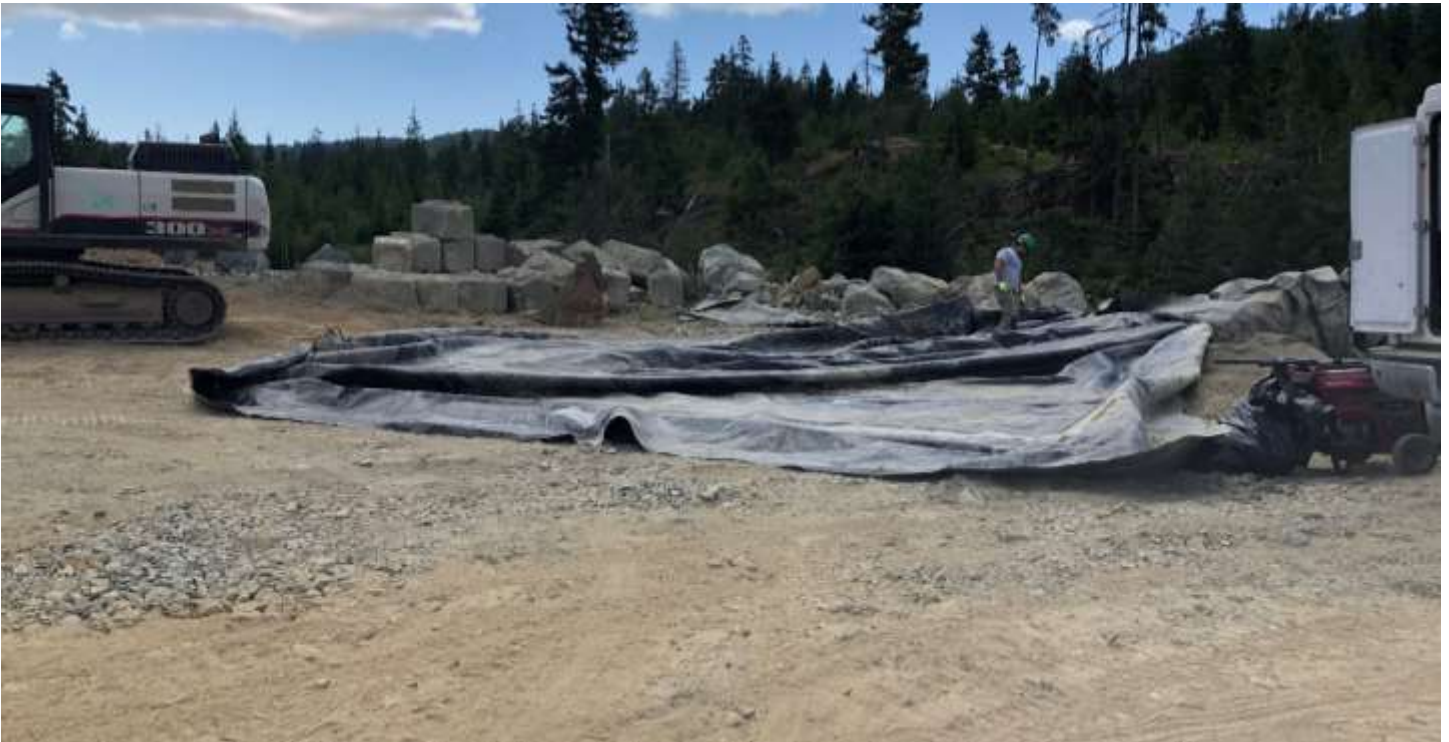
Picture # 1: 40 mil. LLDPE geomembrane on site used for patching and repairs of geomembrane on PEA.

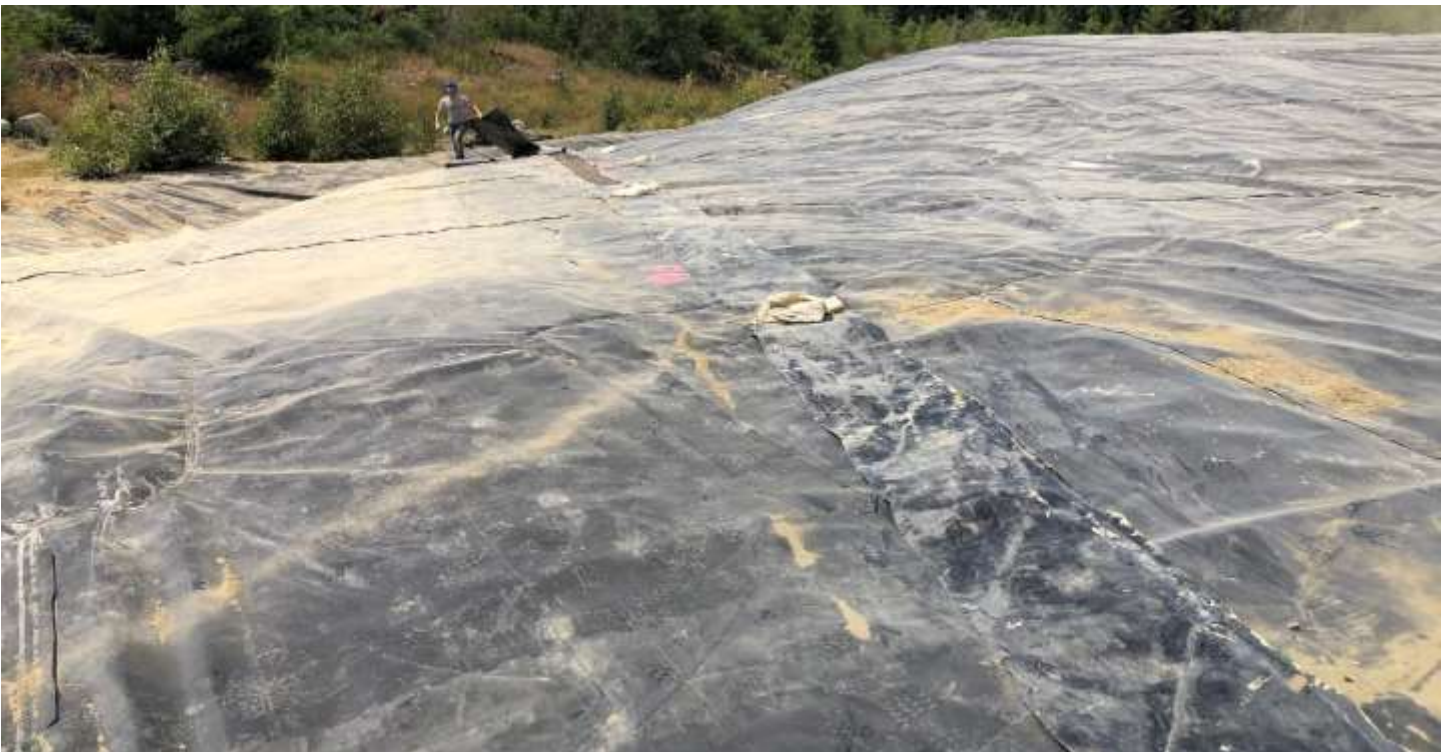
Picture # 2: Geomembrane patches placed on PEA crest.

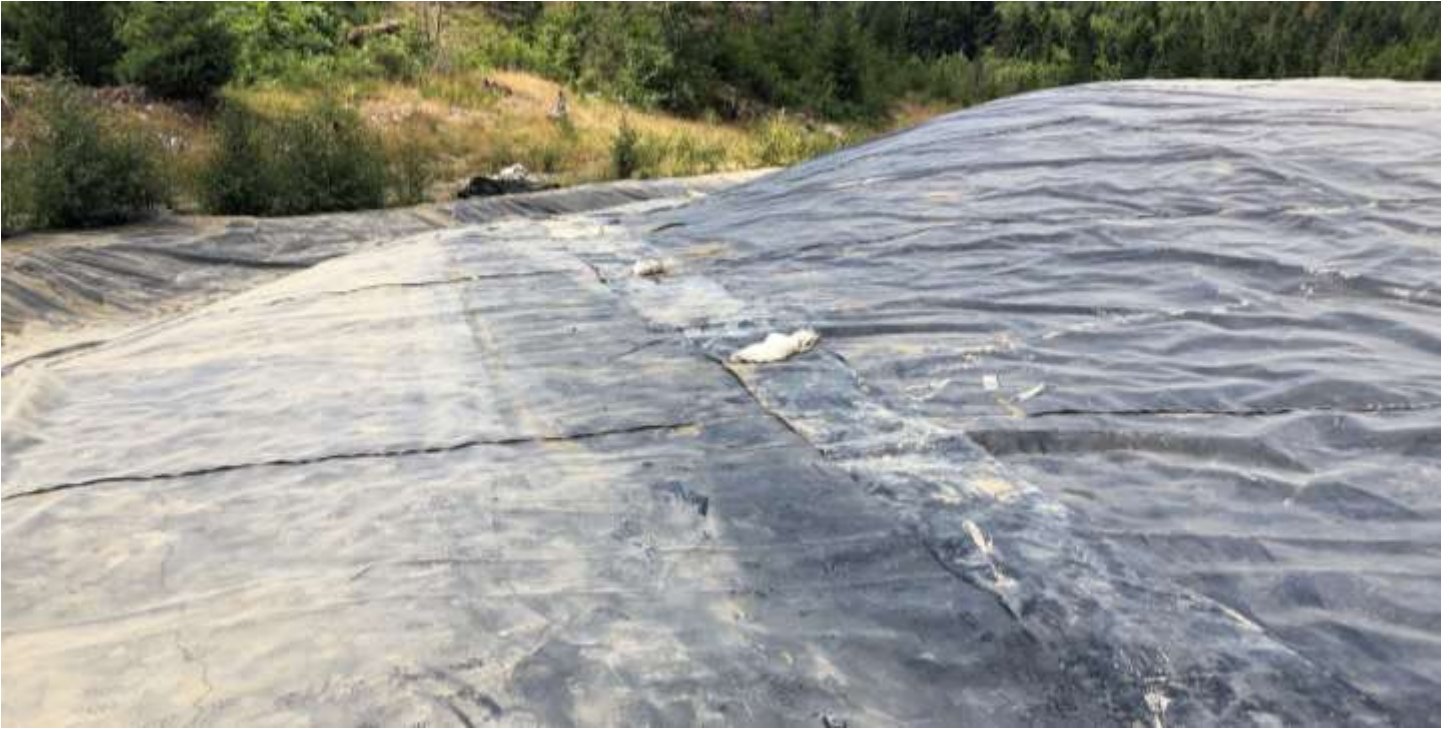
Picture # 3: Geomembrane patches placed on PEA crest.

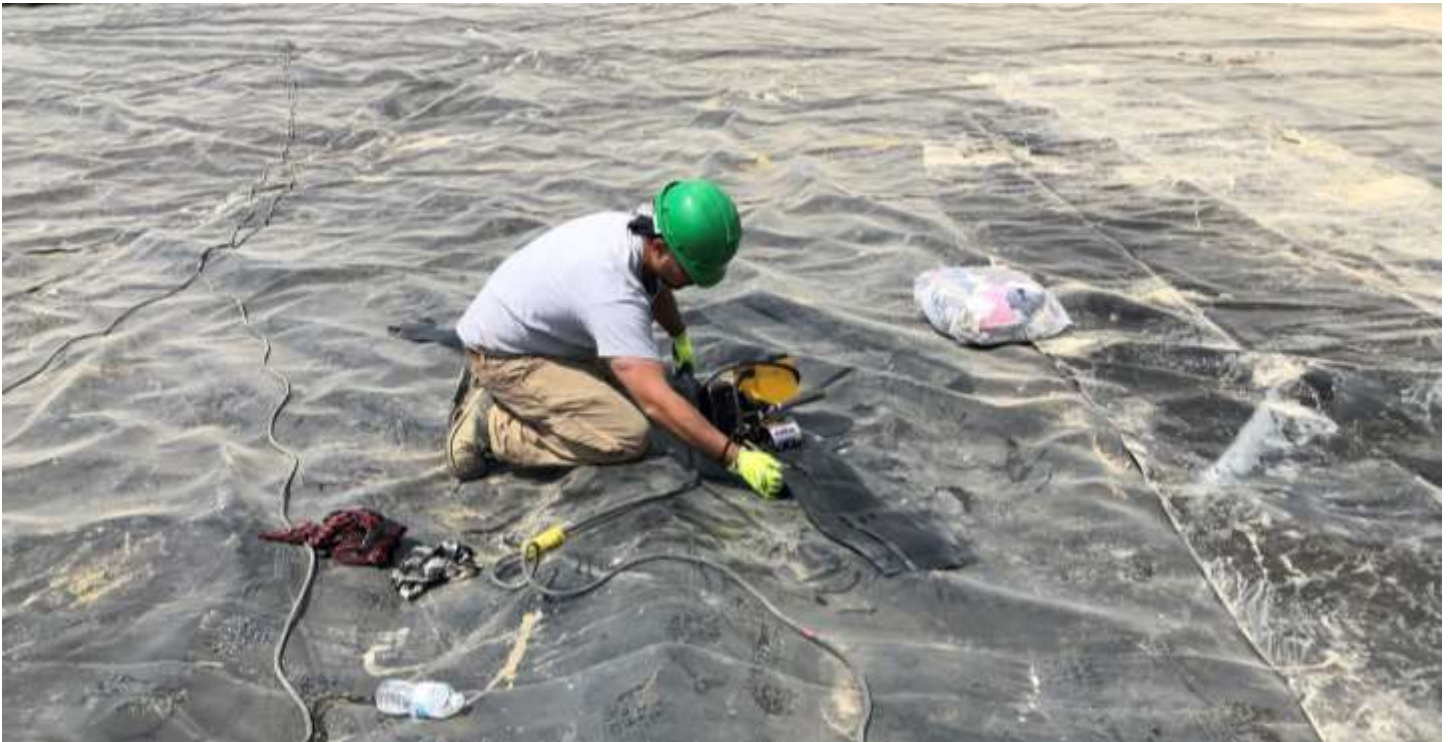
Picture # 5: Western Tank & Lining (WTL) qualifying wedge welder by welding test strips.

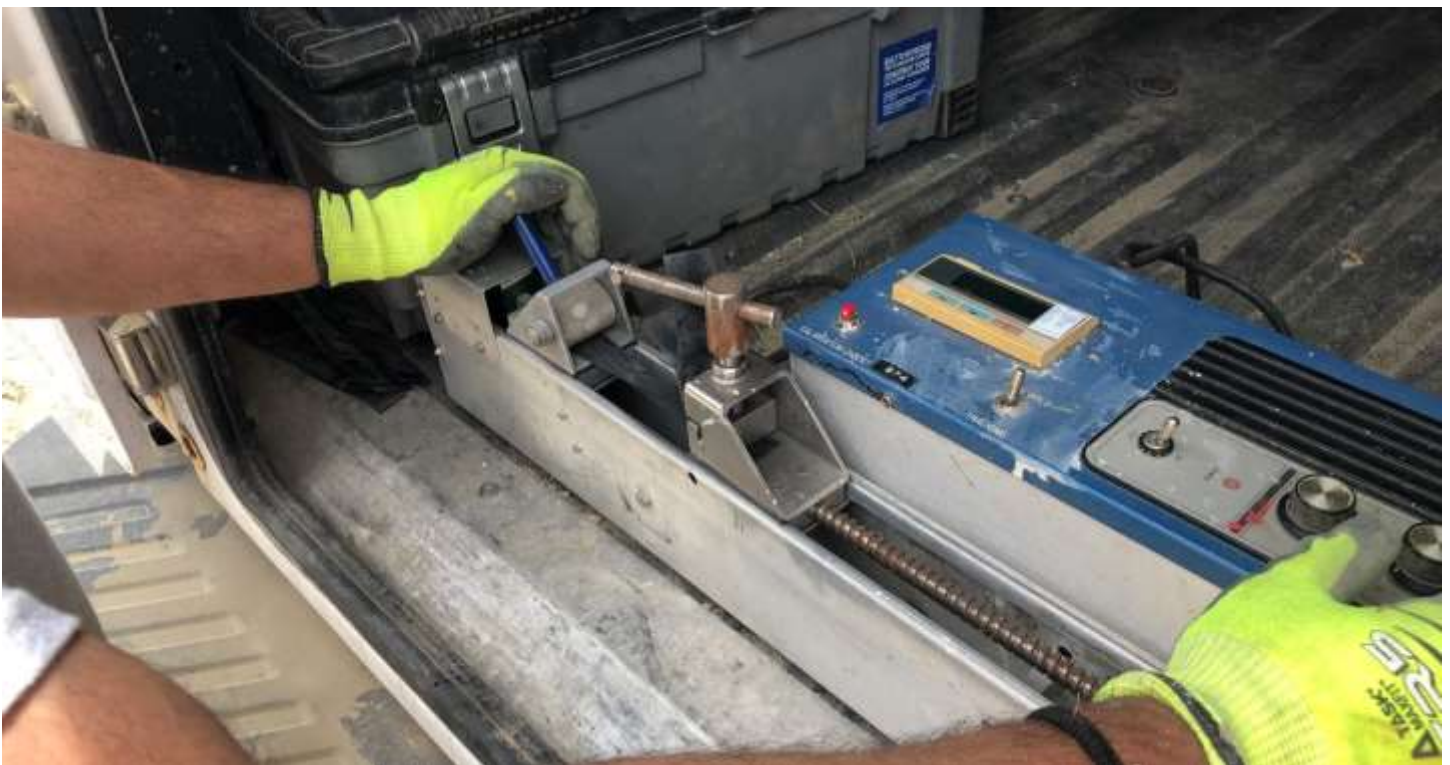
Picture # 6: WTL using tensiometer to conduct peel and shear tests on wedge weld test strips. A total of five peel tests and 2 shear tests were performed on the wedge weld.

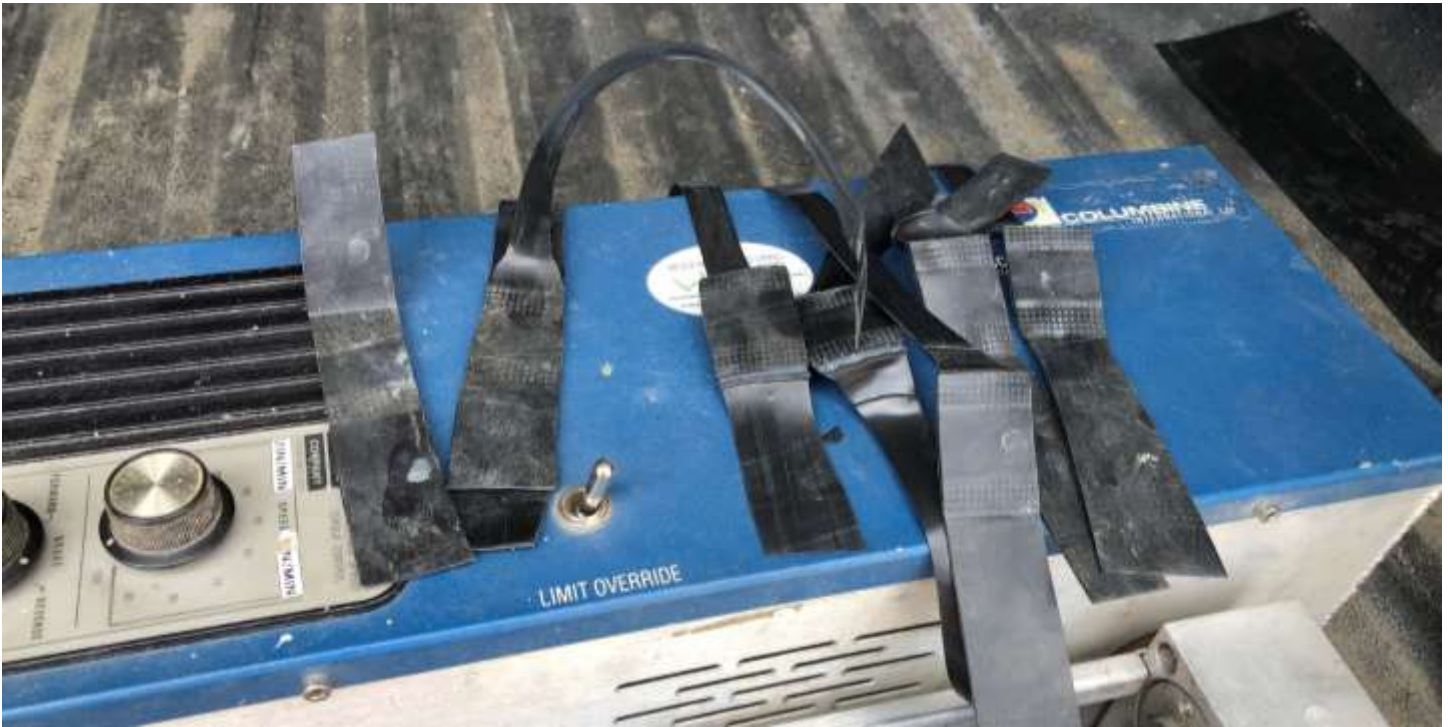
Picture # 7: Passed test strips.

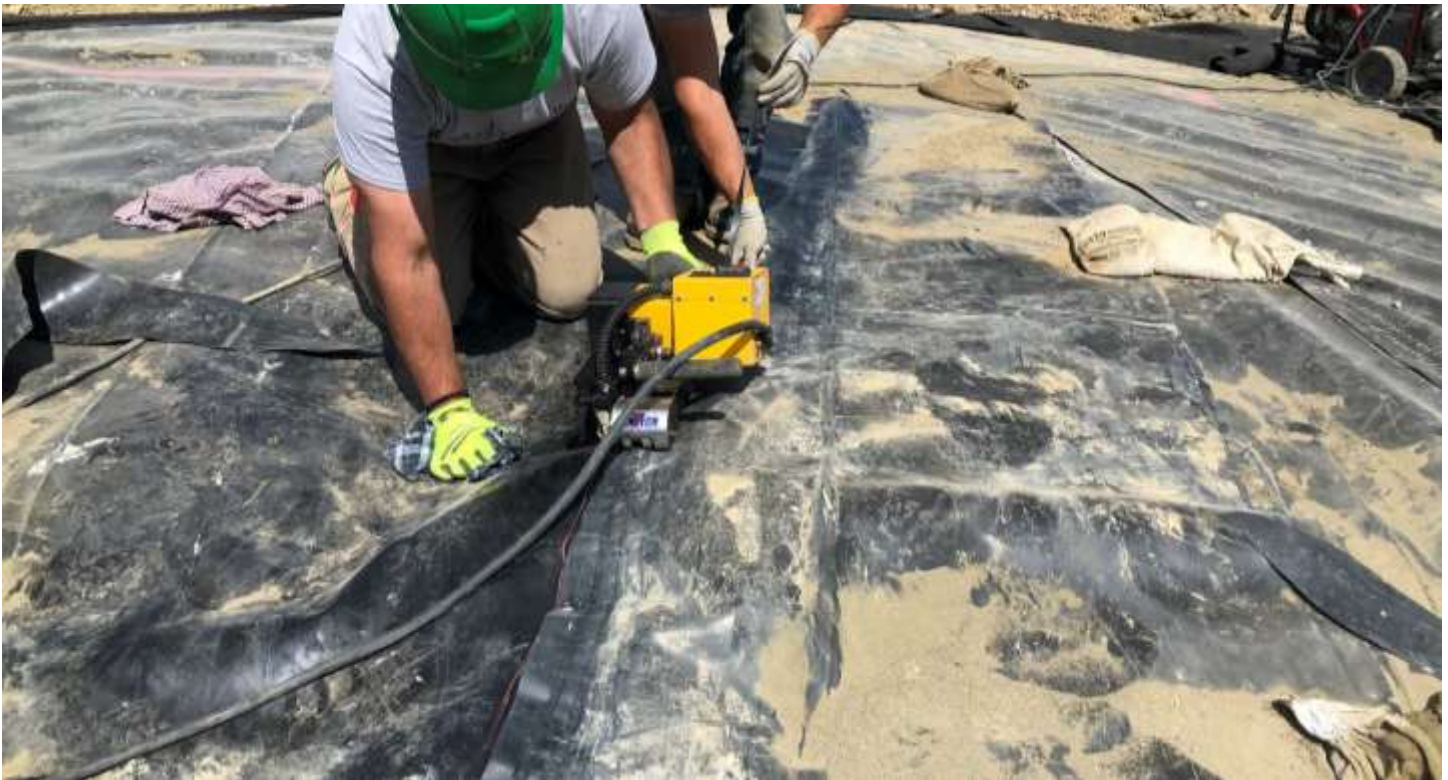
Picture # 8: WTL performing wedge weld on geomembrane patch on PEA.

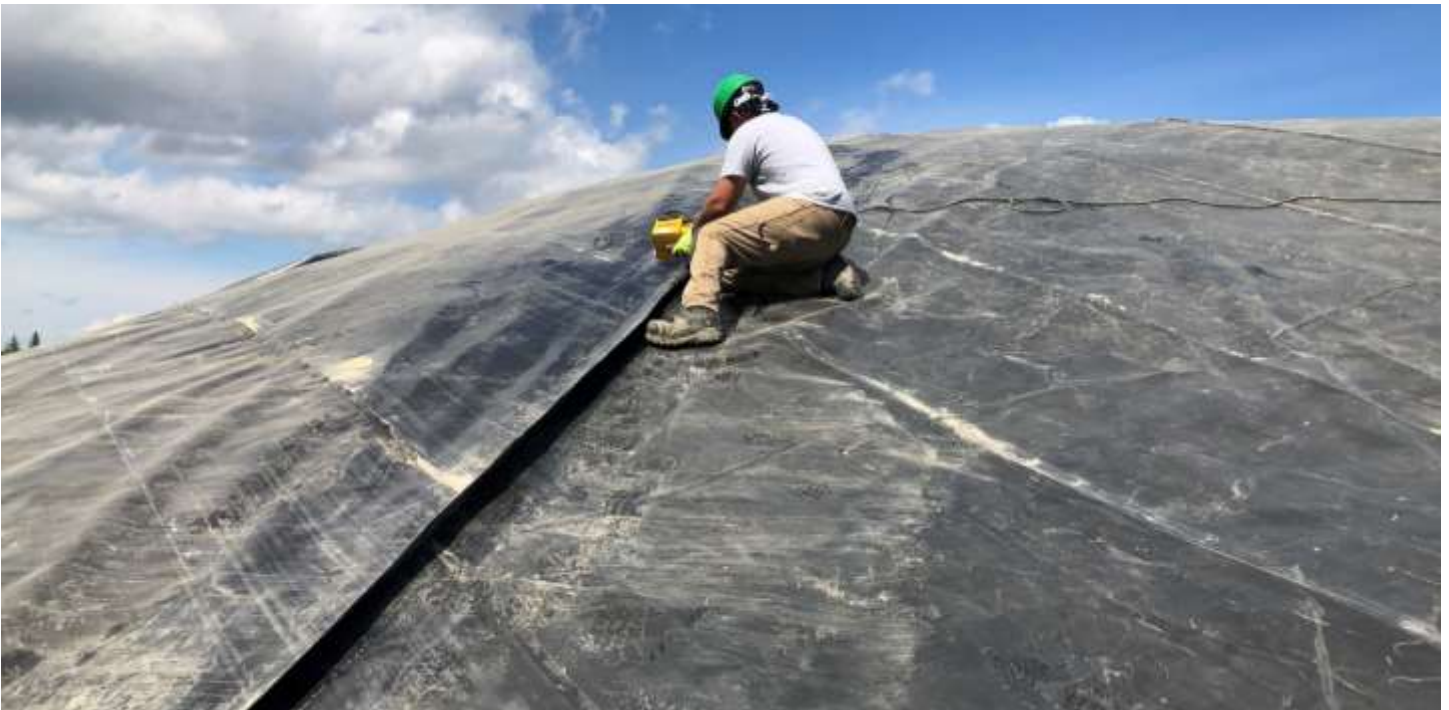
Picture # 12: WTL wedge welding previous wrinkle in geomembrane.

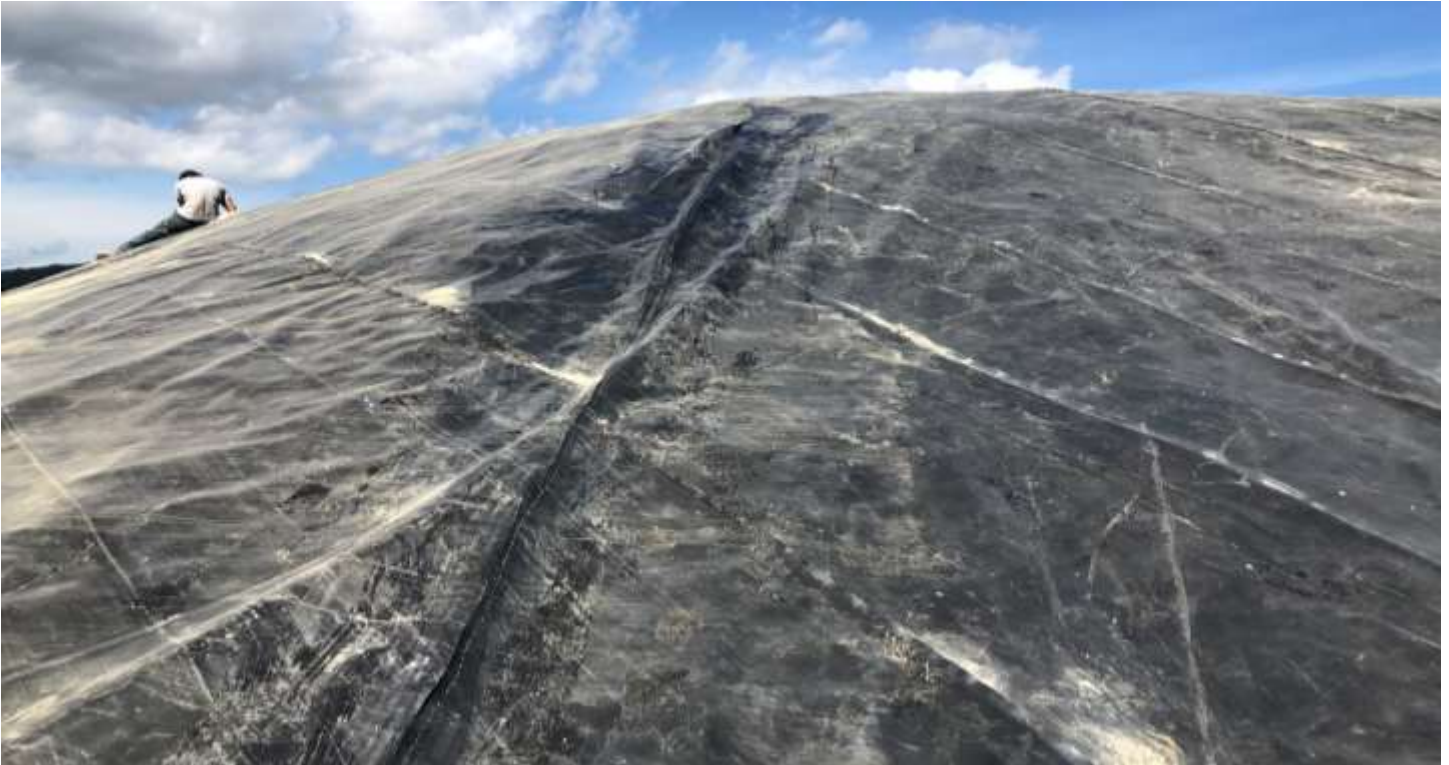
Picture # 13: Completed wedge weld.

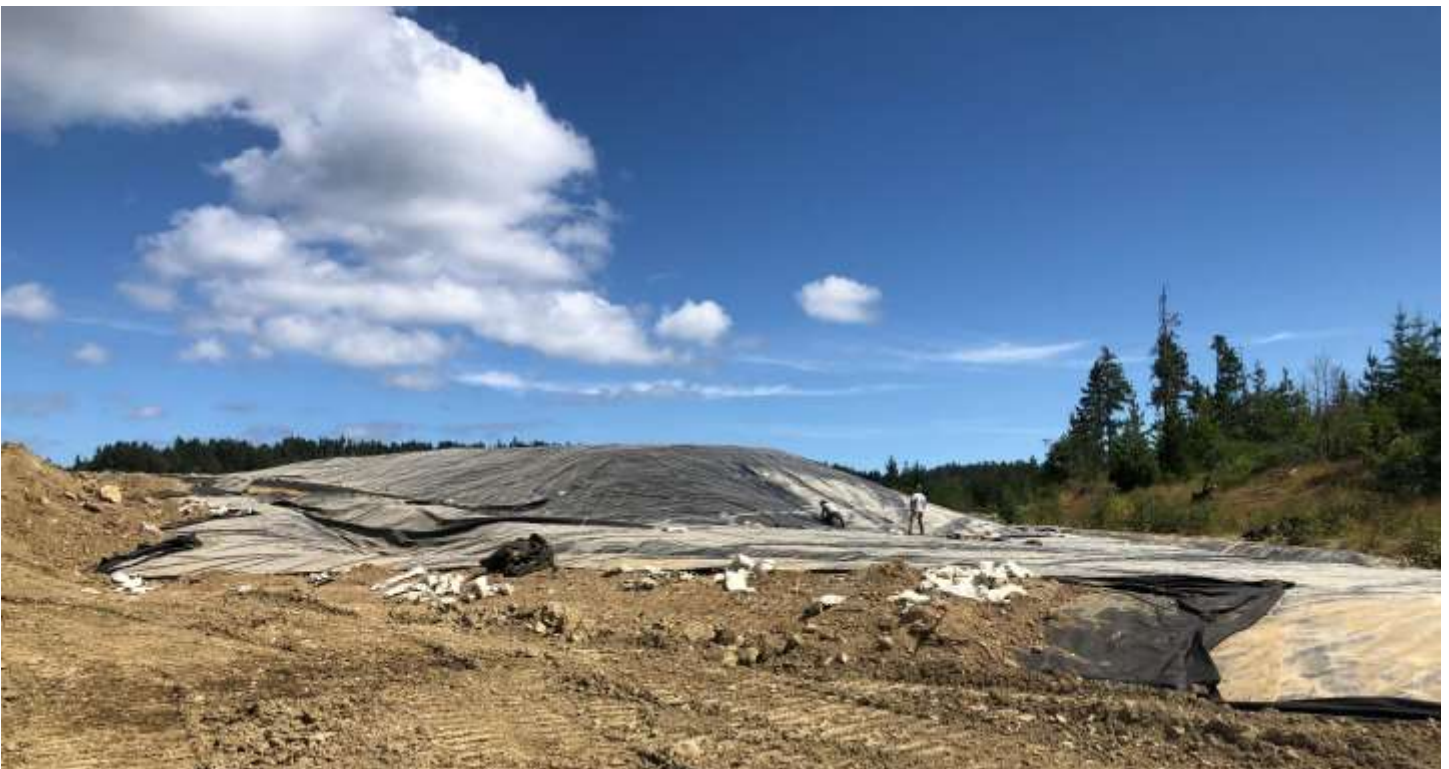
Picture #14: Looking south at PEA

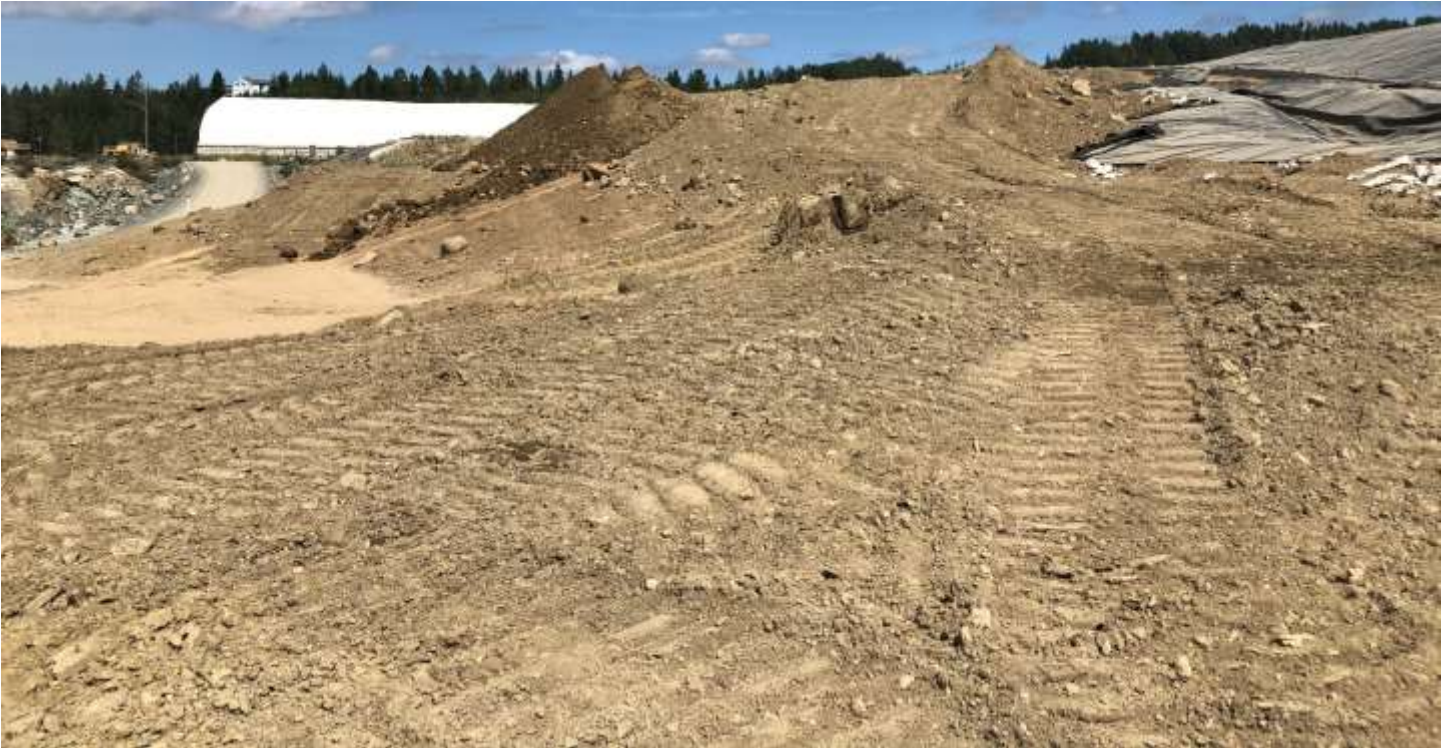
Picture # 15: Alterra relocated common fill to north side of PEA.

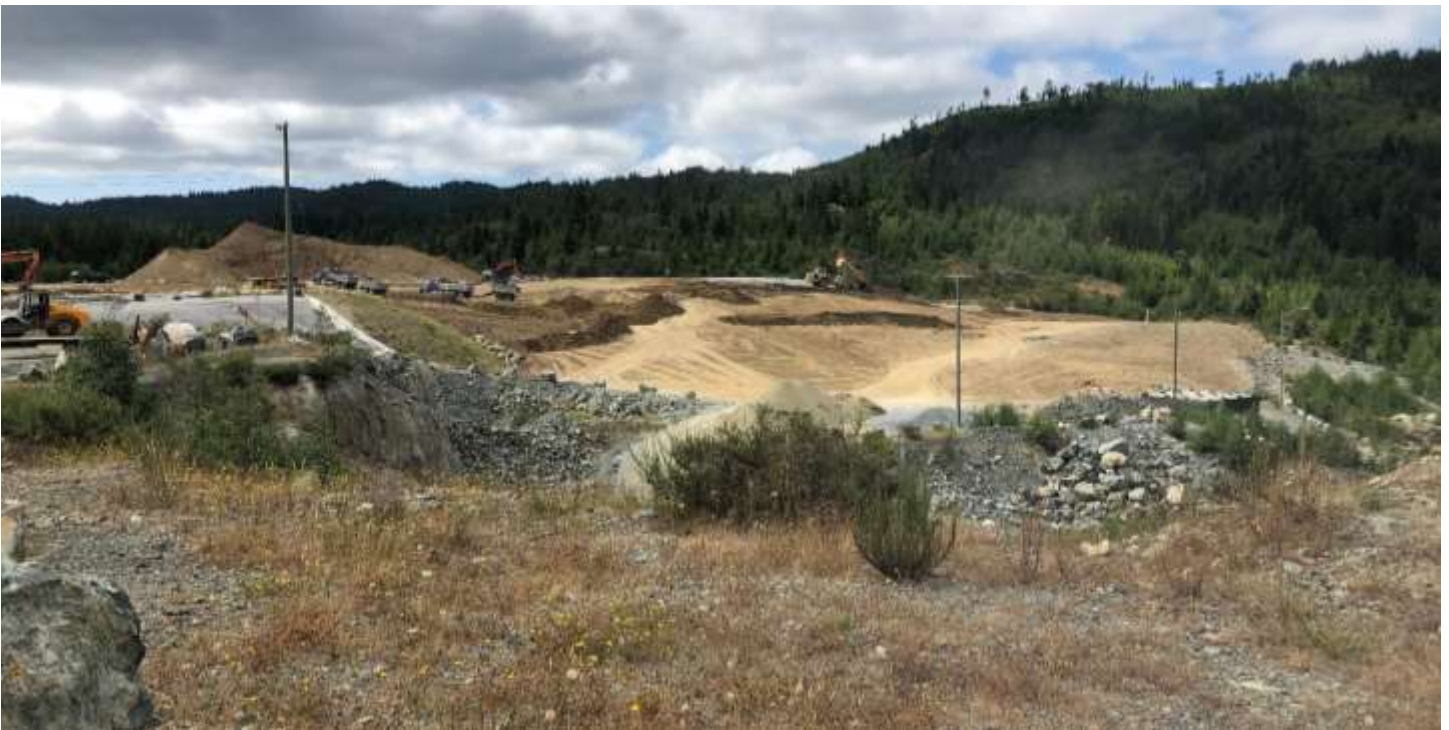
Picture #16: Looking southwest at site.
