BI-WEEKLY STATUS REPORT

Cobble Hill Landfill Closure

PROJECT # : PRJ18074	File #: 18074- BWR-71
REPORT #: 73	Date: July 30, 2020
SHA REPRESENTATIVES: Dr. Tony Sperling, P.Eng. Scott Garthwaite Carly Wolfe, EIT	Owner: Cobble Hill Holdings Ltd. Contractor: Allterra Construction Ltd.

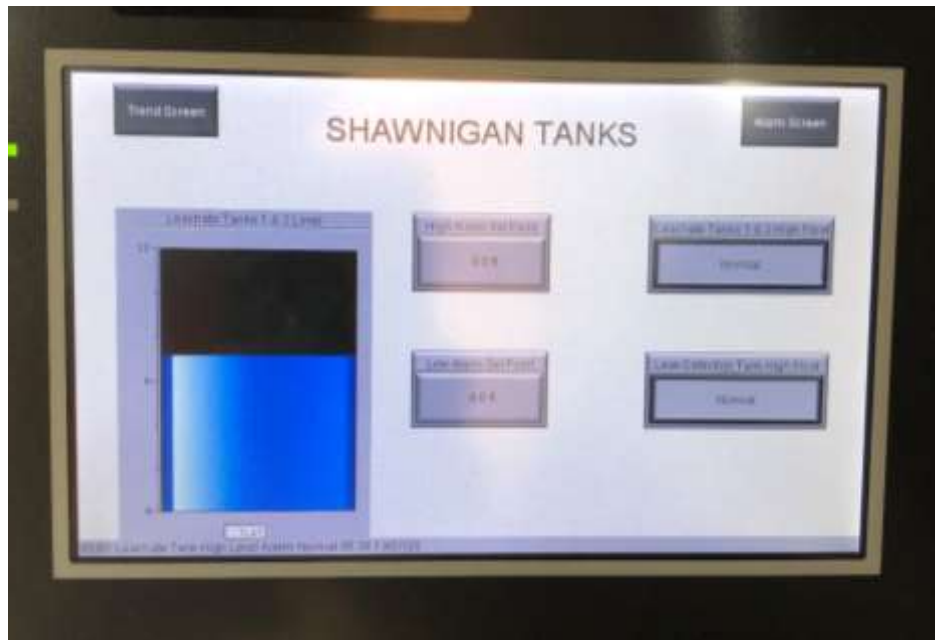
Picture #17: Leachate tank reading 7.17 ft.

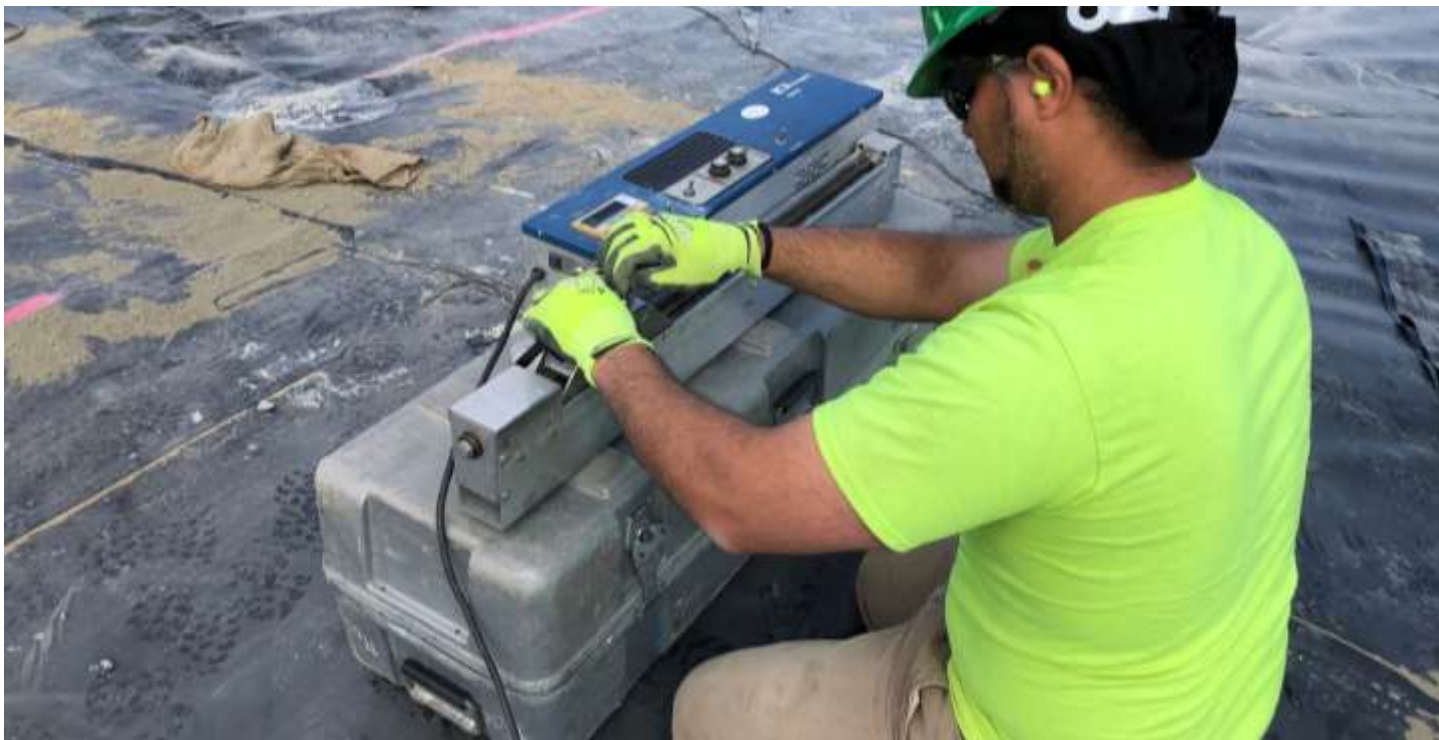
Picture # 1: WTL using tensiometer to test wedge weld.

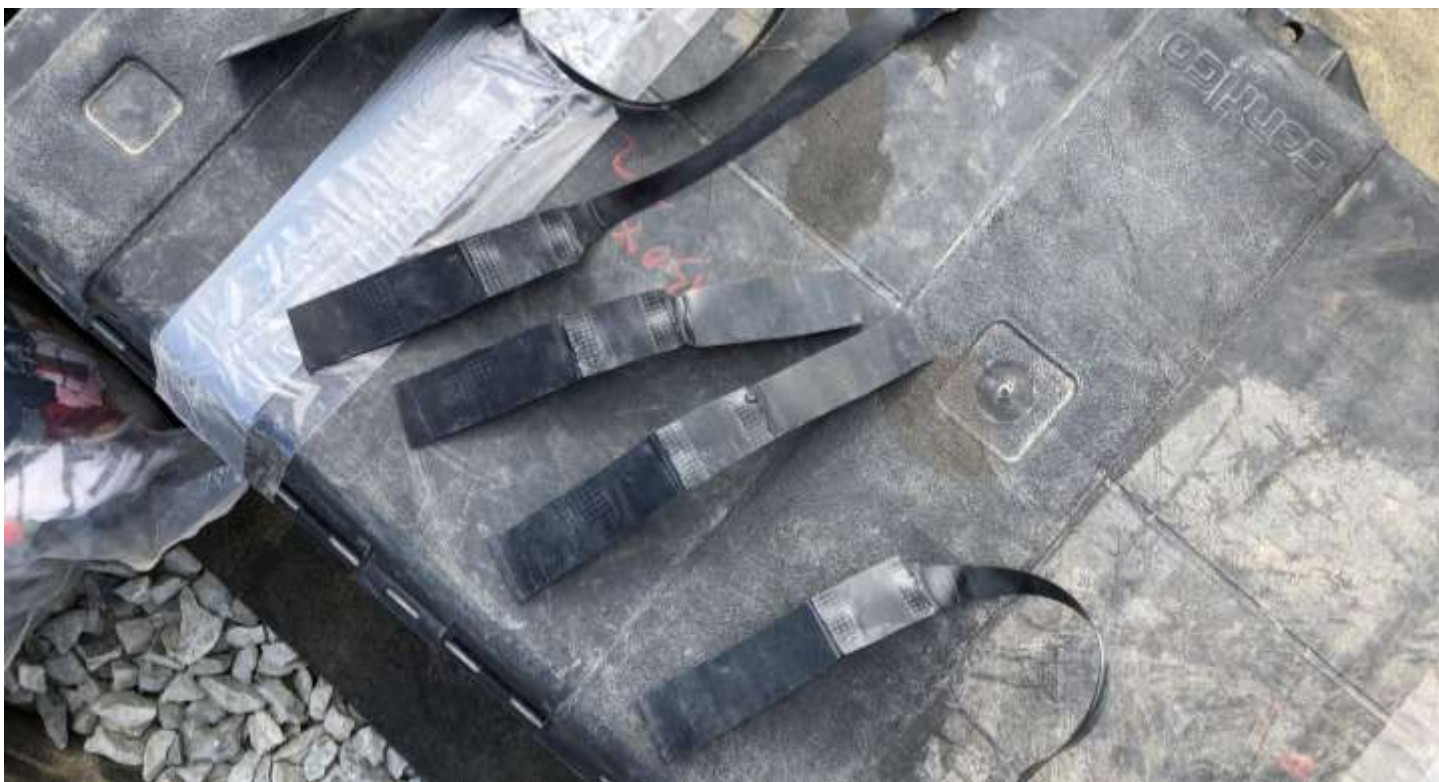
Picture # 2: Examples of passed wedge weld test strips.

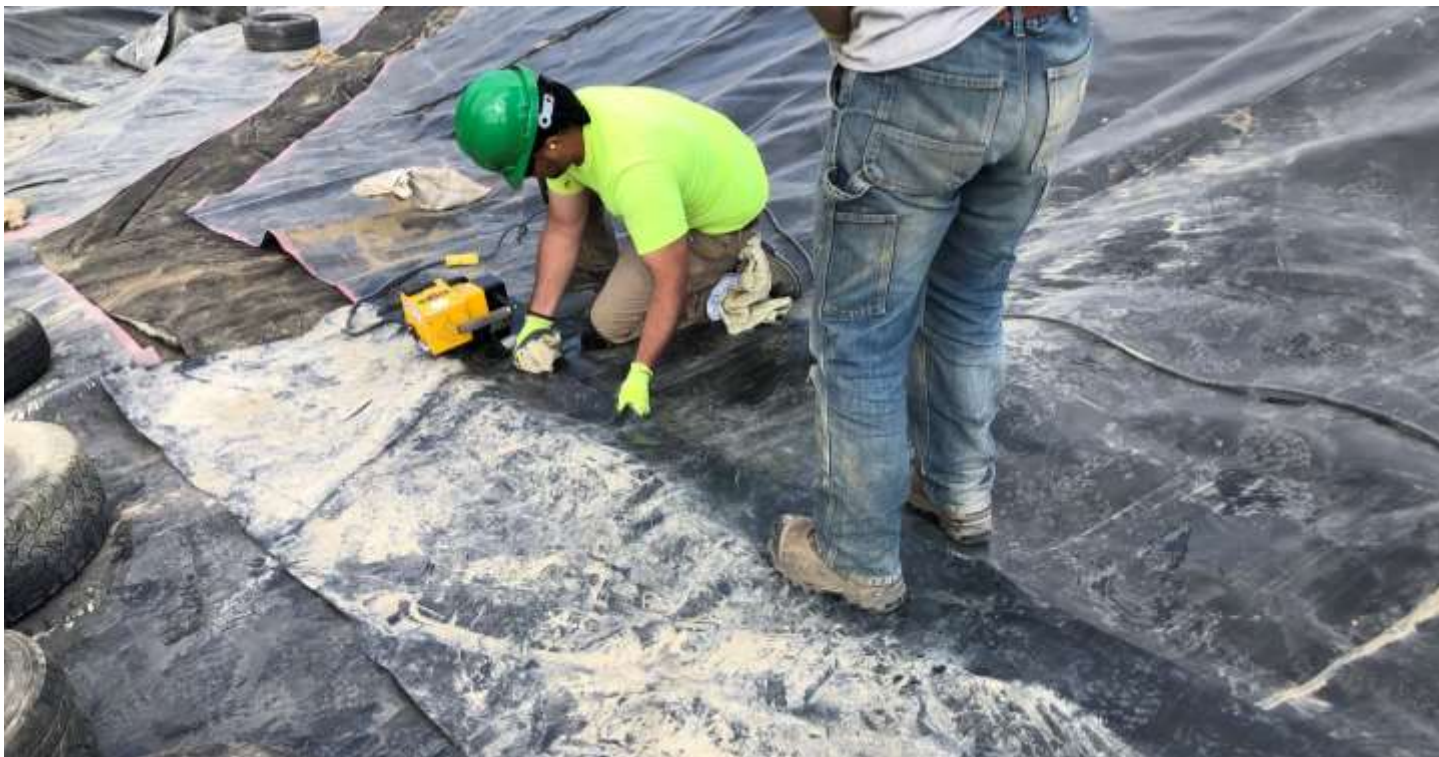
Picture # 3: WTL wedge welding geomembrane patch on crest of PEA.

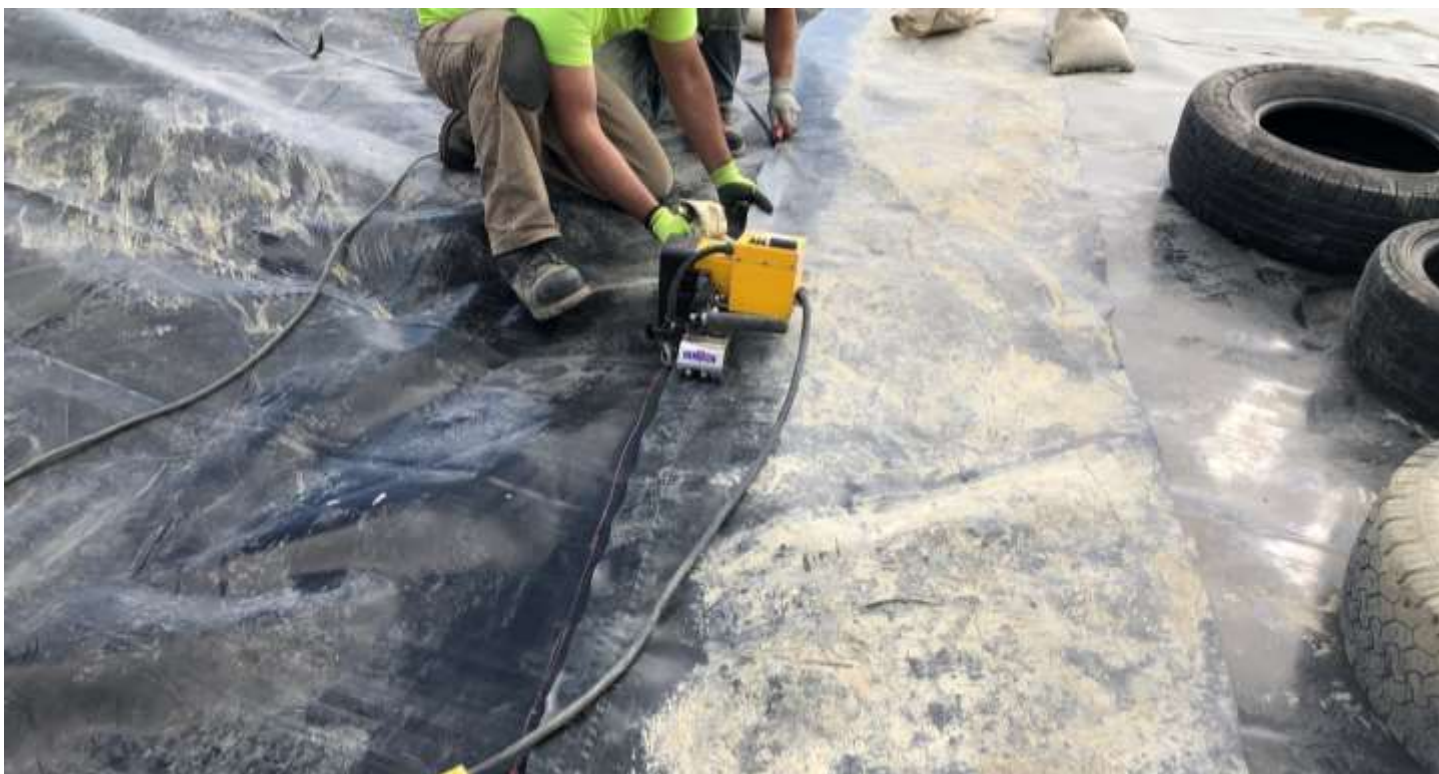
Picture # 4: WTL wedge welding geomembrane patch on crest of PEA.

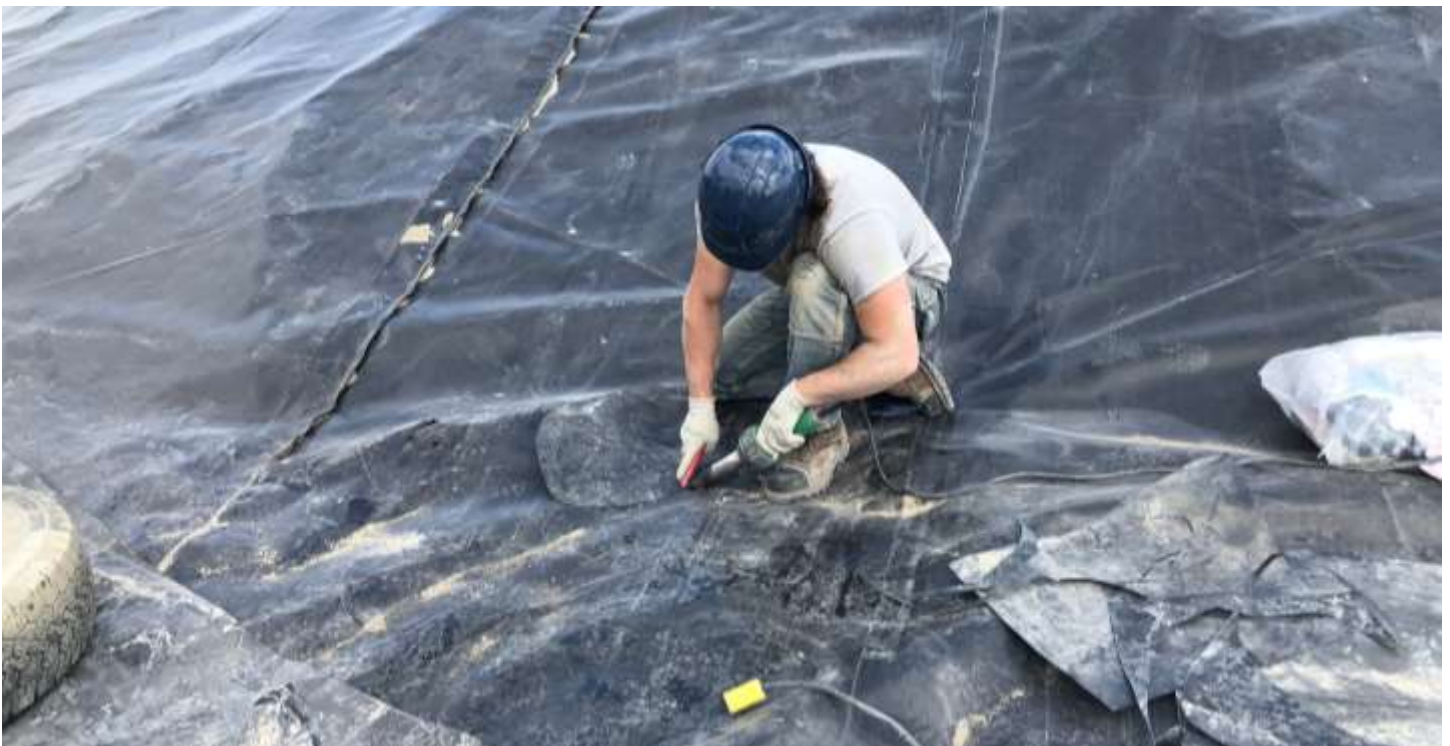
Picture # 6: WTL installing patch on geomembrane.

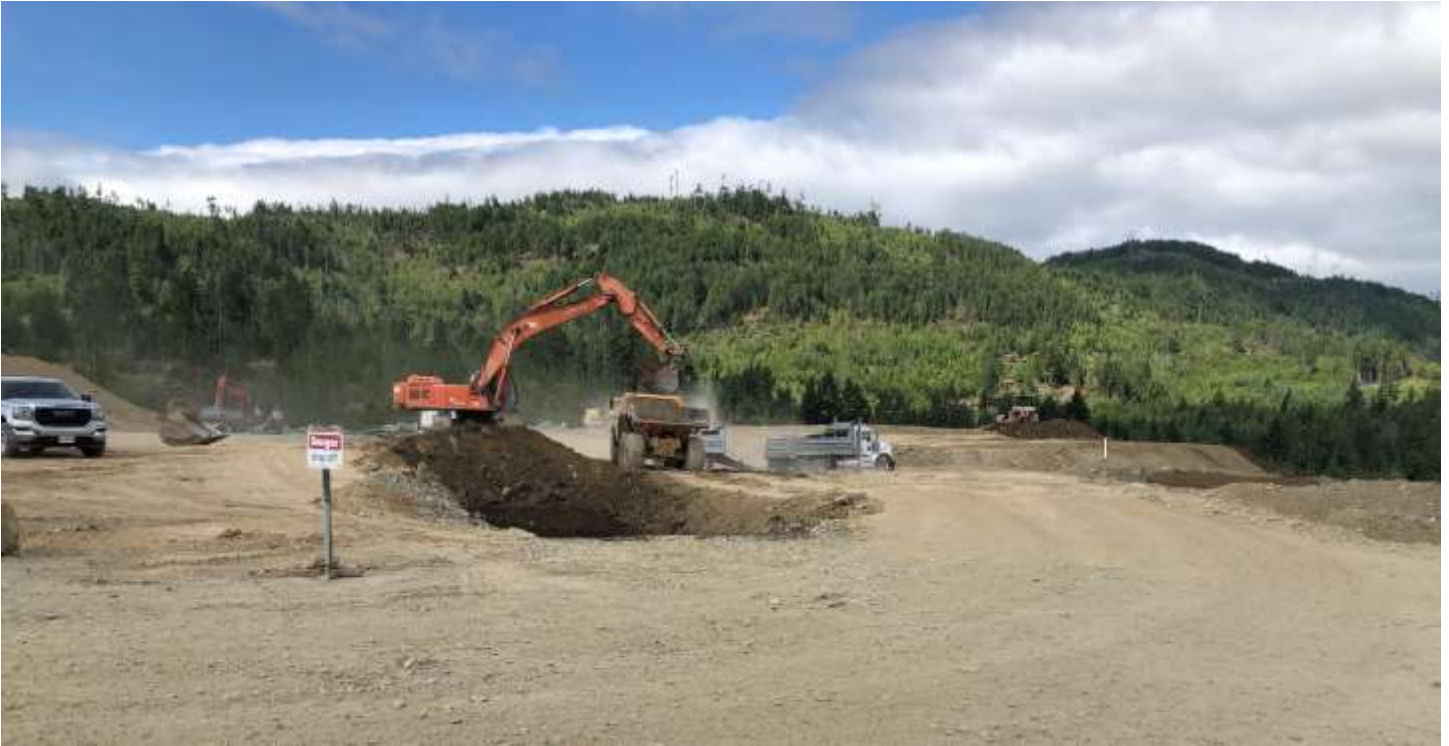
Picture # 7: Alterra excavating and relocating on-site soils

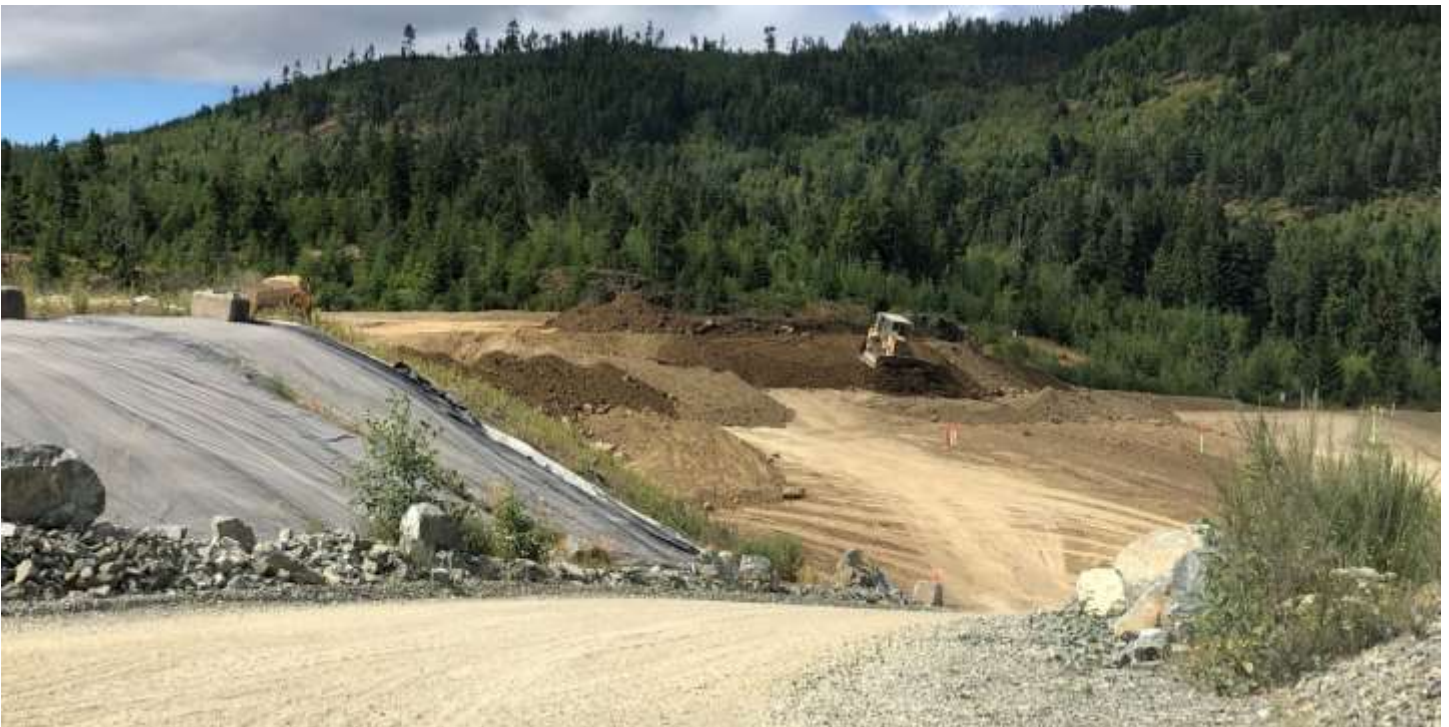
Picture # 8: Alterra grading soils on north slope of PEA

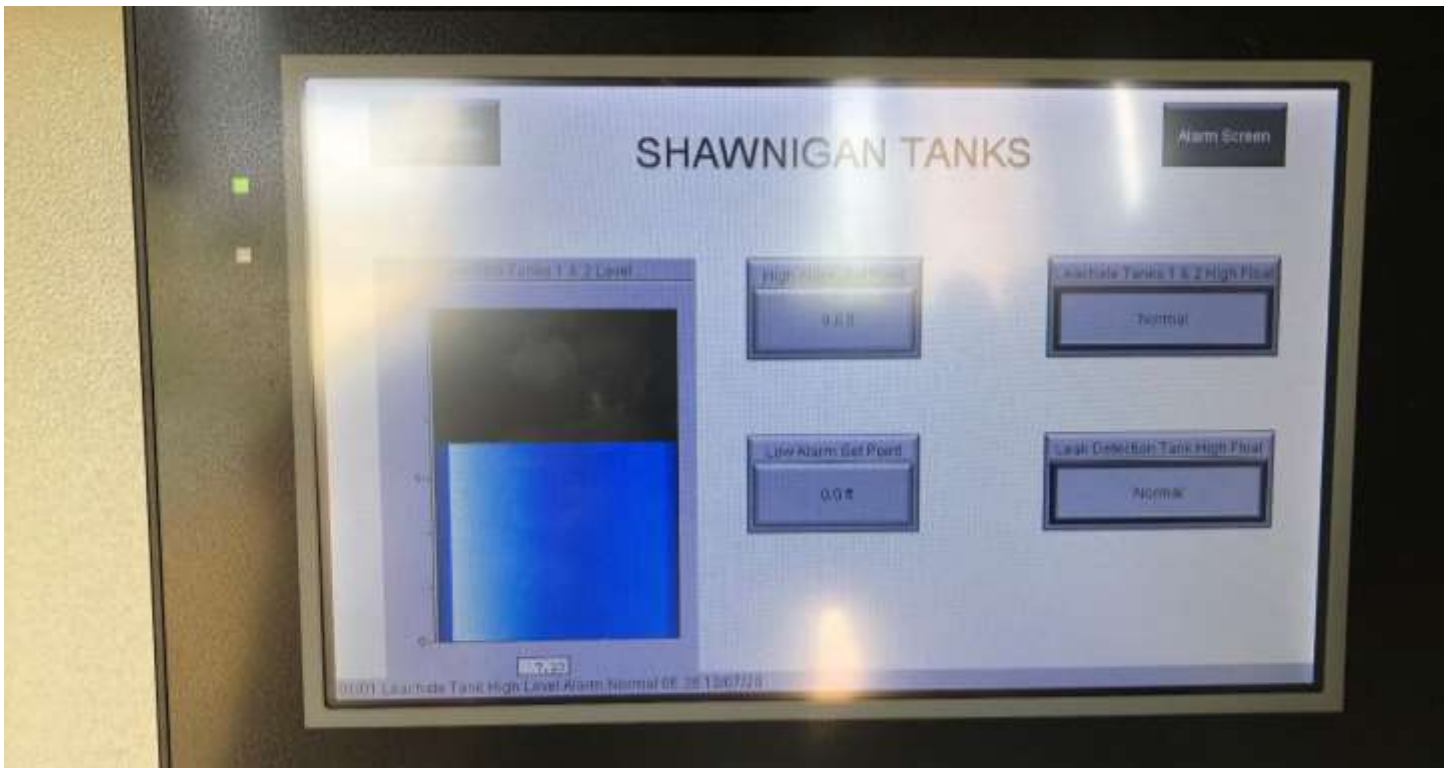
Picture # 9: Leachate tank reading 7.23 ft.

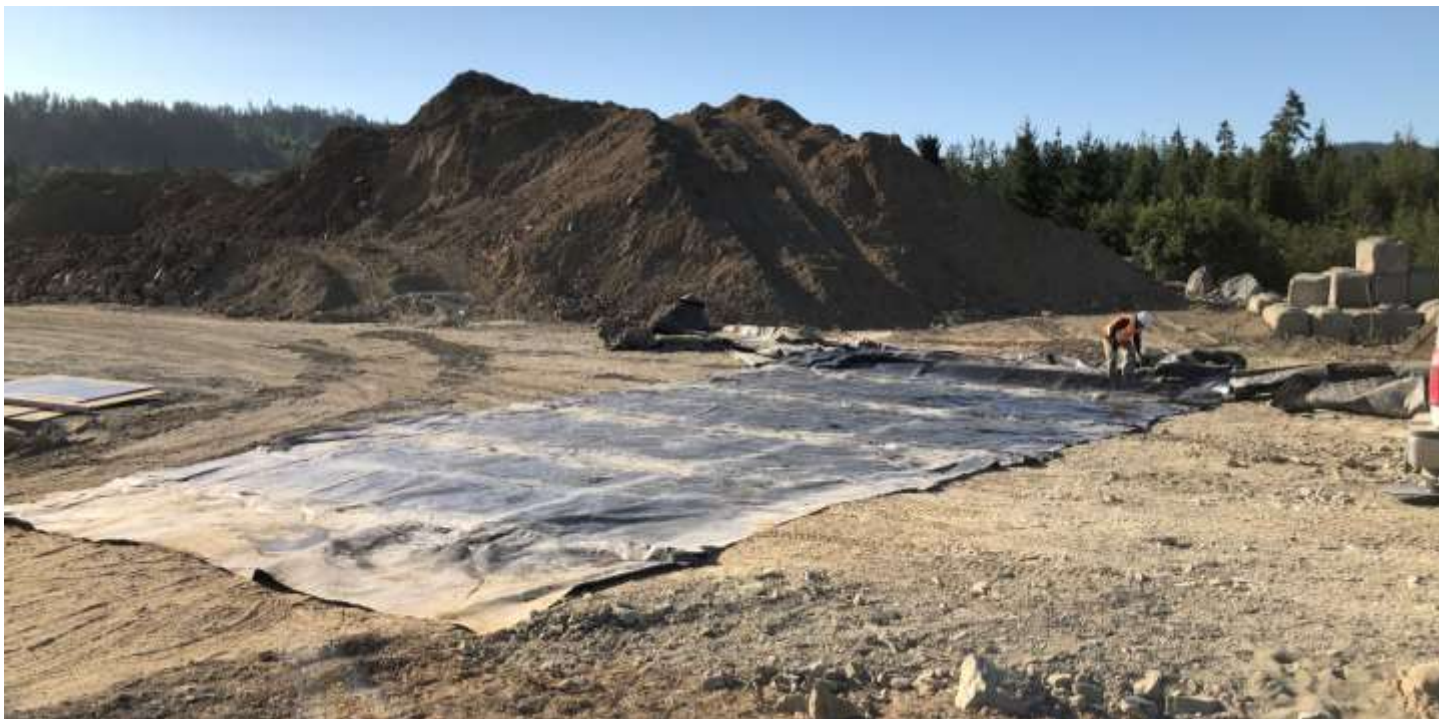
Picture # 1: Geomembrane used for patching geomembrane on PEA

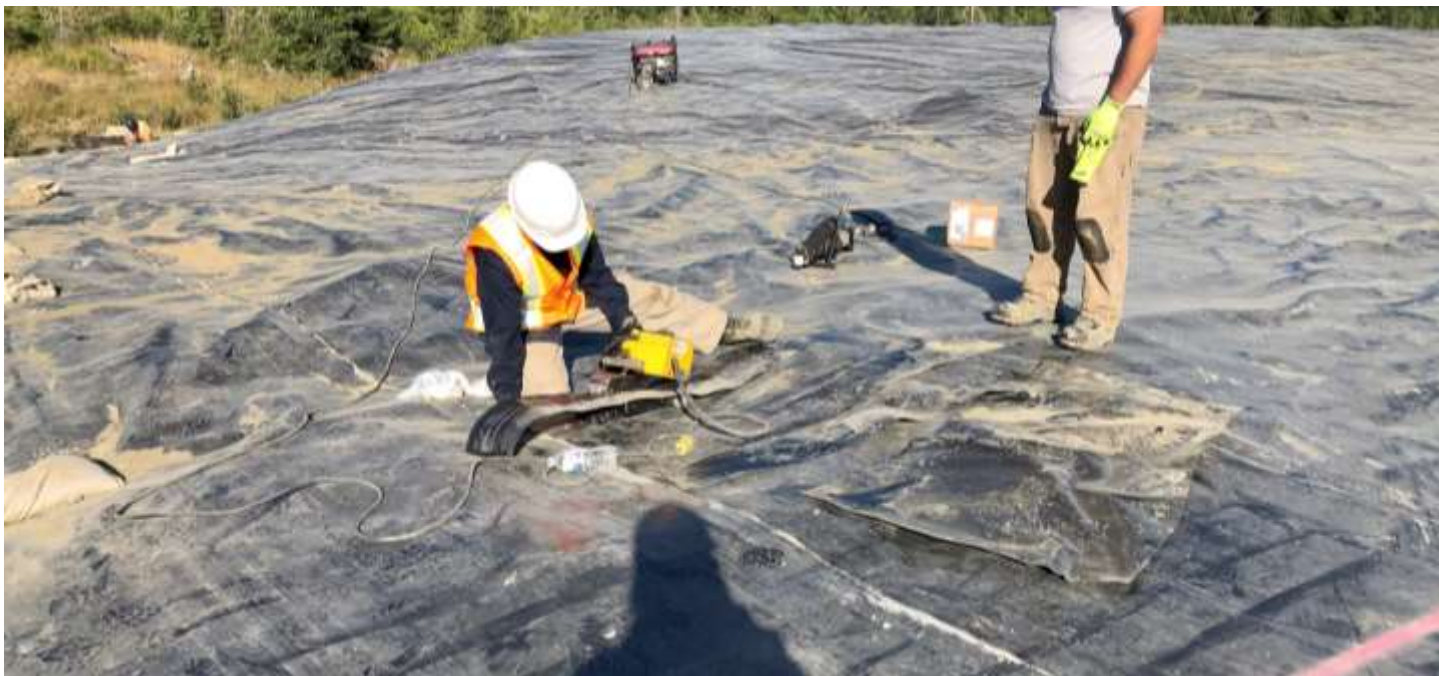
Picture # 2: WTL qualifying wedge welder.

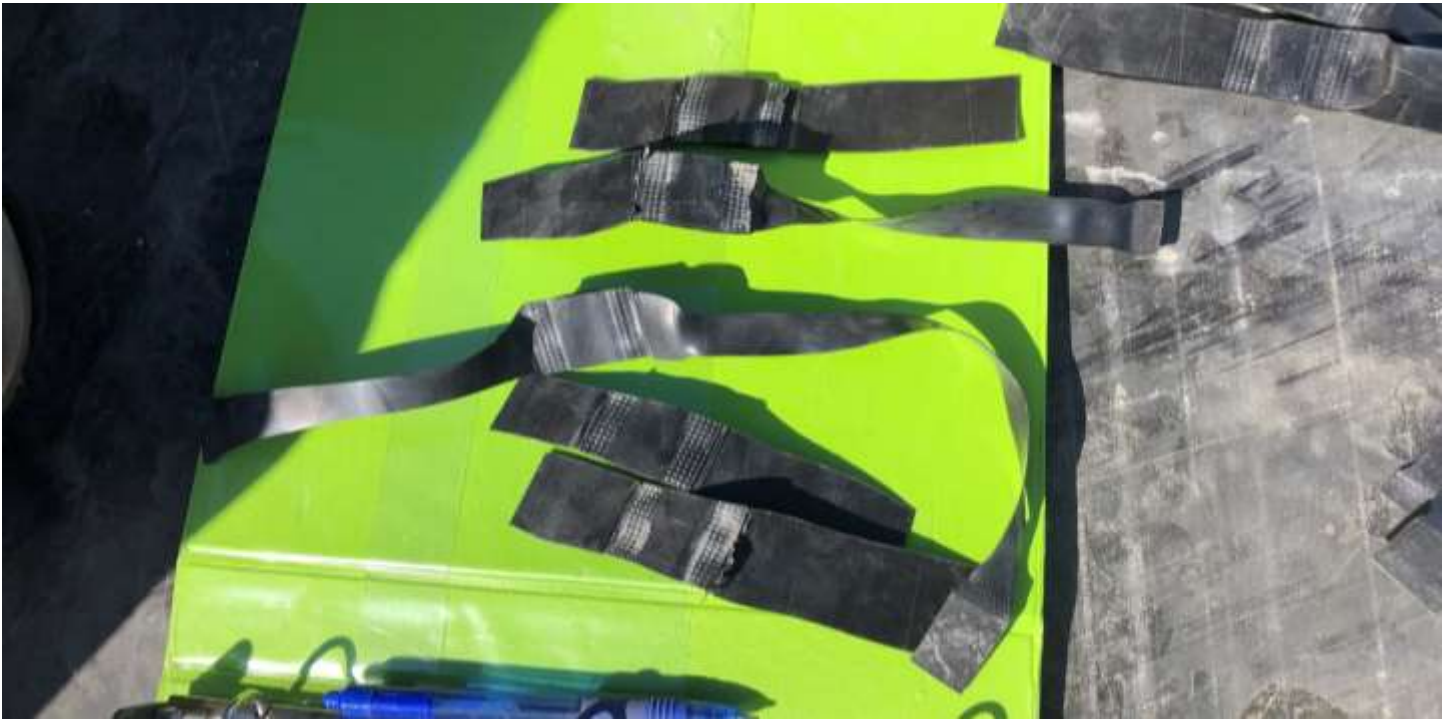
Picture # 3: Wedge weld samples passed.

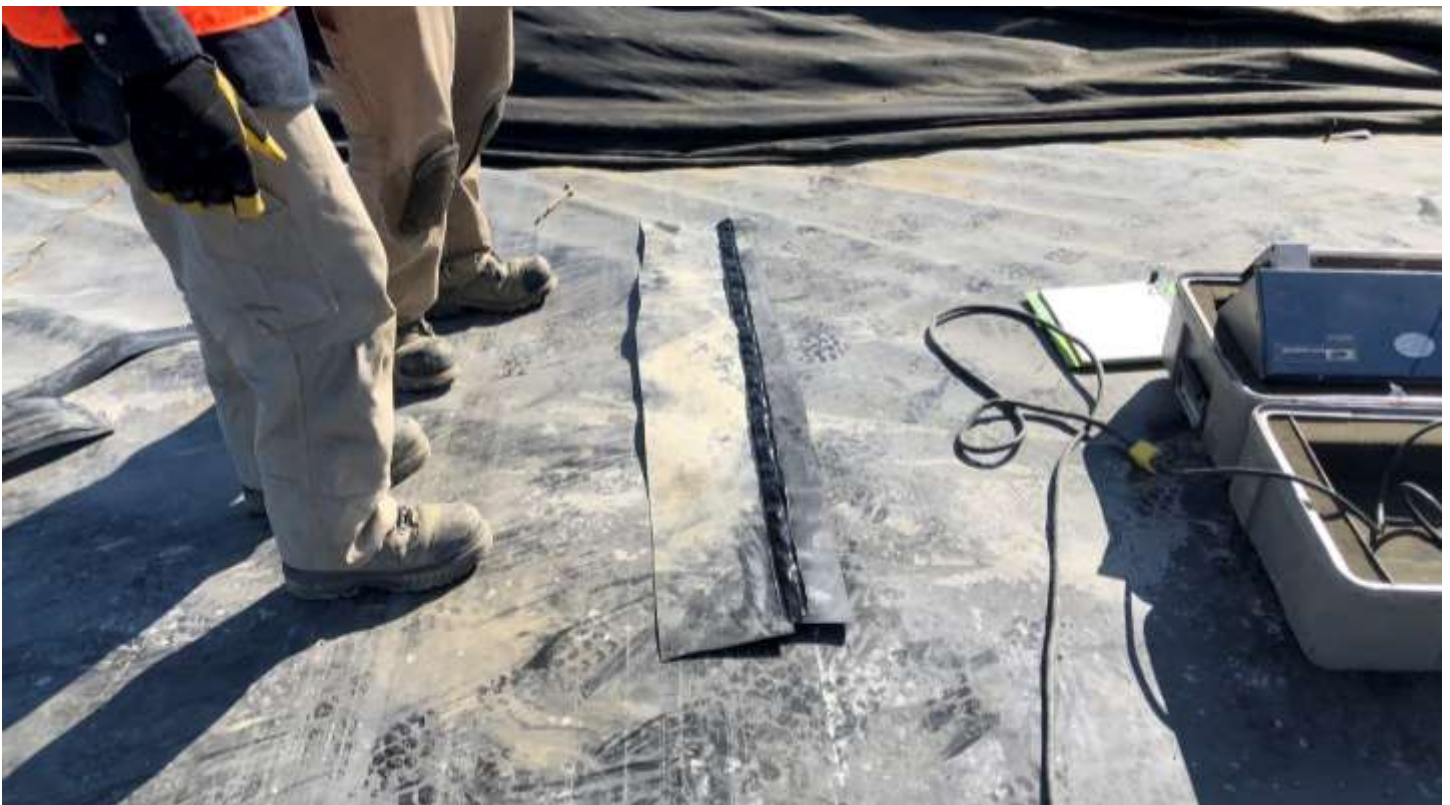
Picture # 4: WTL qualifying extrusion welder.

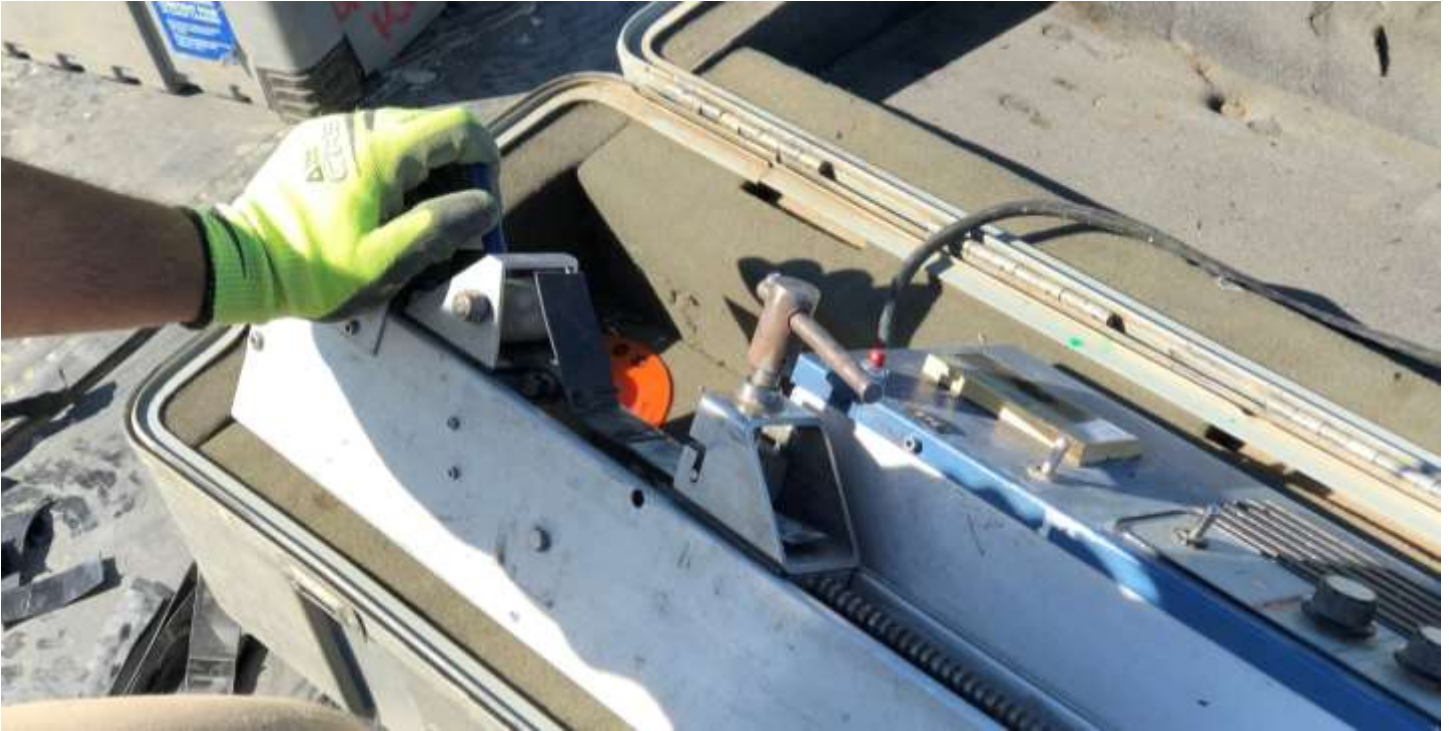
Picture # 5: WTL using tensiometer to test extrusion weld samples.

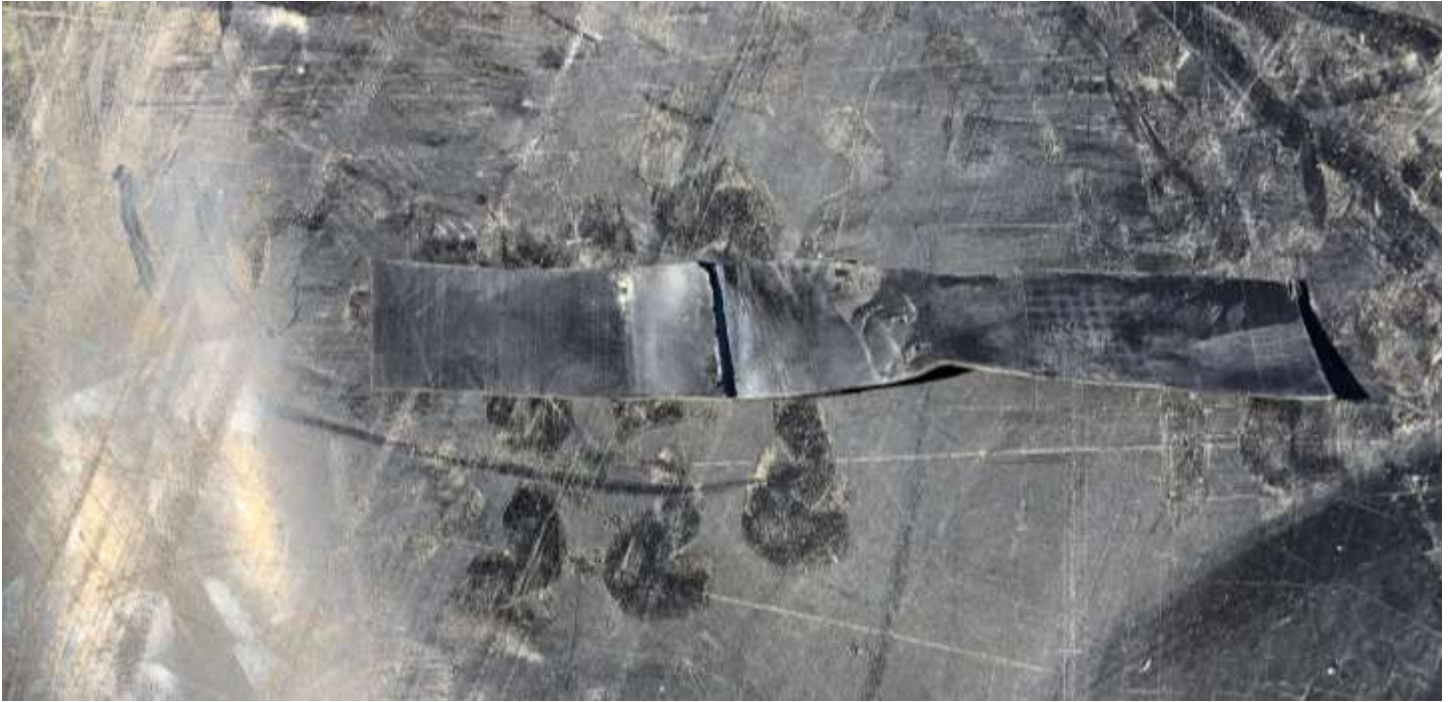
Picture # 7: Example of passed extrusion weld sample.

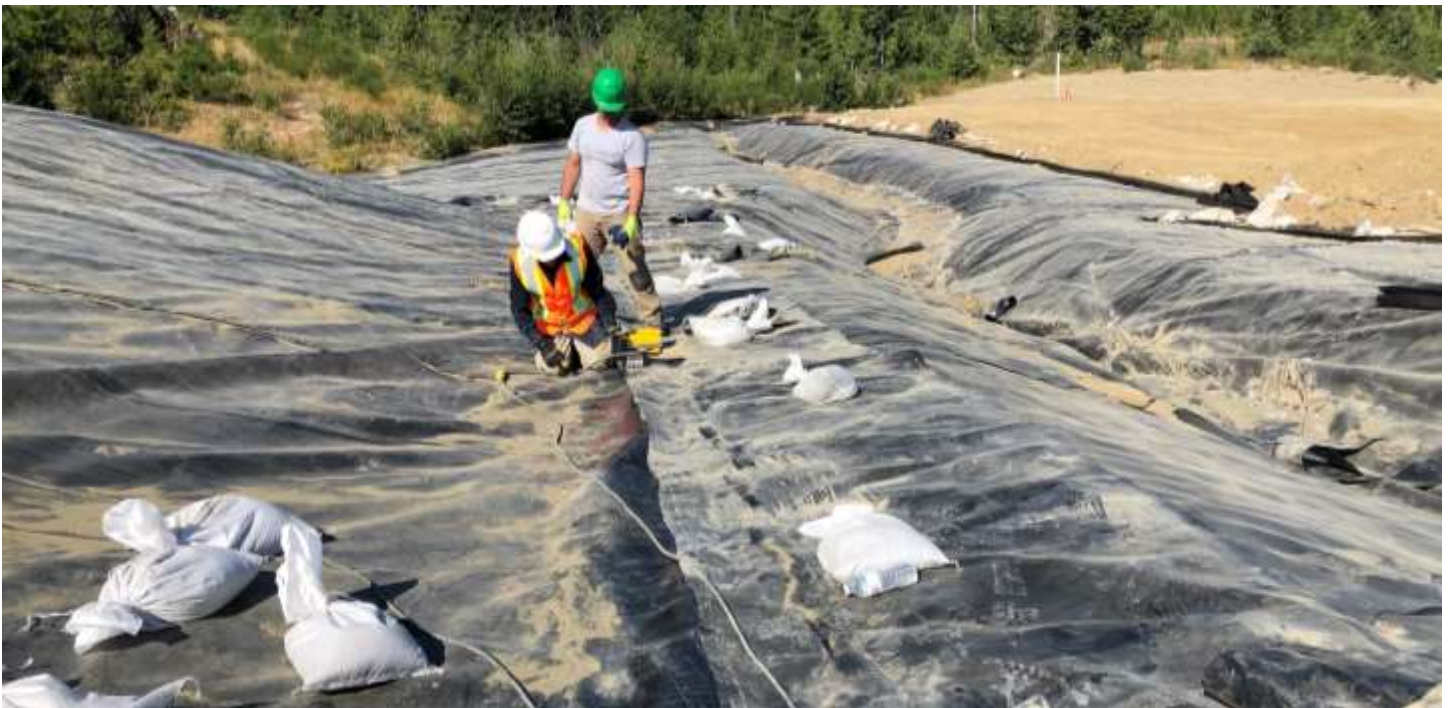
Picture # 8: WTL wedge welding patch on north side of PEA crest.

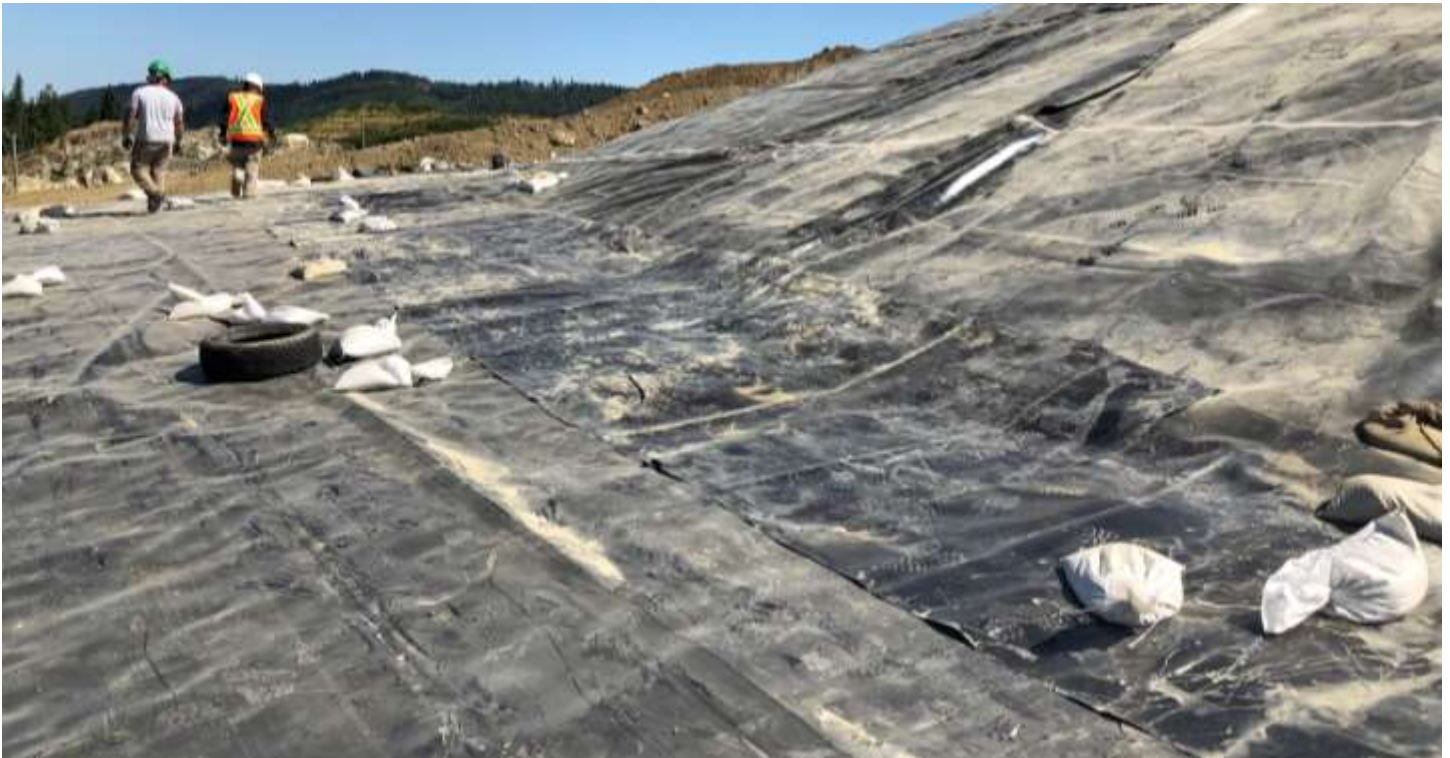
Picture # 9: Geomembrane patch on west side of PEA crest.

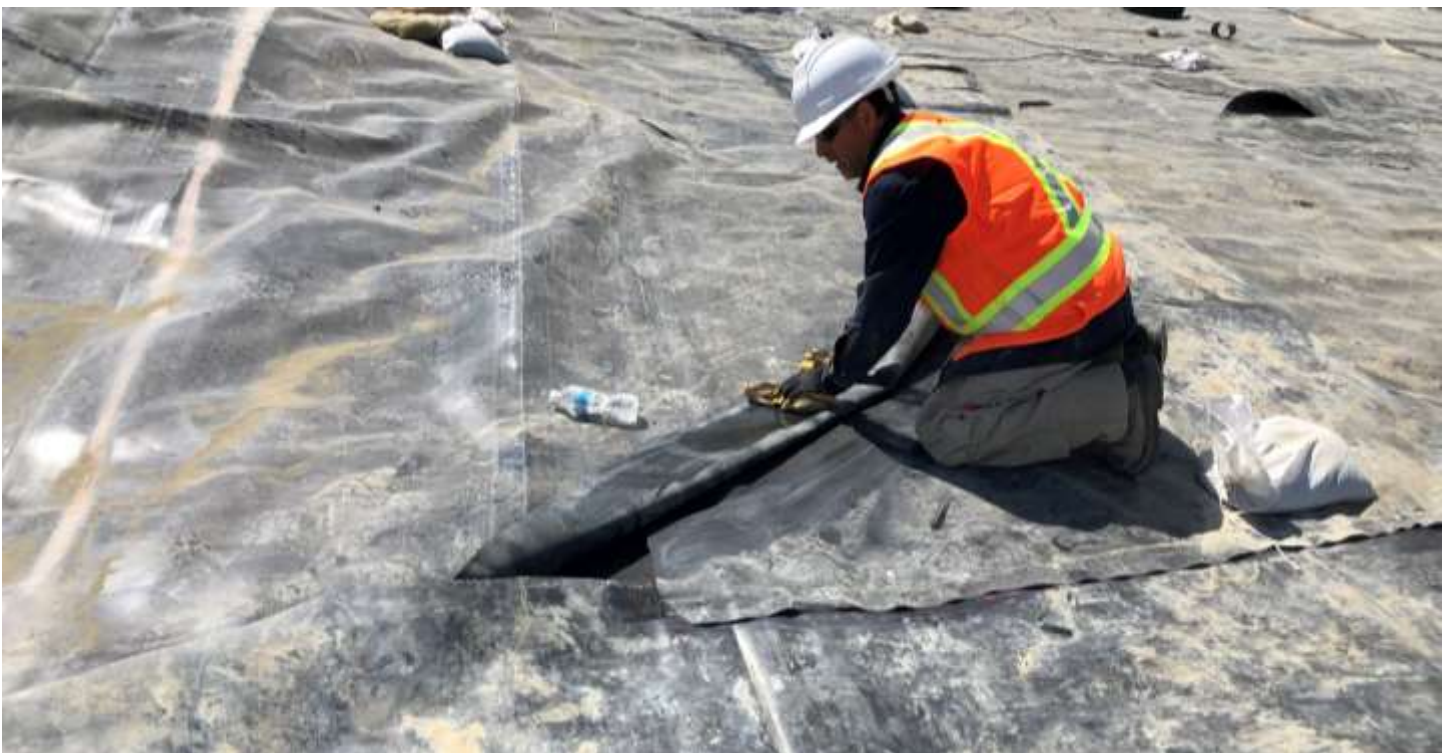
Picture # 10: WTL cleaning geomembrane prior to wedge welding to ensure integrity of weld.

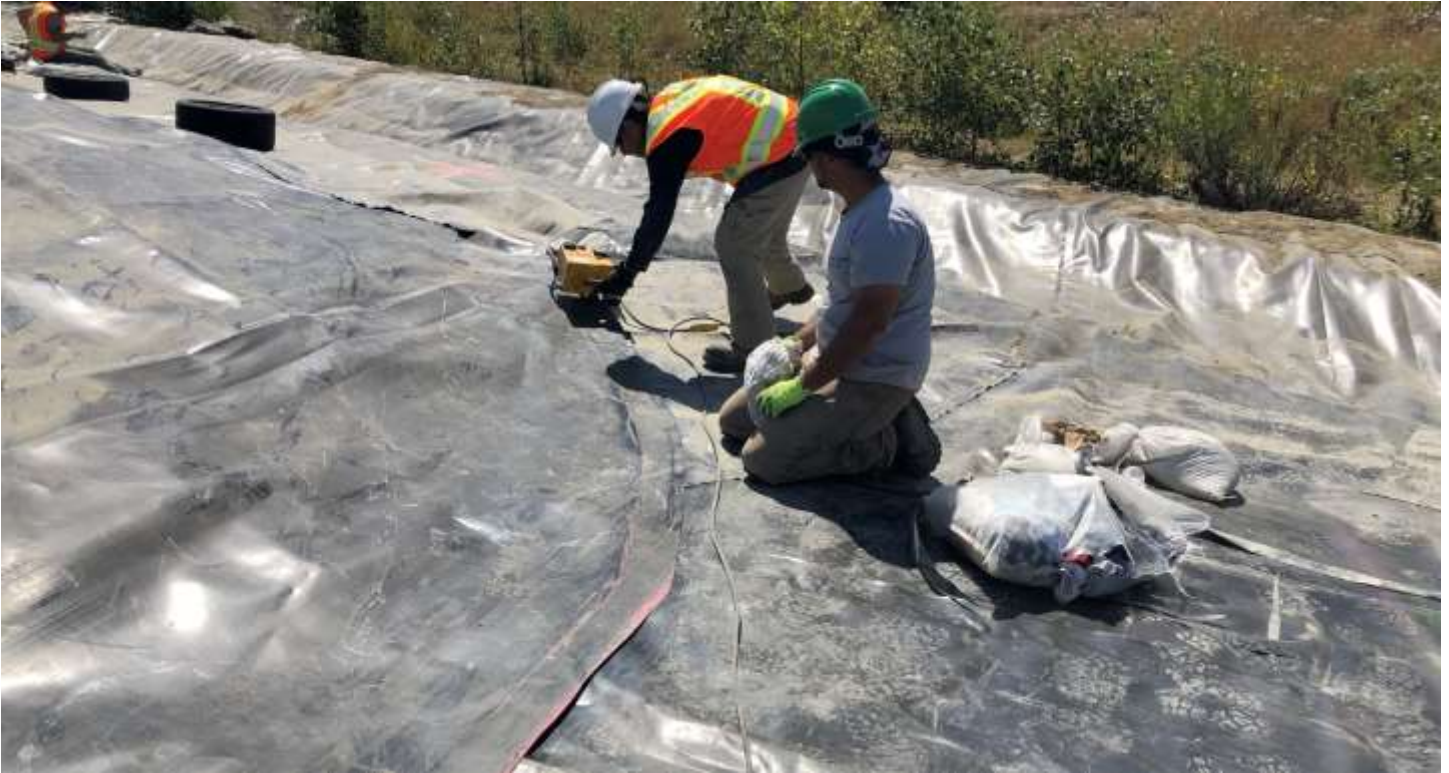
Picture # 11: WTL wedge welding patch on west side of PEA crest.

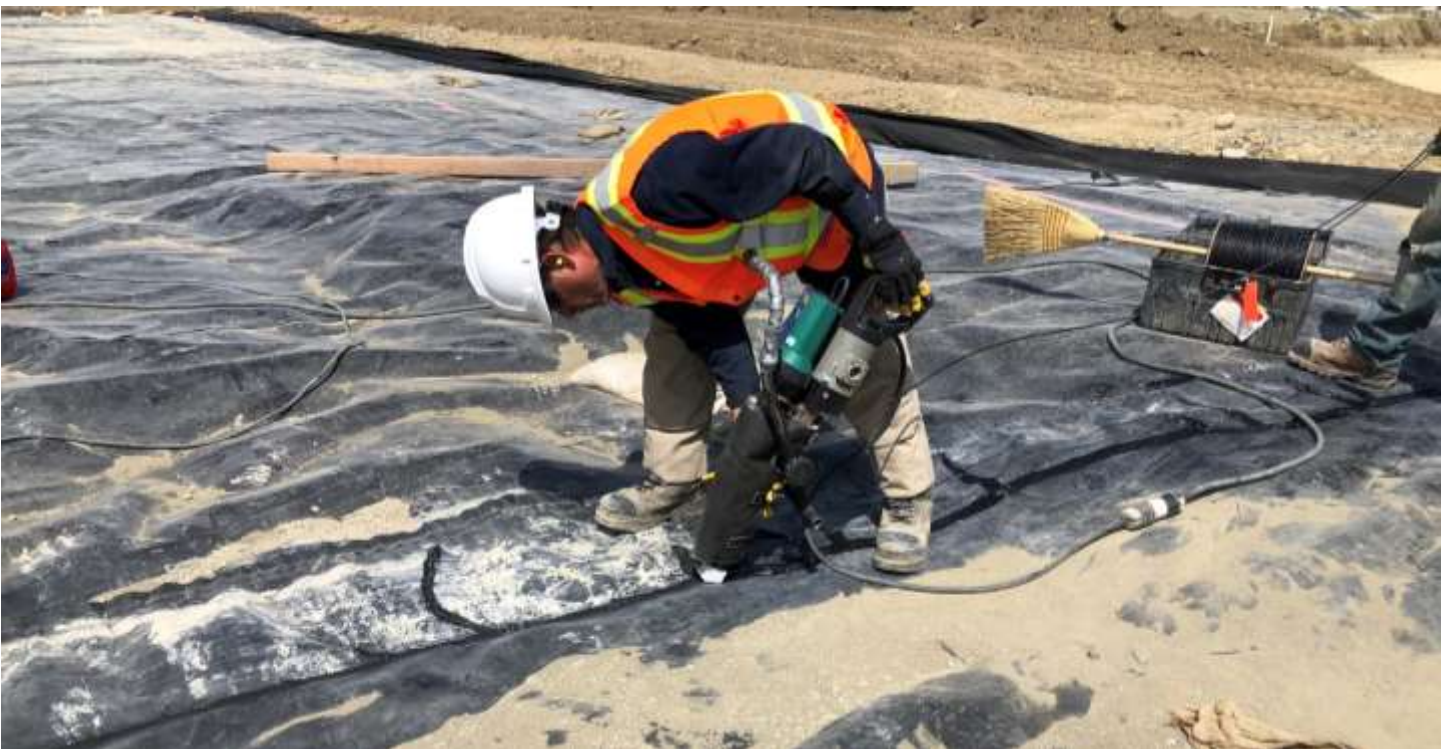
Picture # 12: WTL extrusion welding patch on southeast side of PEA crest.

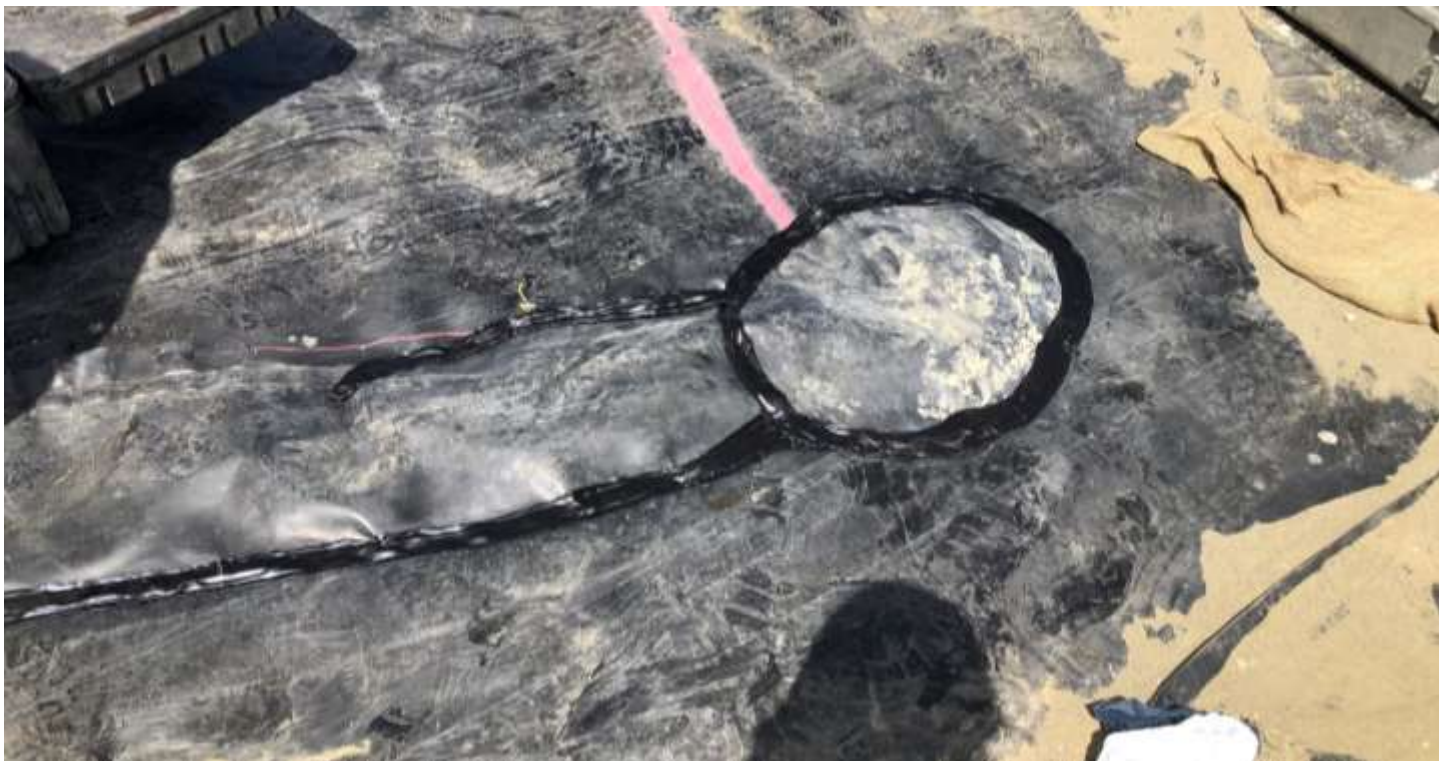
Picture # 13: Example of extrusion weld patch on geomembrane.

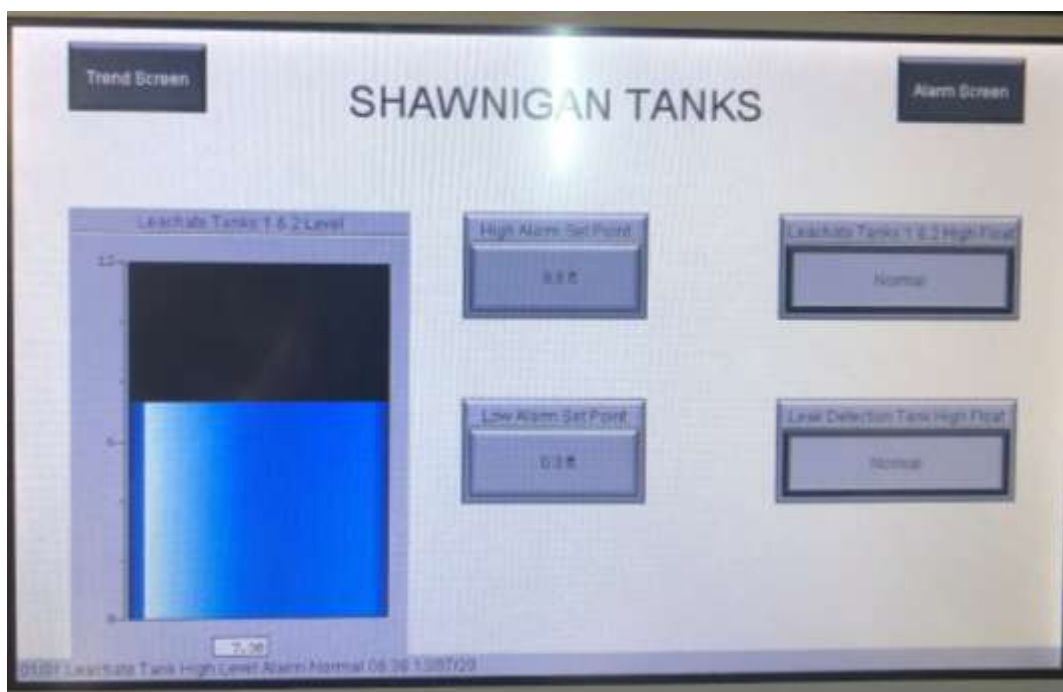
Picture # 14: Leachate tank reading 7.30 ft.
