BI-WEEKLY STATUS REPORT

Cobble Hill Landfill Closure

PROJECT # : PRJ18074	File #: 18074- BWR-71
REPORT #: 73	Date: July 30, 2020
SHA REPRESENTATIVES: Dr. Tony Sperling, P.Eng. Scott Garthwaite Carly Wolfe, EIT	Owner: Cobble Hill Holdings Ltd. Contractor: Allterra Construction Ltd.

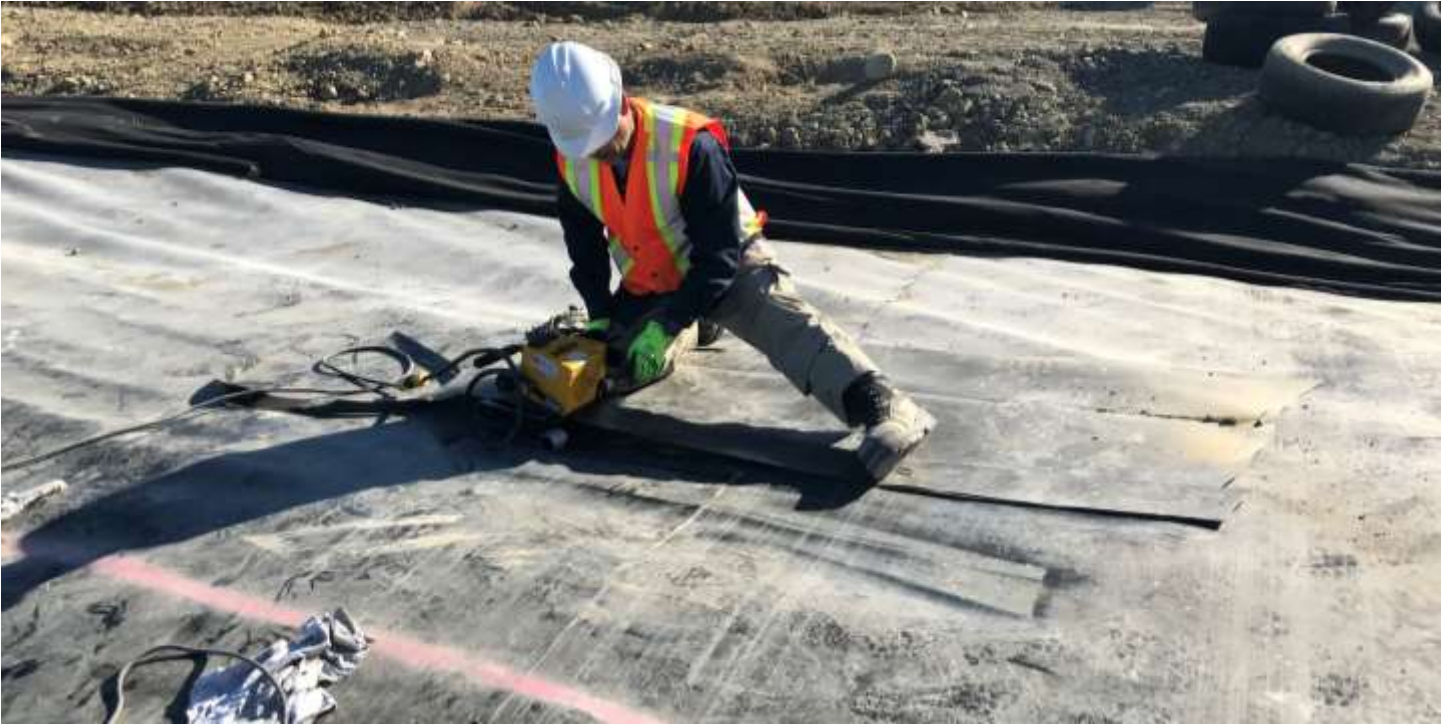
Picture # 1: WTL qualifying wedge welder.

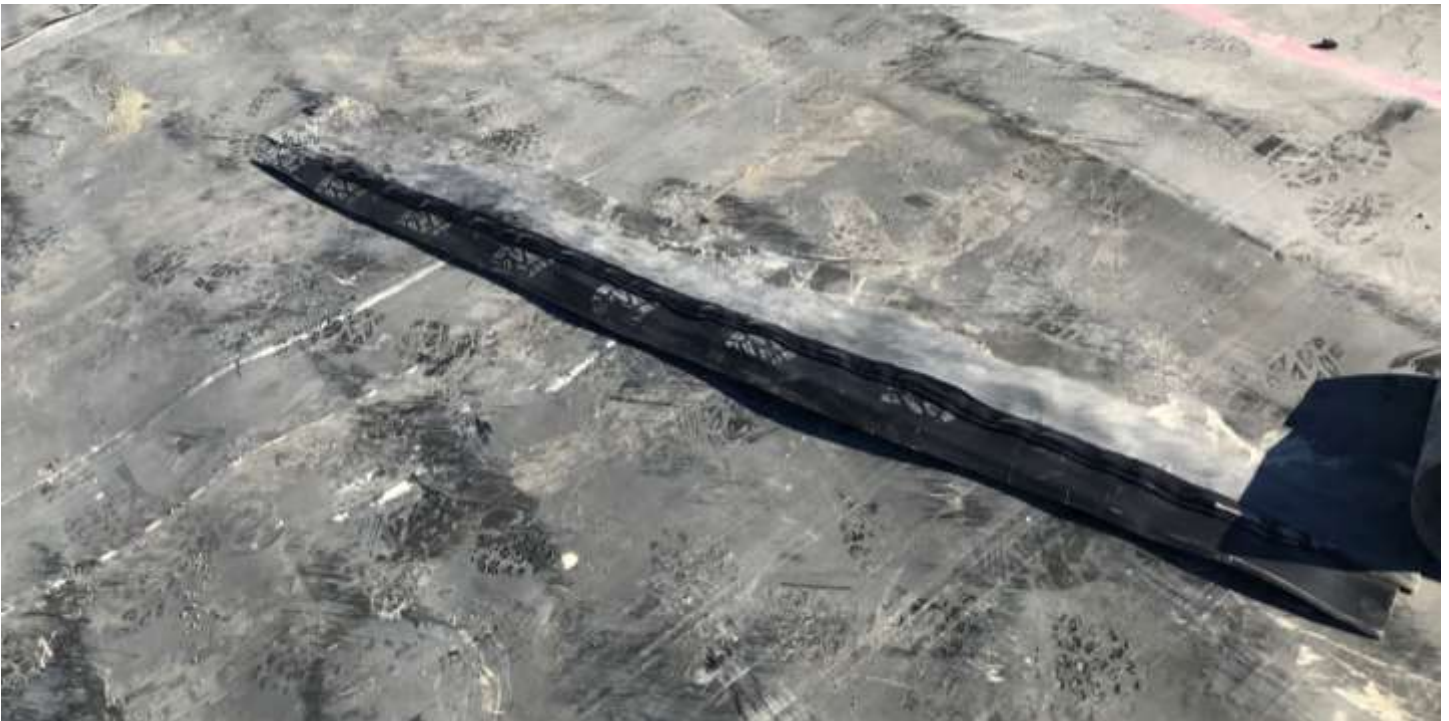
Picture # 2: Extrusion weld test strip.

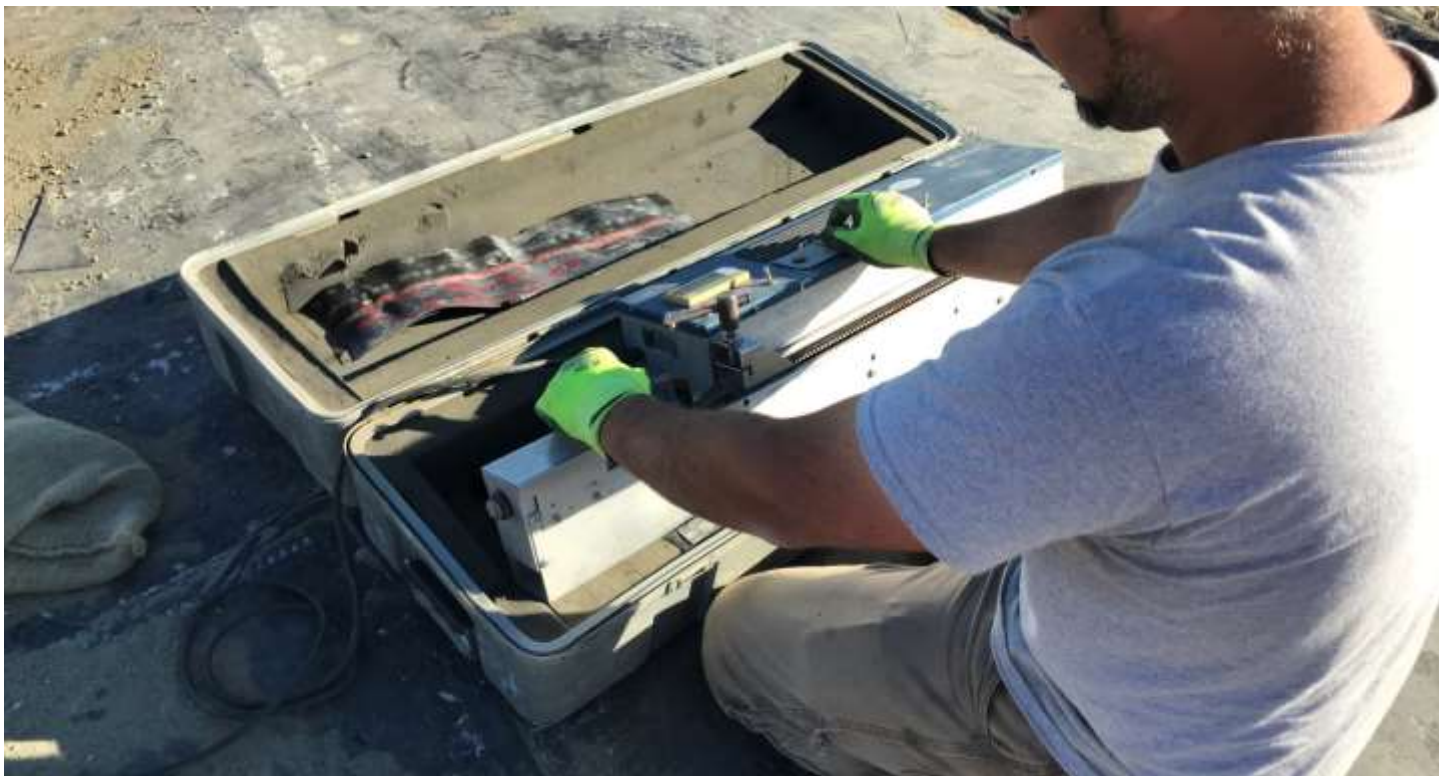
Picture # 3: WTL using tensiometer to test wedge weld and extrusion weld samples.

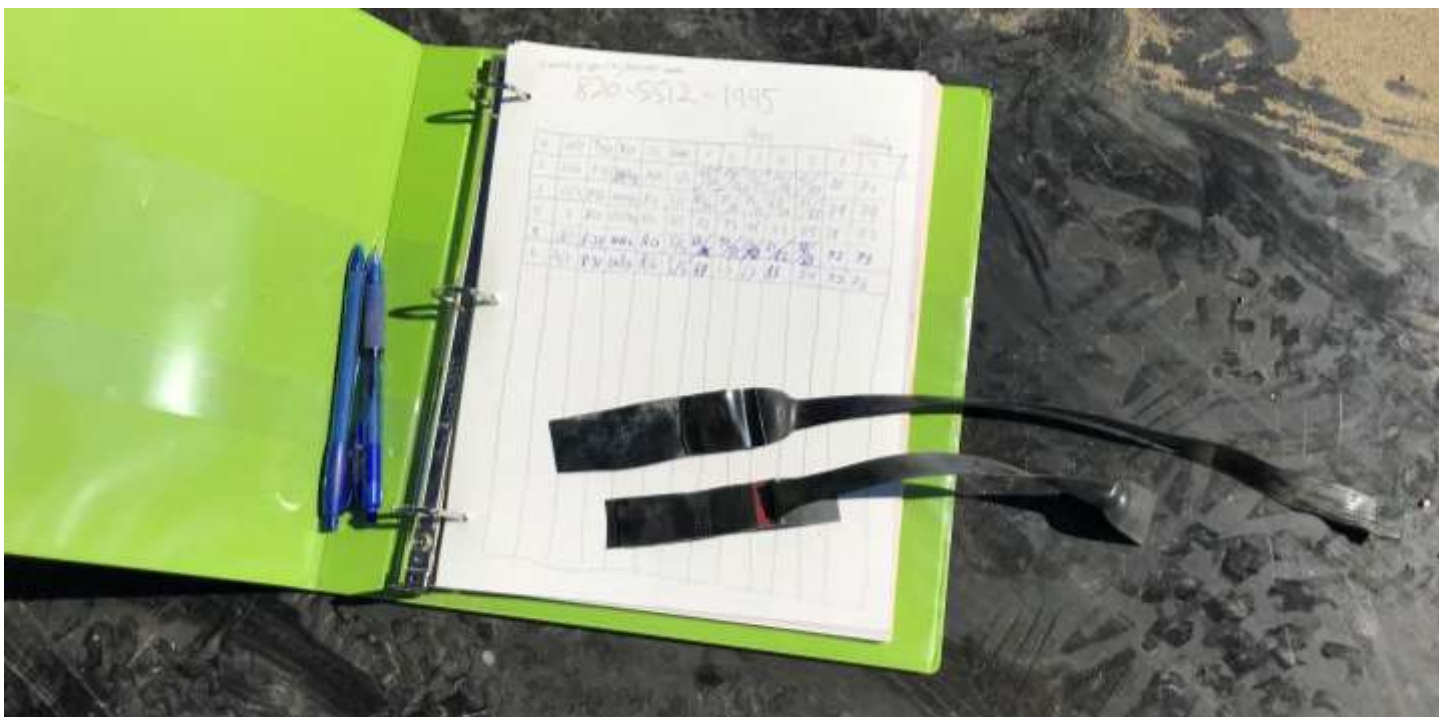
Picture # 4: Example of passed wedge weld and extrusion weld samples.

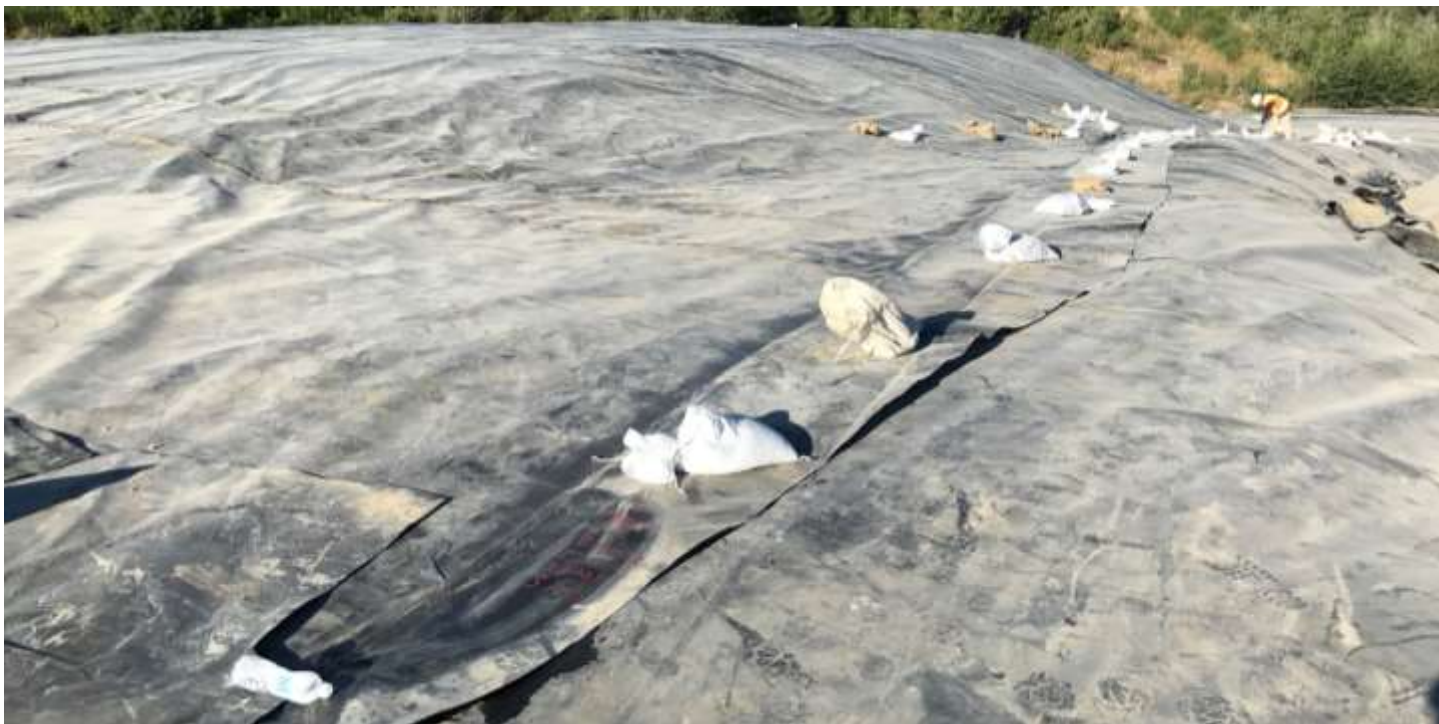
Picture # 5: Geomembrane patch on north crest of PEA.

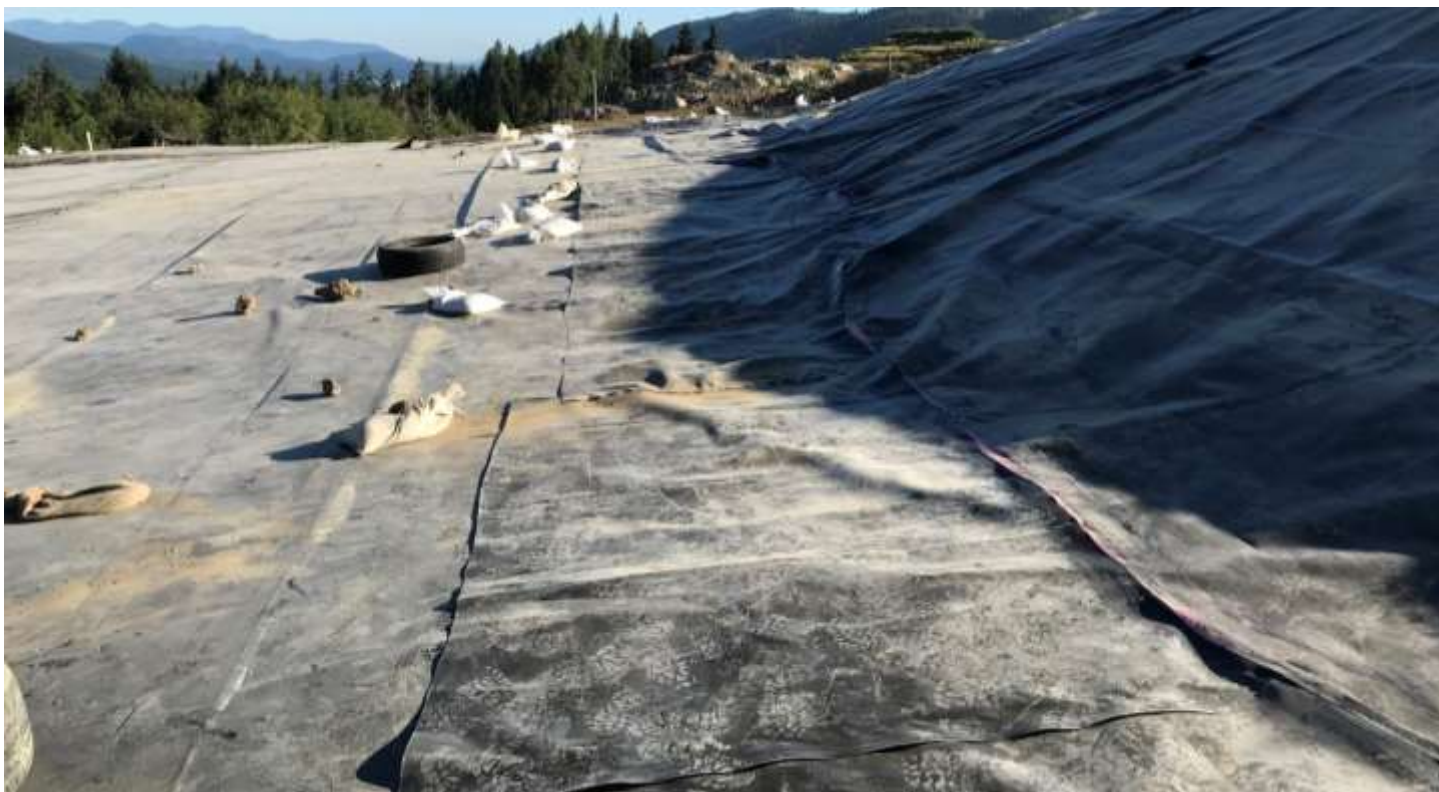
Picture #6: Geomembrane patch on west crest of PEA.

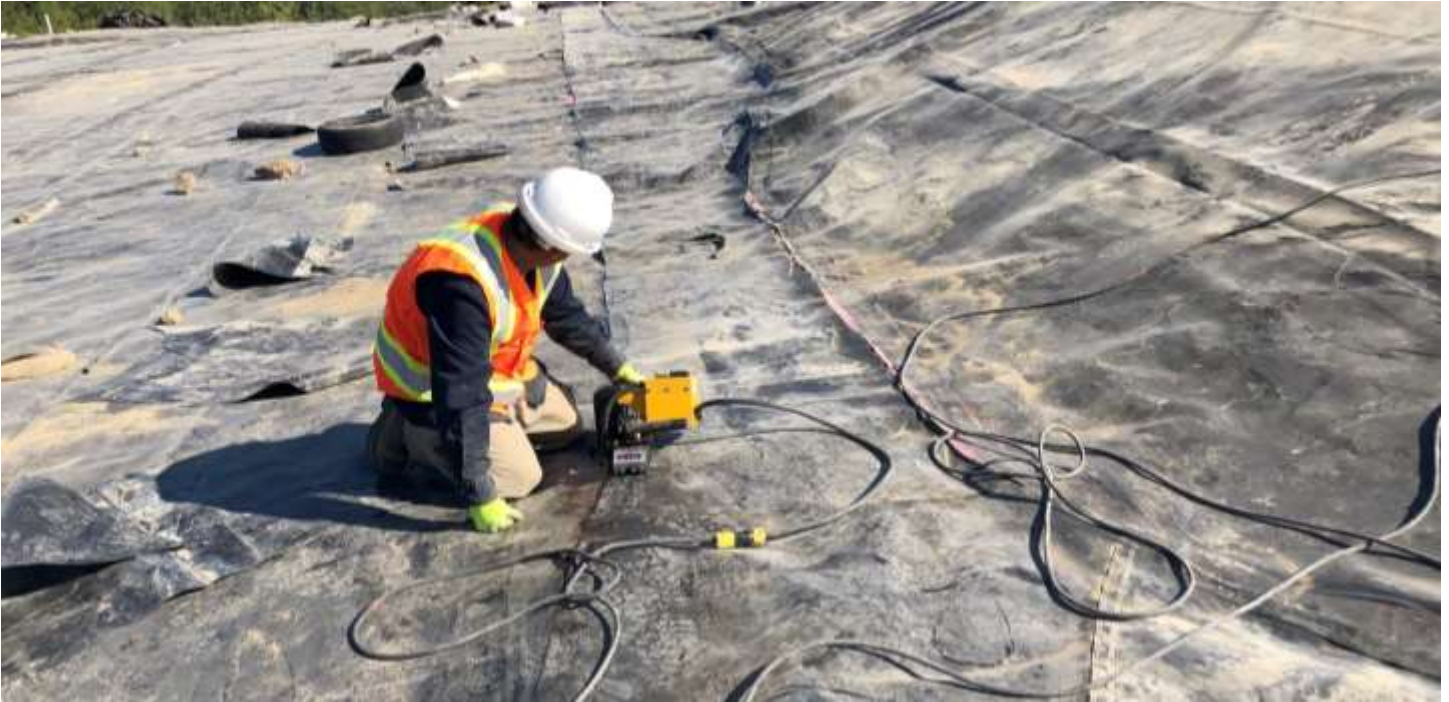
Picture # 7 : WTL wedge welding geomembrane on west crest of PEA.

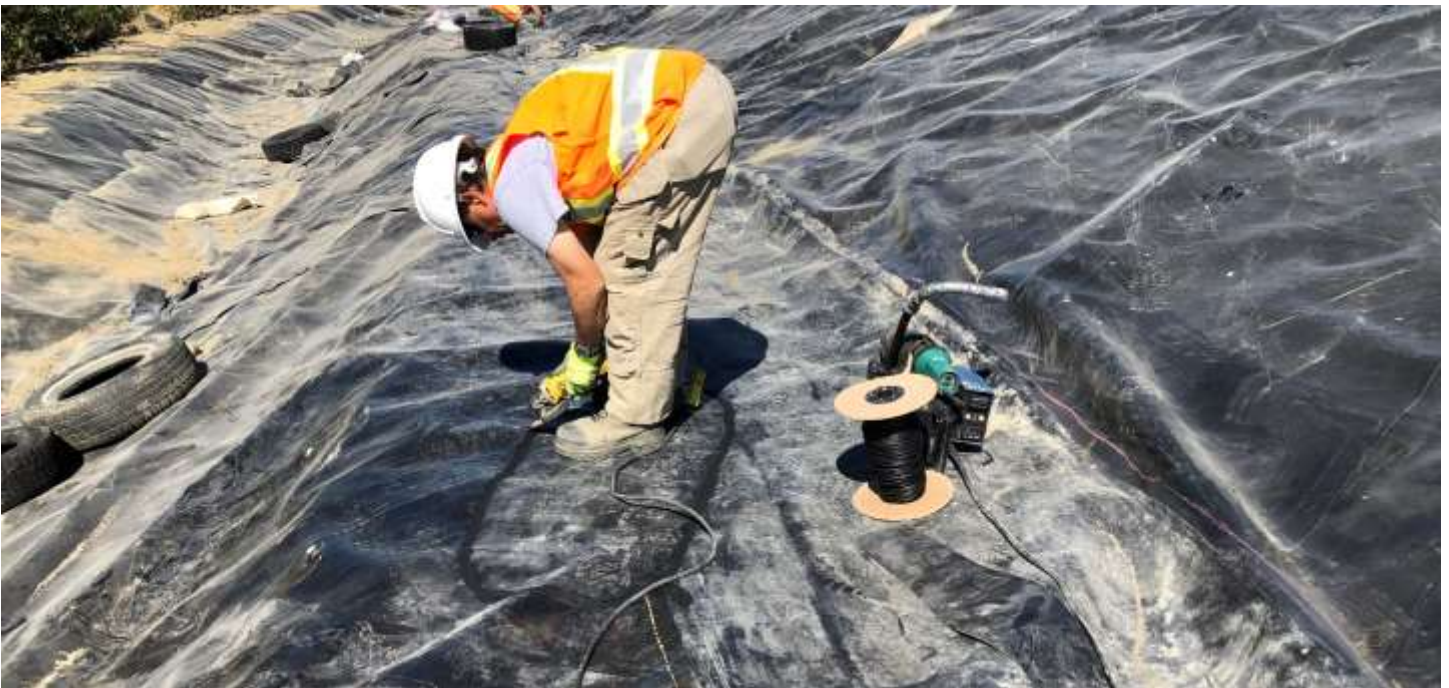
Picture # 8: WTL installing geomembrane patch on south crest of PEA.

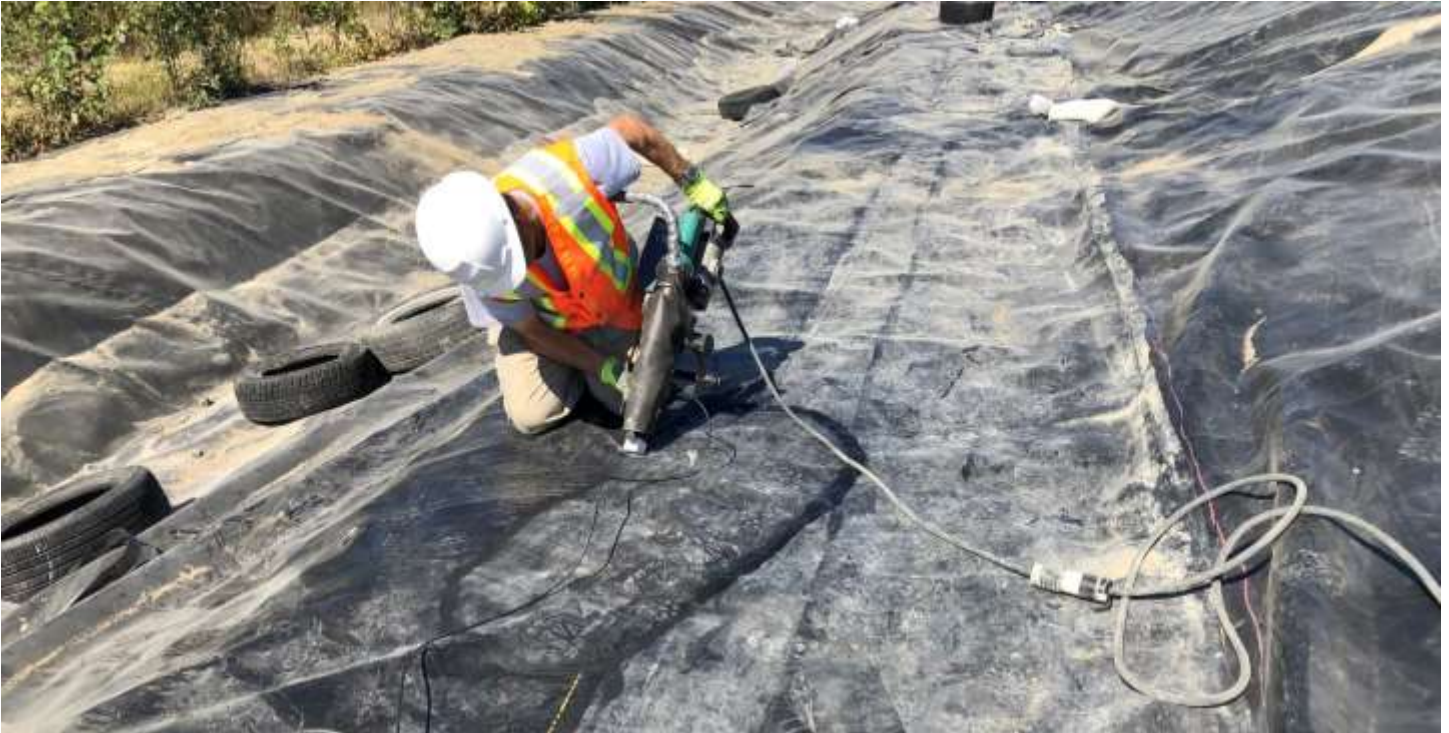
Picture # 9: WTL extrusion welding geomembrane patch on south crest of PEA.

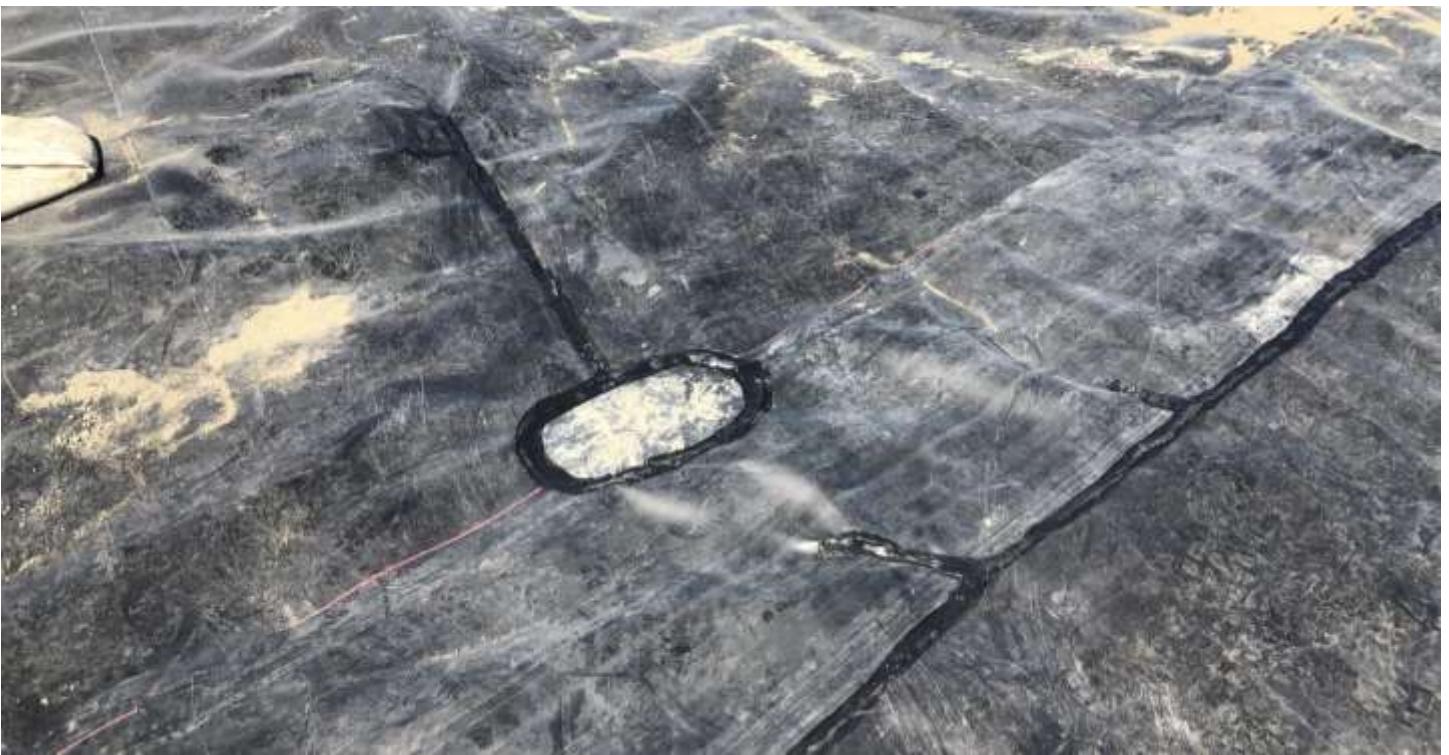
Picture # 10: Example of extrusion welded patch on geomembrane.

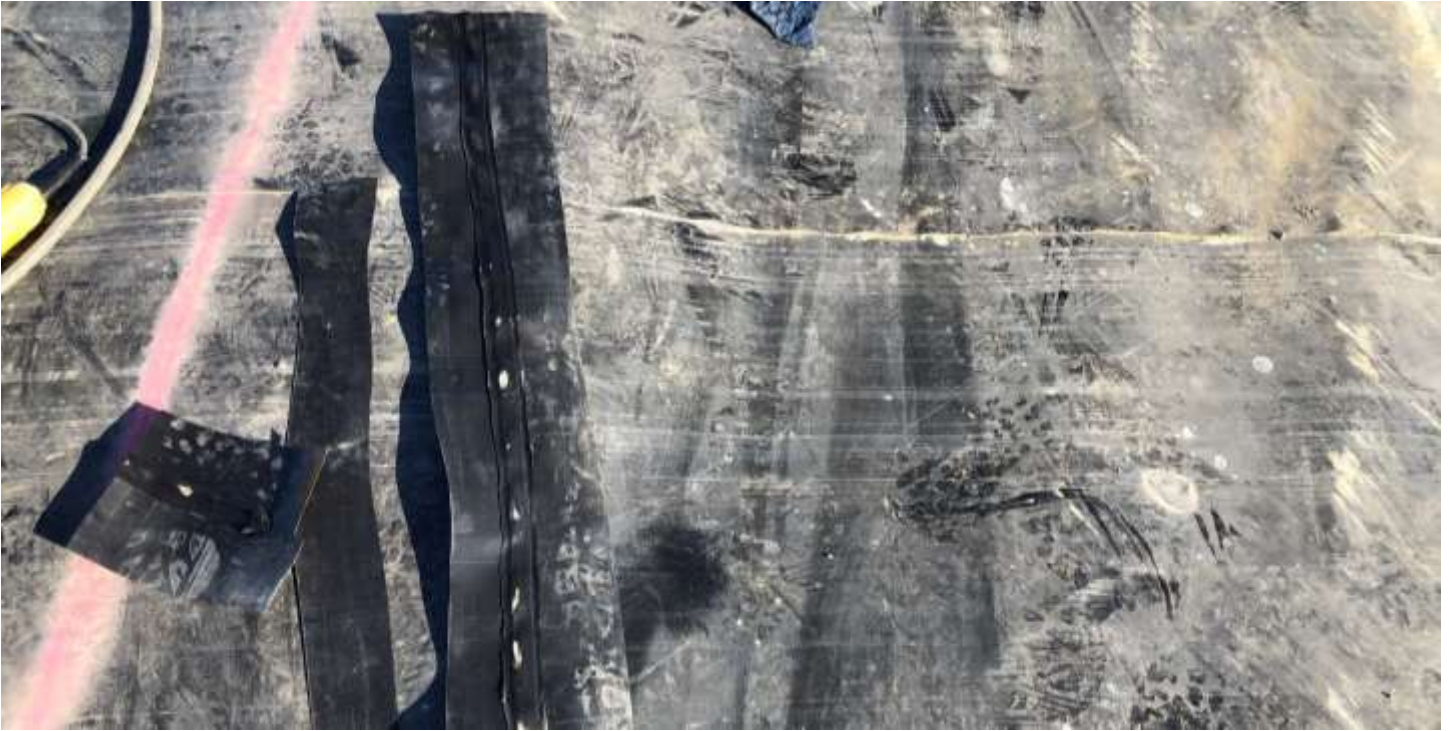
Picture # 1: Extrusion weld test sample.

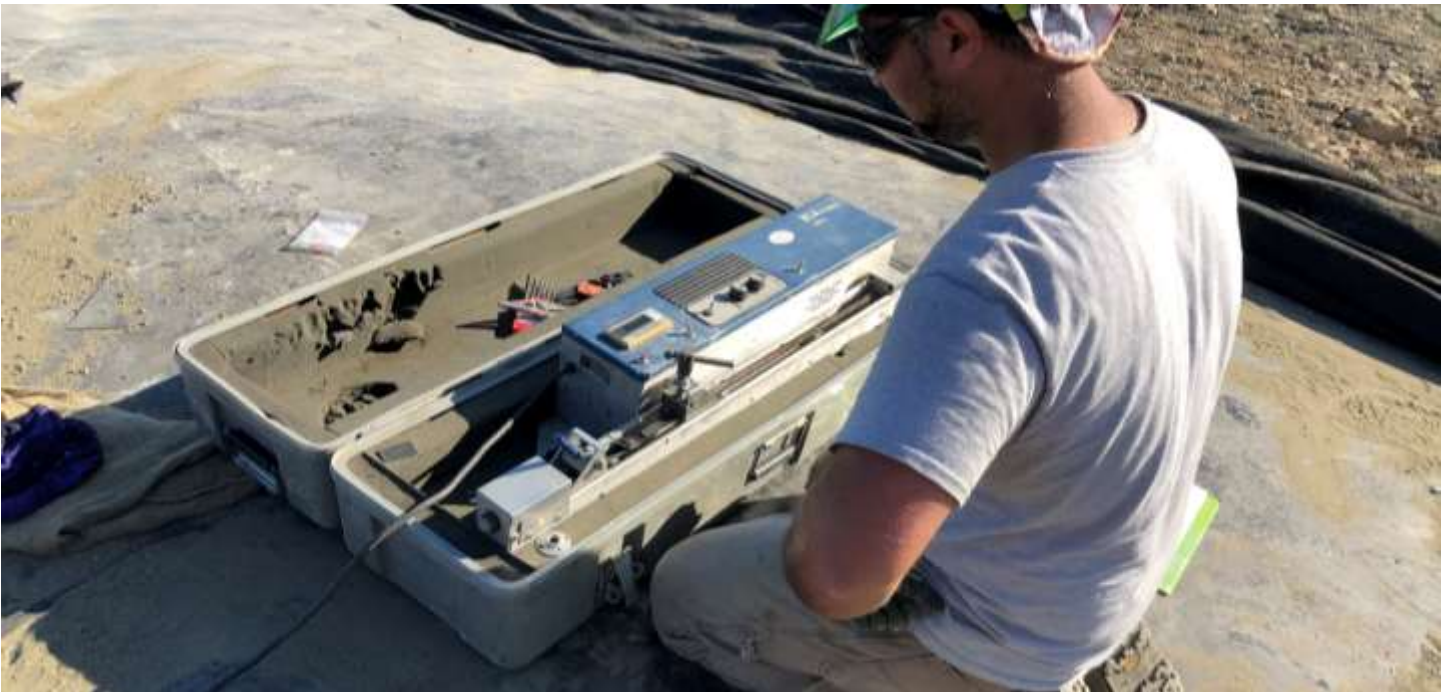
Picture # 2: WTL using tensiometer to test extrusion weld samples. A total of 5 peel tests and 2 shear tests were performed.

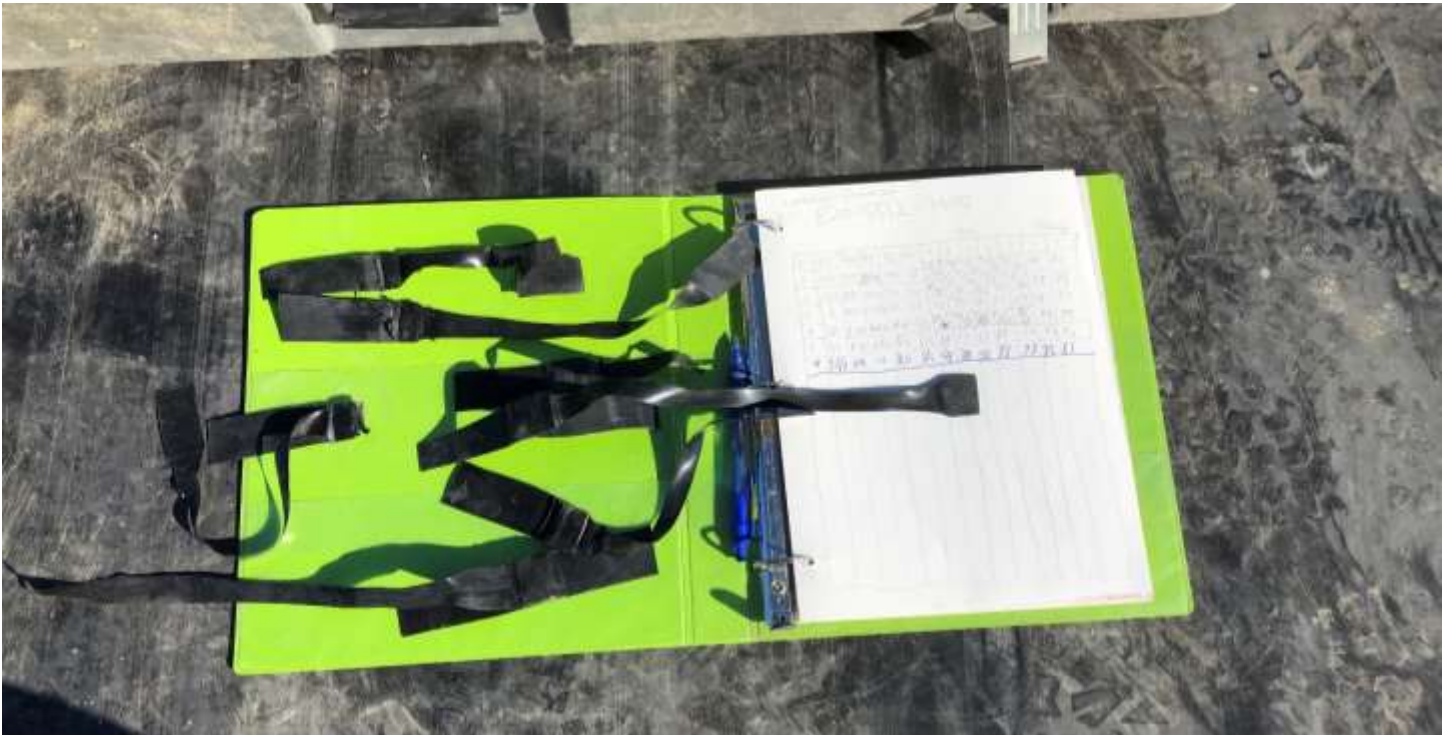
Picture # 3: Passed test samples.

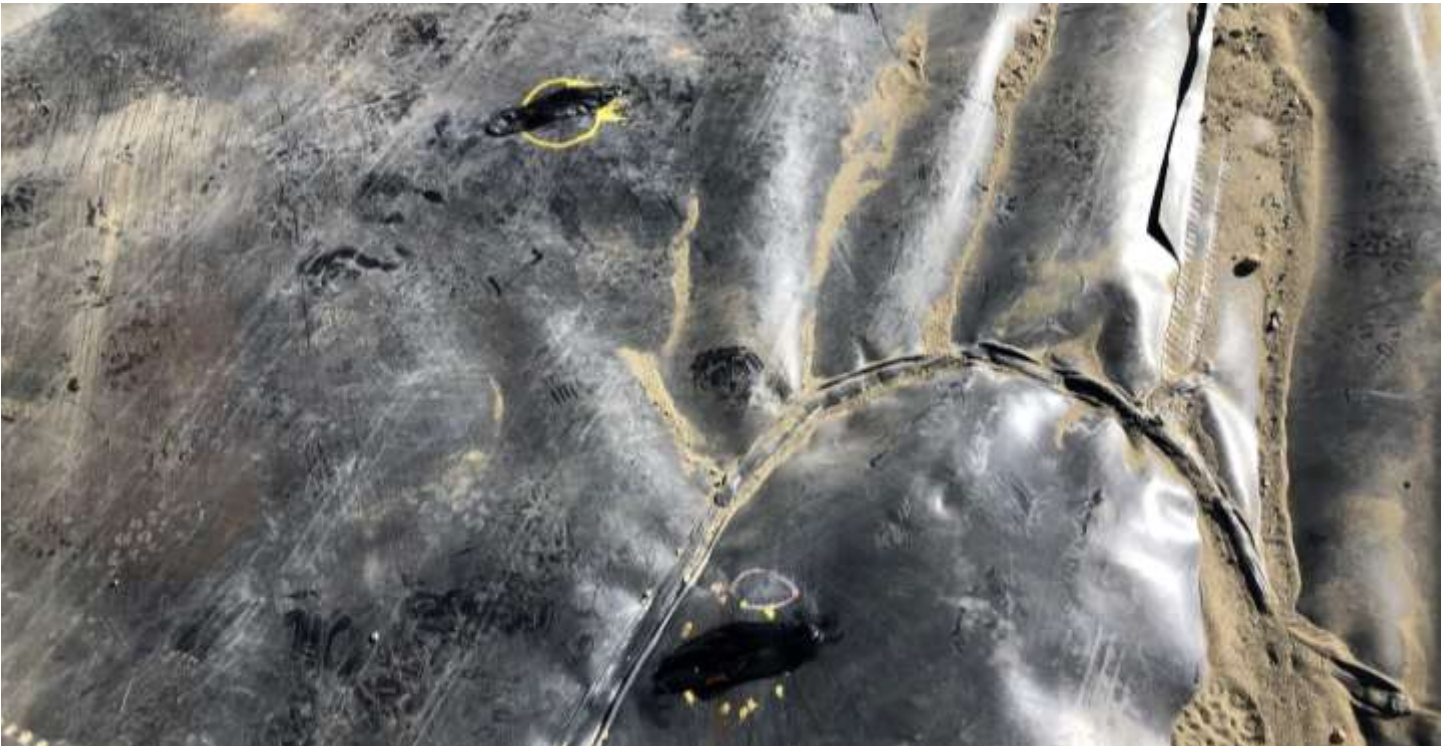
Picture #5: Small repairs with extrusion welder on geomembrane liner.

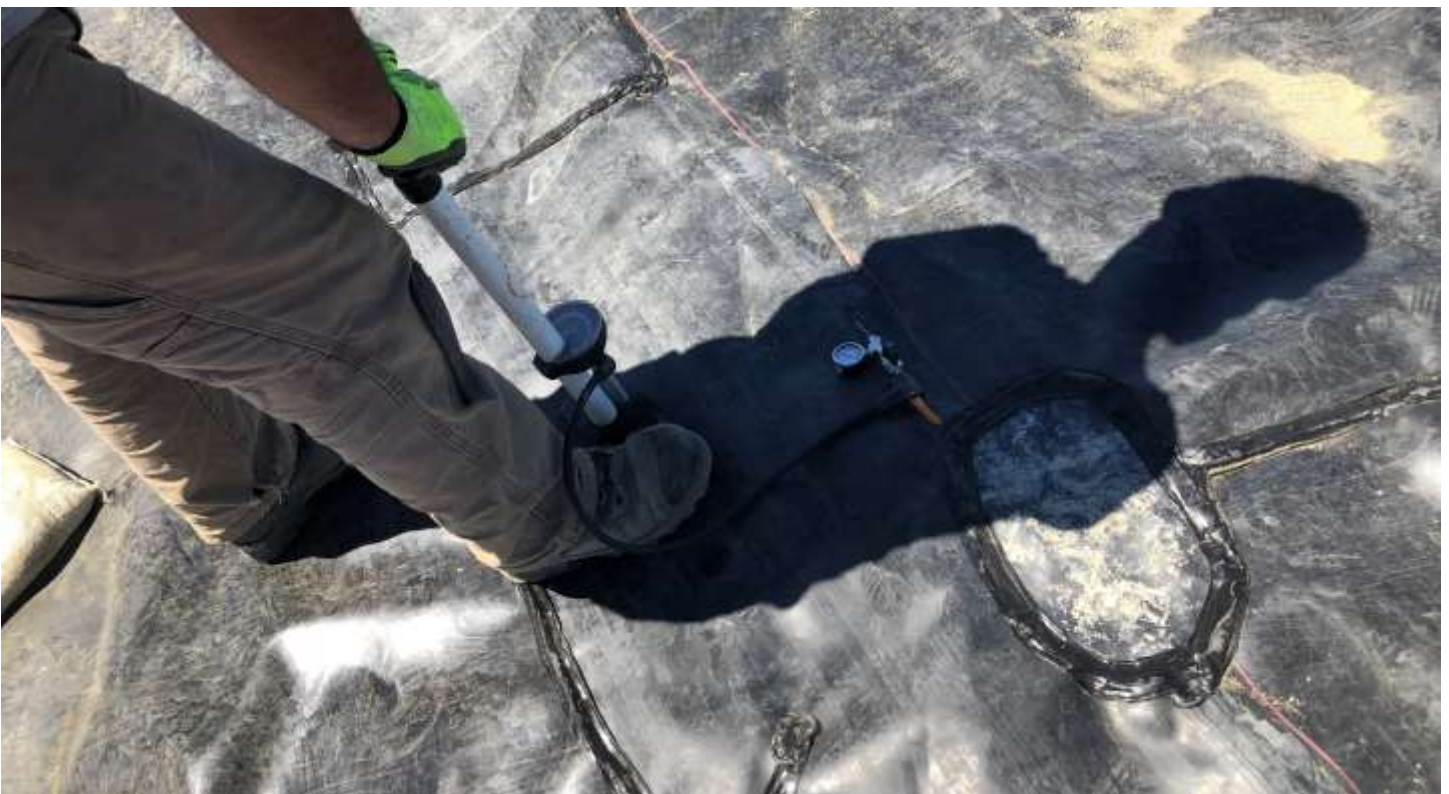
Picture #6: WTL air testing wedge weld.

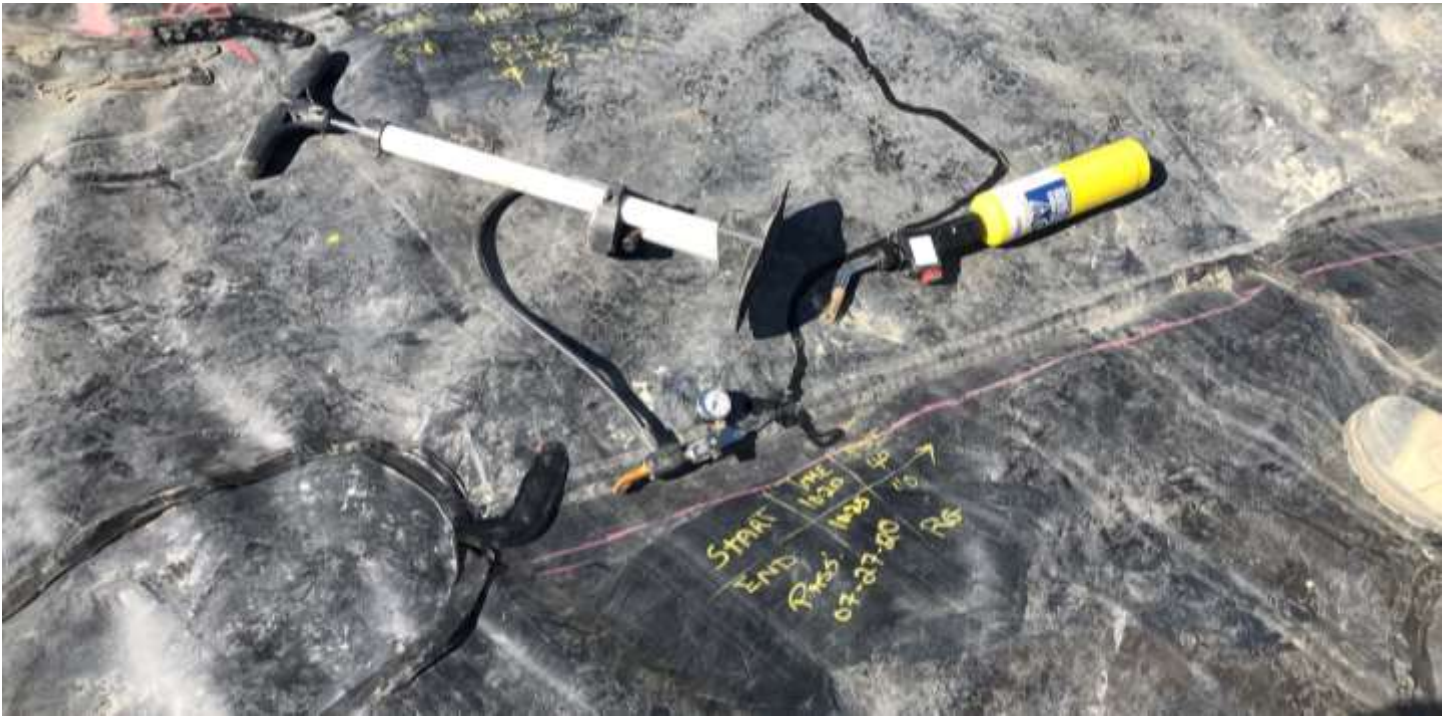
Picture #7: Example of air test results. Pressurized to 40 psi for 5 minutes. Passed.

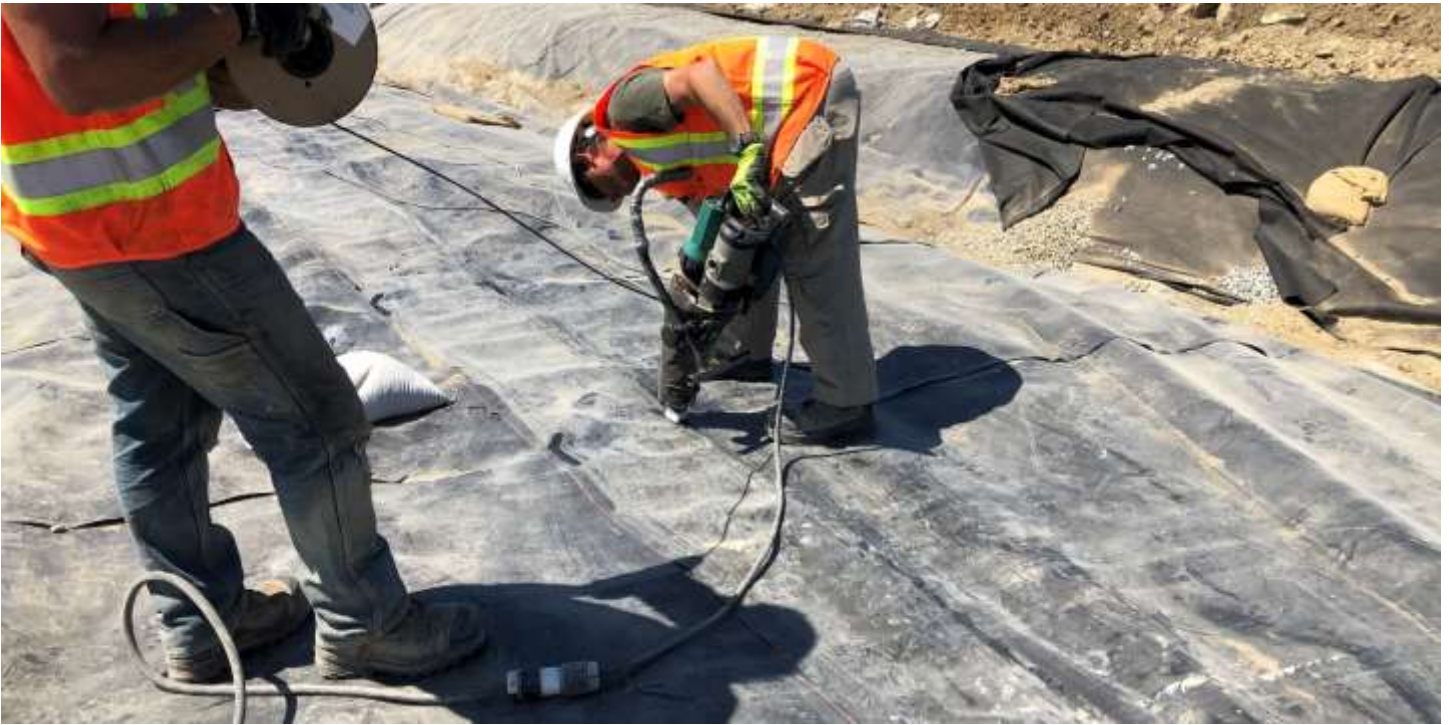
Picture #9: WTL performing extrusion weld.

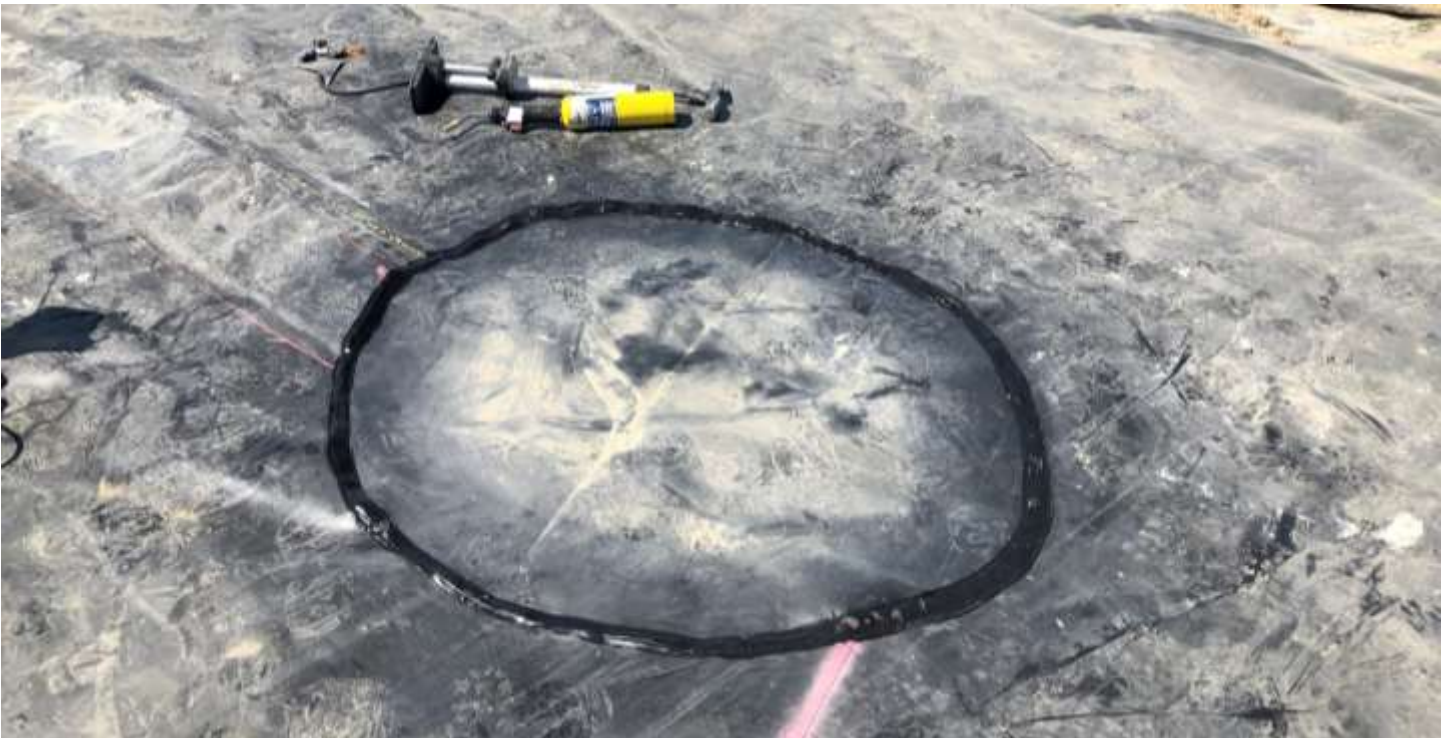
Picture #10: Example of extrusion welded patch on geomembrane.

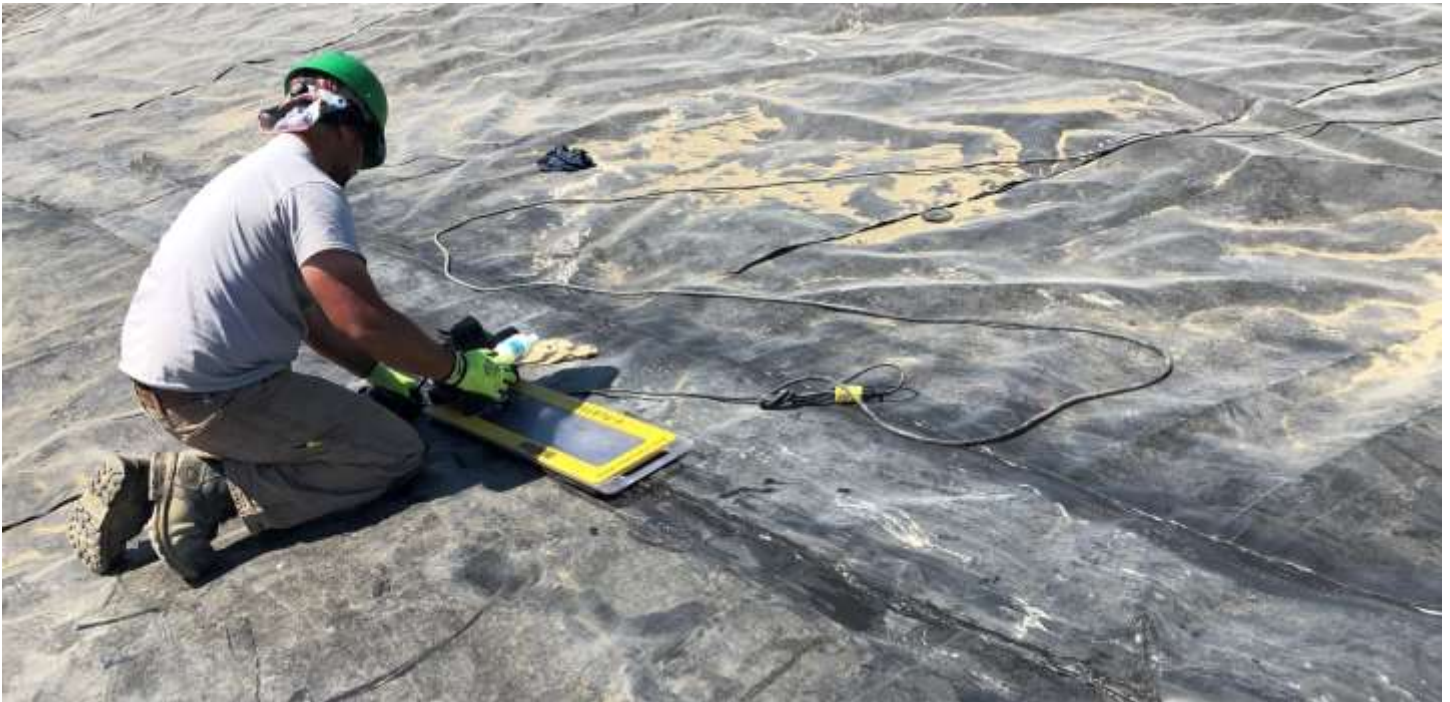
Picture #11: WTL performing vacuum box test on extrusion weld.

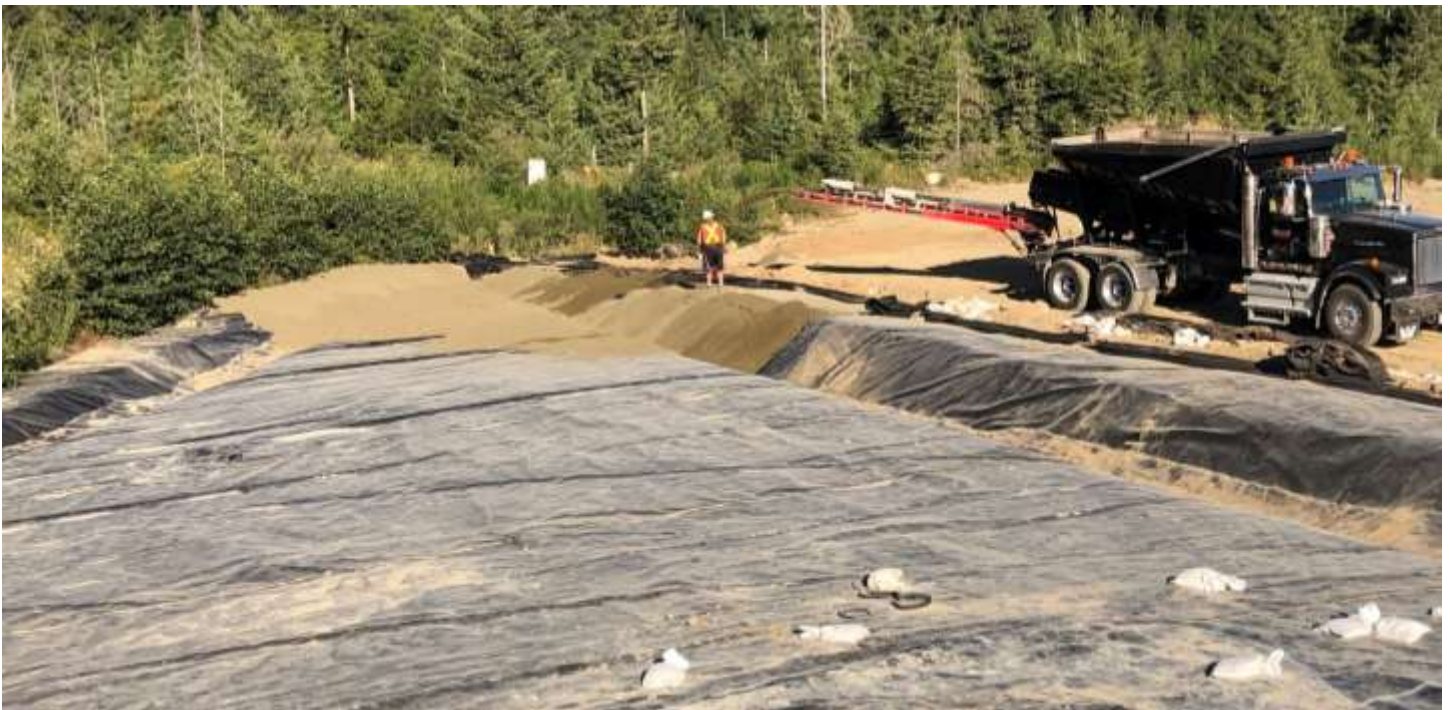
Picture # 12: Alterra using slinger to place 50mm thick sand layer on southwest crest of PEA. In some areas the sand was applied thicker than 50 mm so that it would not slide down the slopes of the ditch.

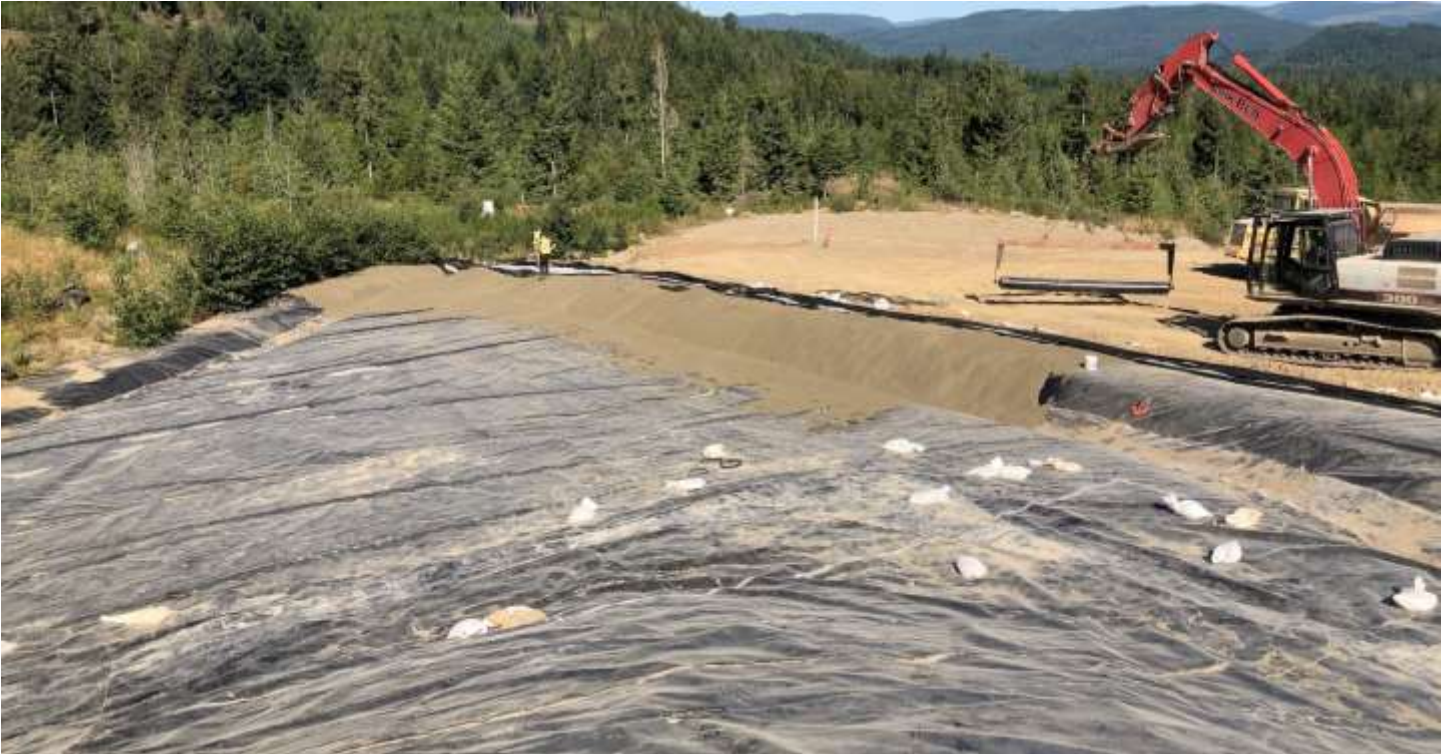
Picture # 13: Sand placed in ditch at northwest crest of PEA.
