BI-WEEKLY STATUS REPORT

Cobble Hill Landfill Closure

PROJECT # : PRJ18074	File #: 18074- BWR-71
REPORT #: 73	Date: July 30, 2020
SHA REPRESENTATIVES: Dr. Tony Sperling, P.Eng. Scott Garthwaite Carly Wolfe, EIT	Owner: Cobble Hill Holdings Ltd. Contractor: Allterra Construction Ltd.

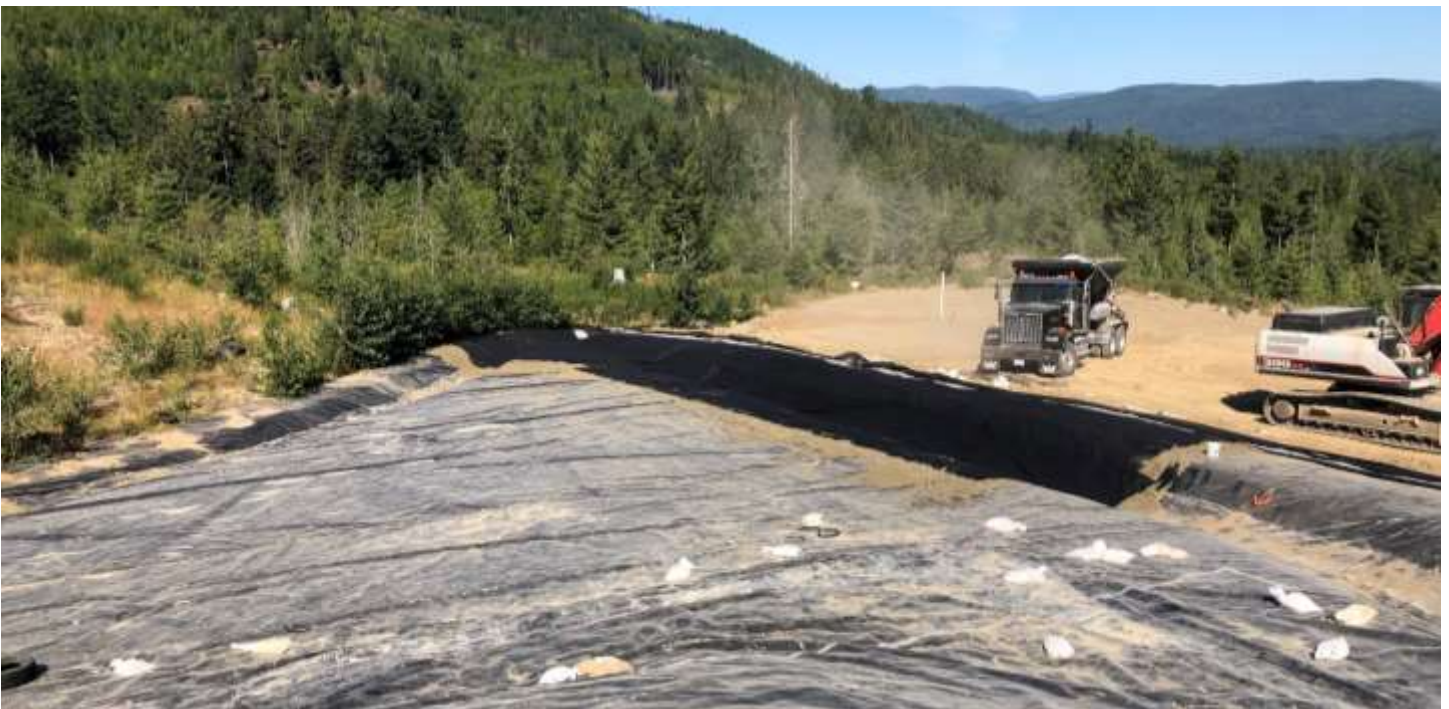
Picture # 14: Alterra deployed 12 oz. geotextile above sand layer at northwest crest ditch.

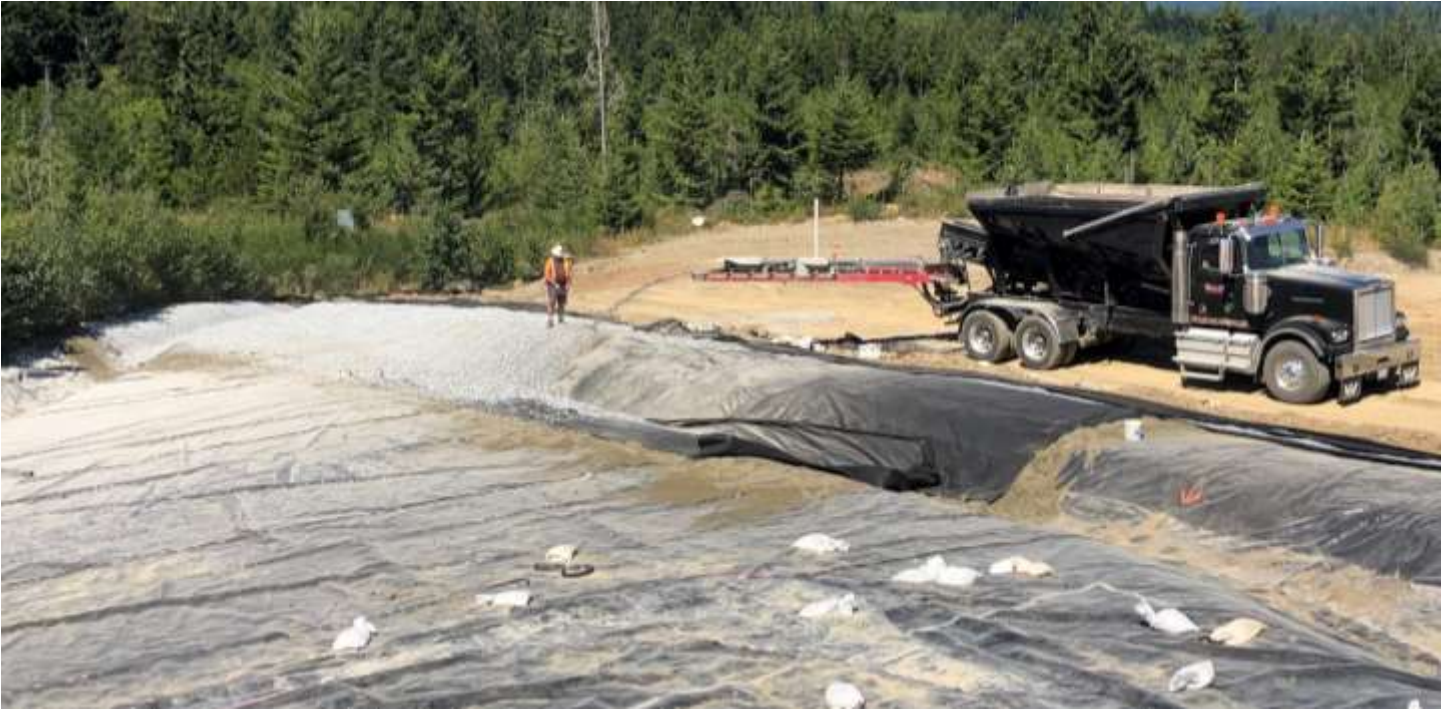
Picture # 15: Alterra placing 200 mm thick layer of drainage gravel in northwest crest ditch above 12 oz. geotextile.

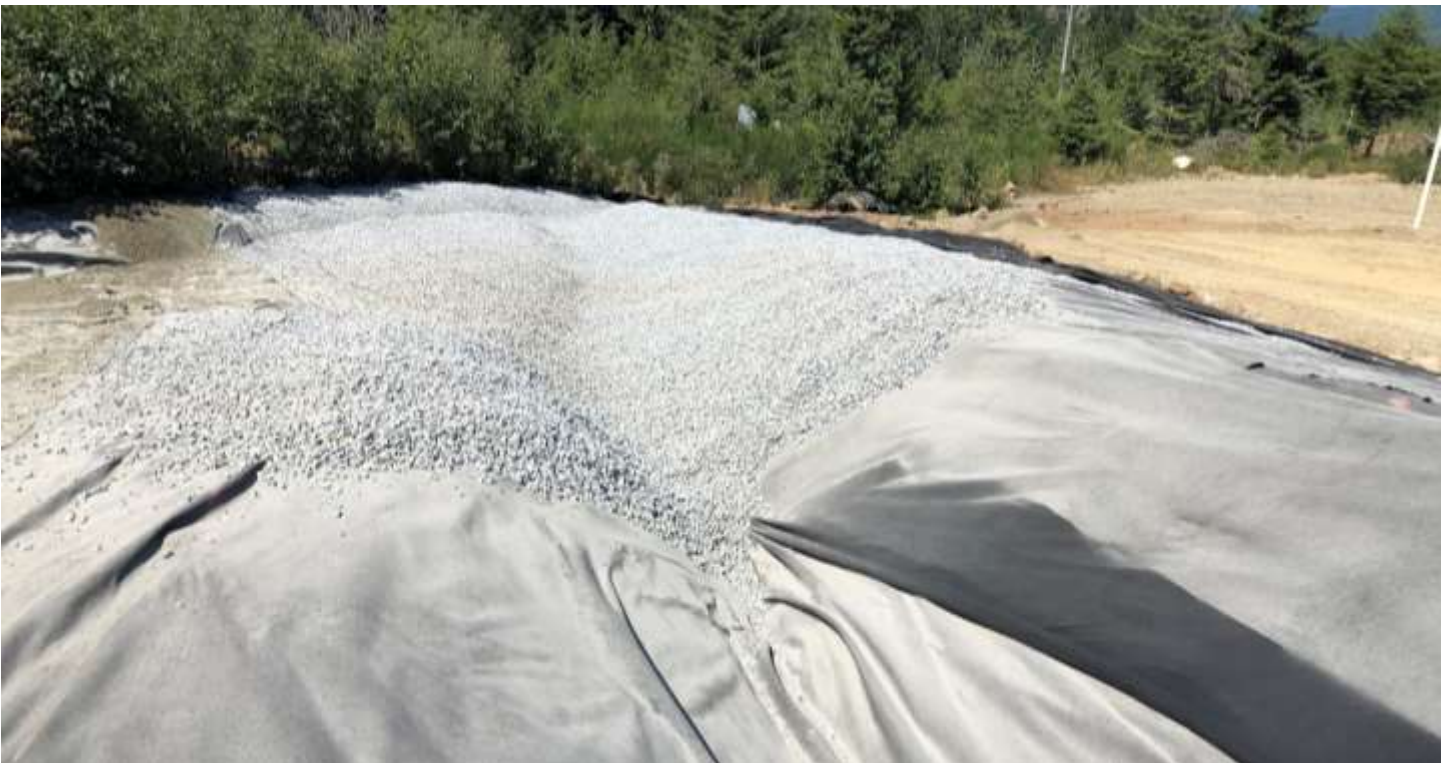
Picture # 16: Drainage gravel placed in northwest crest ditch above 12 oz. geotextile.

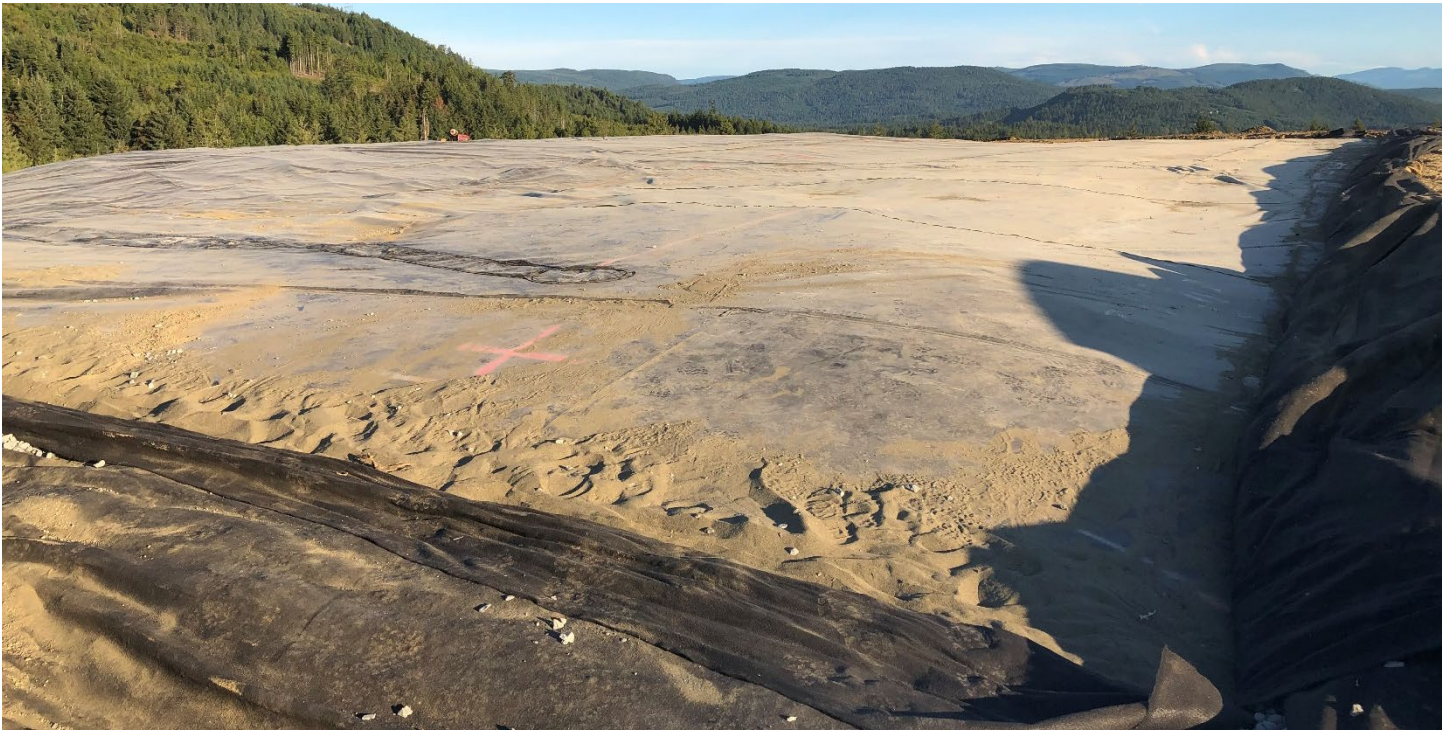
Picture # 1: Looking northwest at crest of PEA.

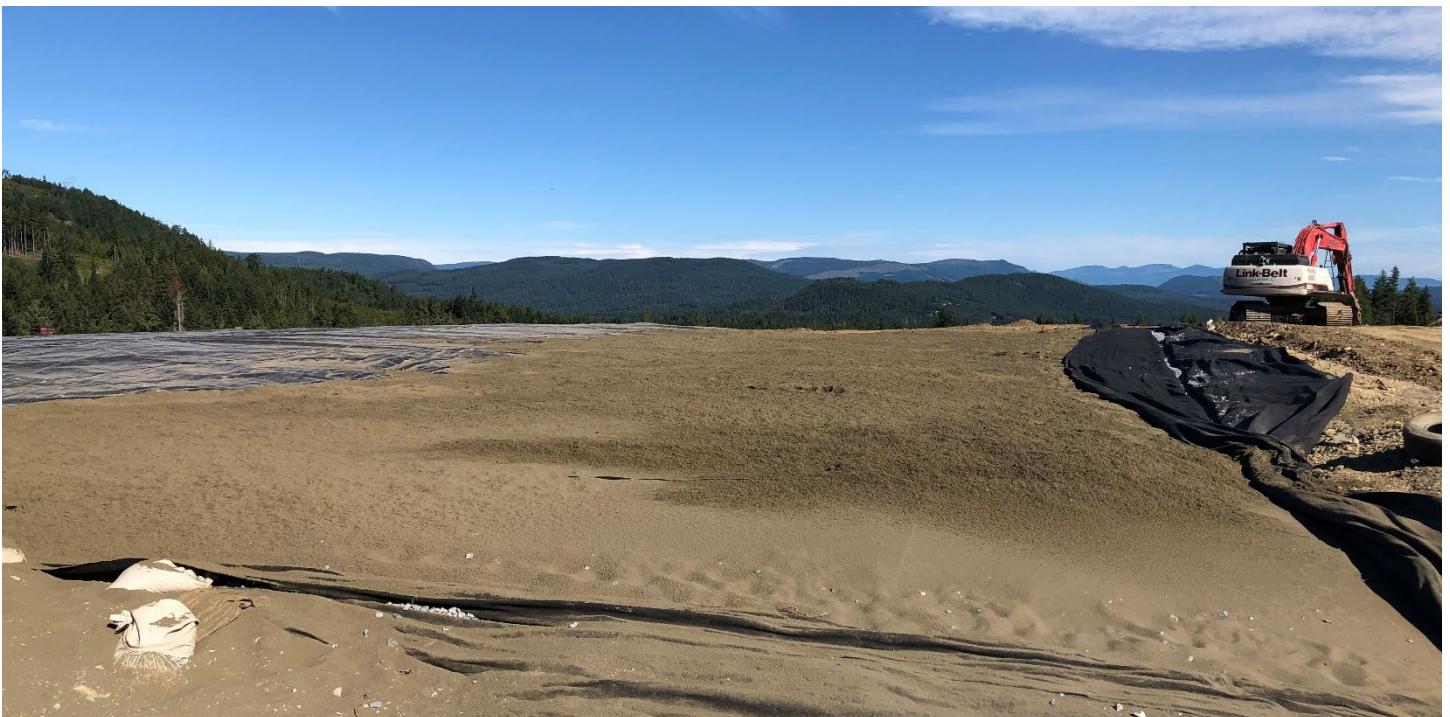
Picture # 2: 50mm thick sand layer placed on east crest of PEA.

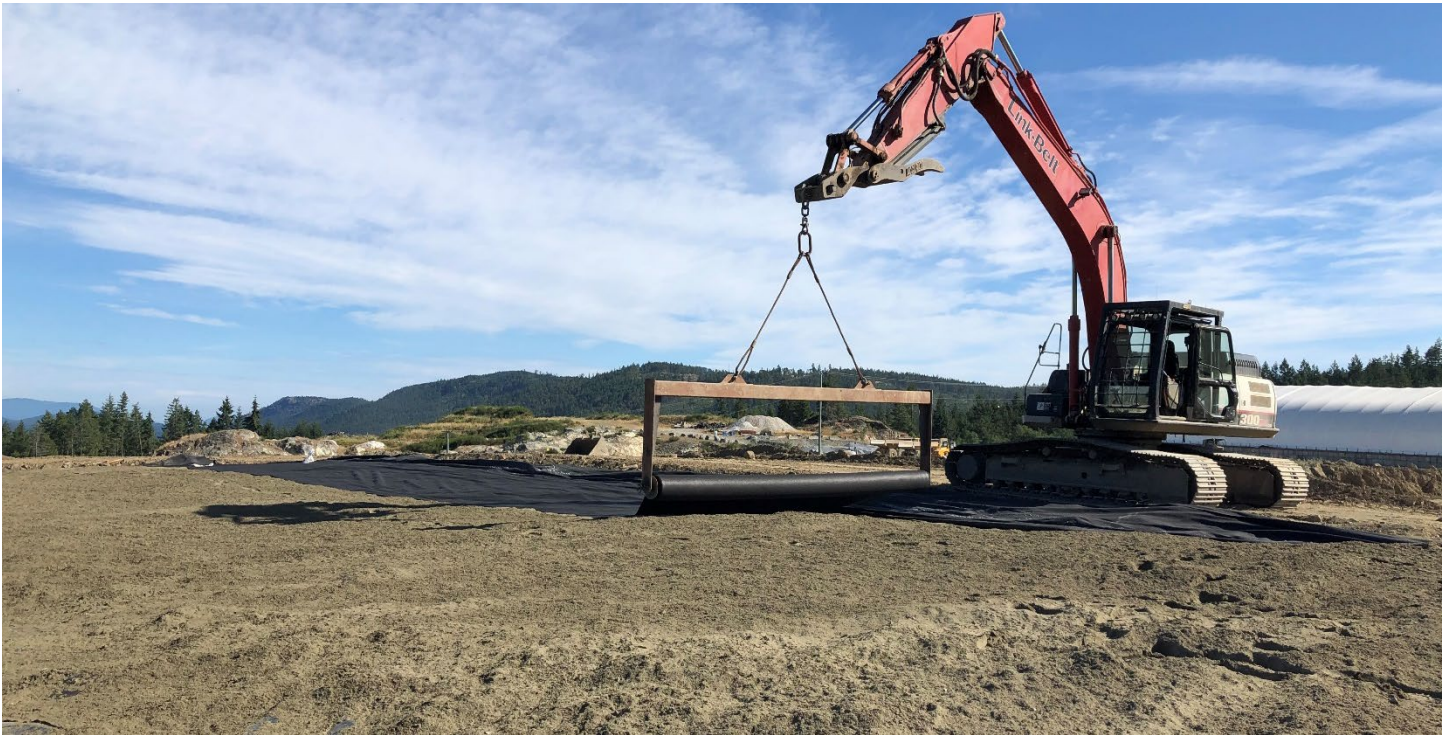
Picture # 3: Alterra deploying 12 oz. geotextile over sand layer on east crest of PEA.

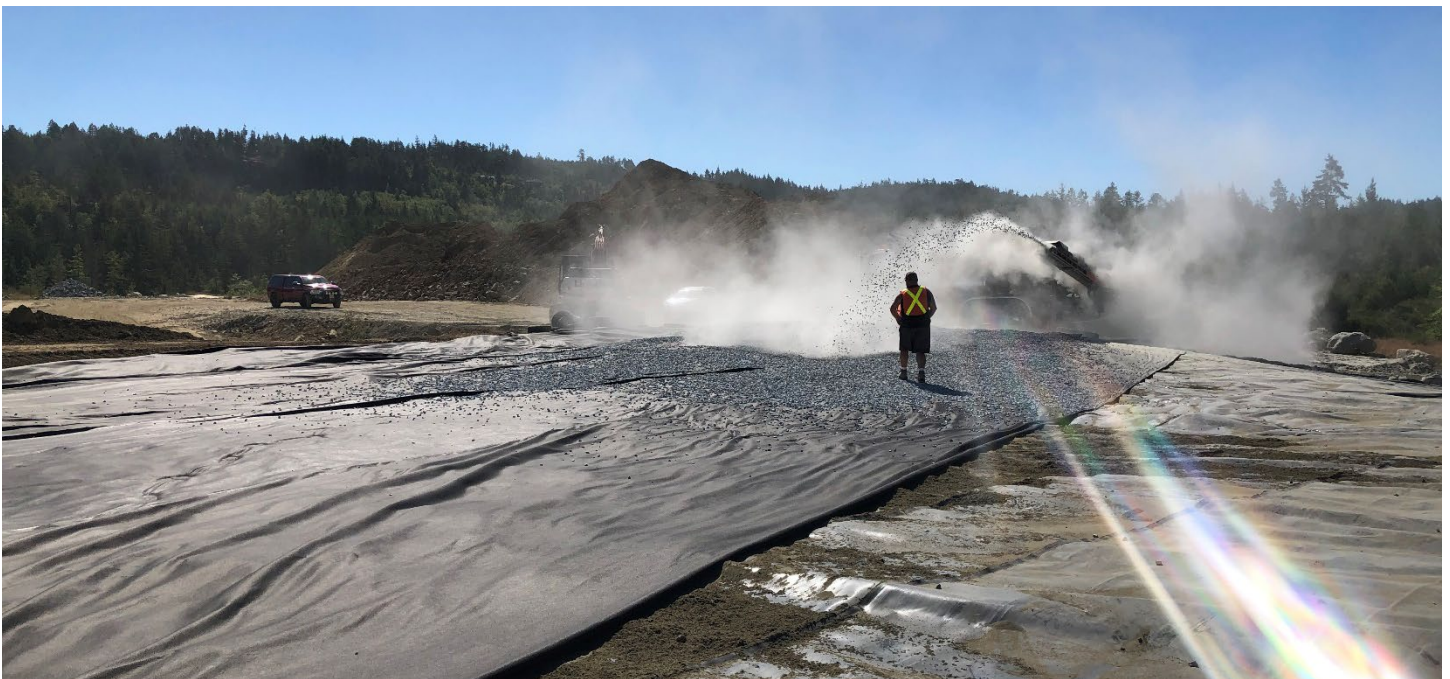
Picture # 5: Alterra using slinger to place 200mm thick layer of drainage gravel over 12 oz. geotextile on east crest of PEA.

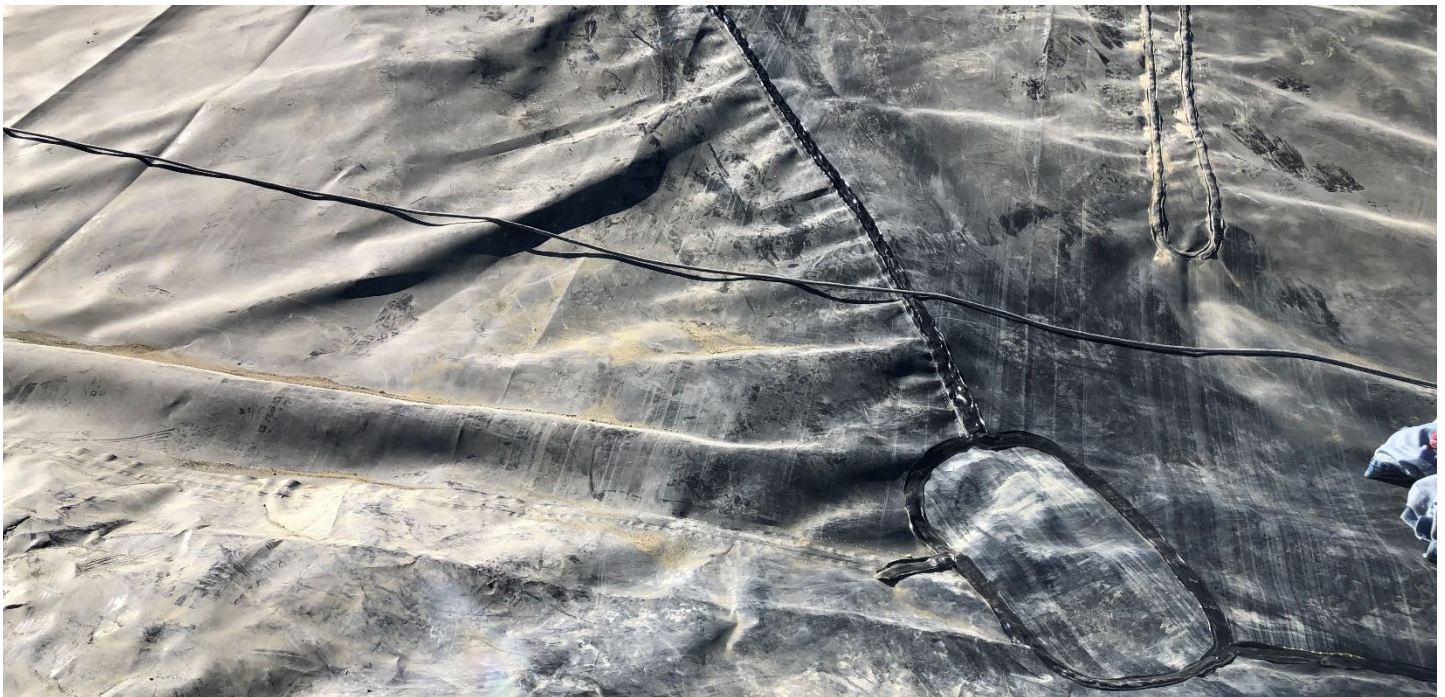
Picture # 7: Extrusion welded repair on geomembrane.
