**PENDER ISLAND – CANAL ROAD DIP SLIDE  
GEOTECHNICAL DESIGN REPORT**

**BC Ministry of Transportation and Infrastructure**

Date: May 8, 2023  
File: 34450

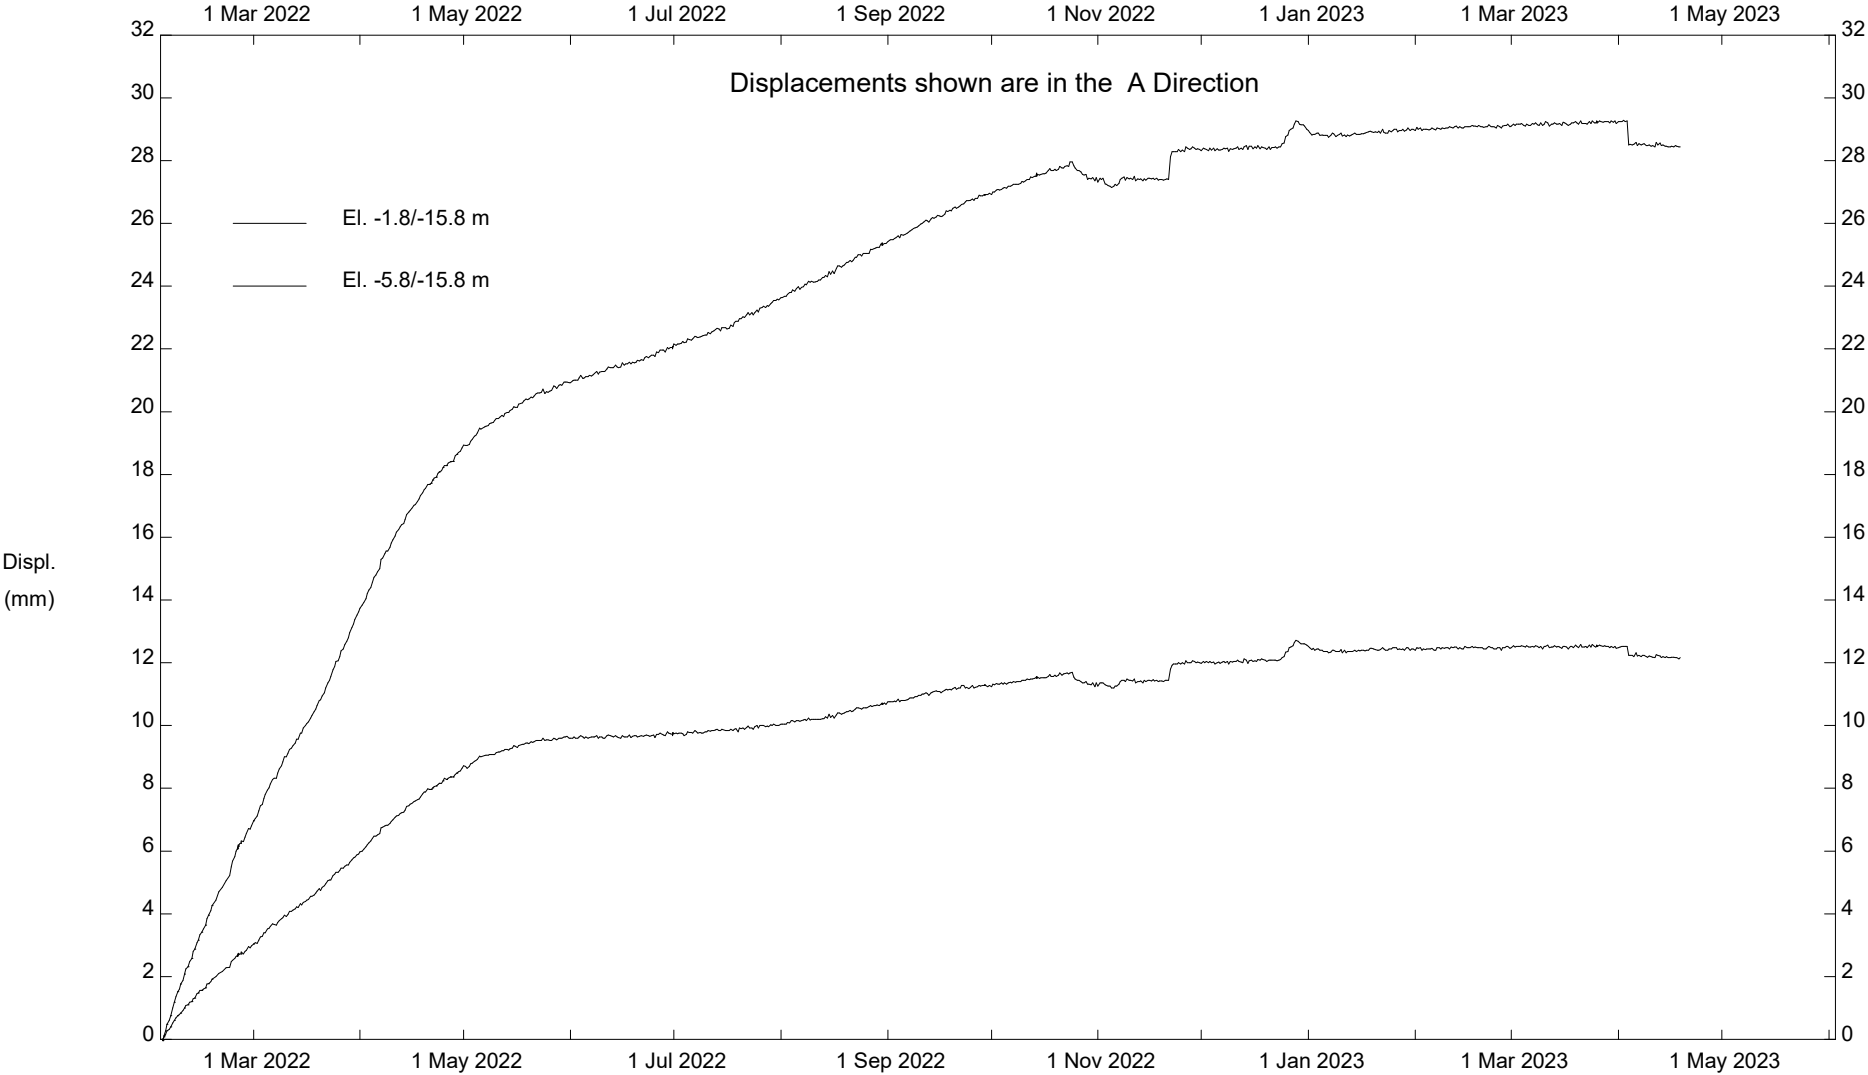
Canal Road Slide, Inclinator TH22-01  
BC MoTI

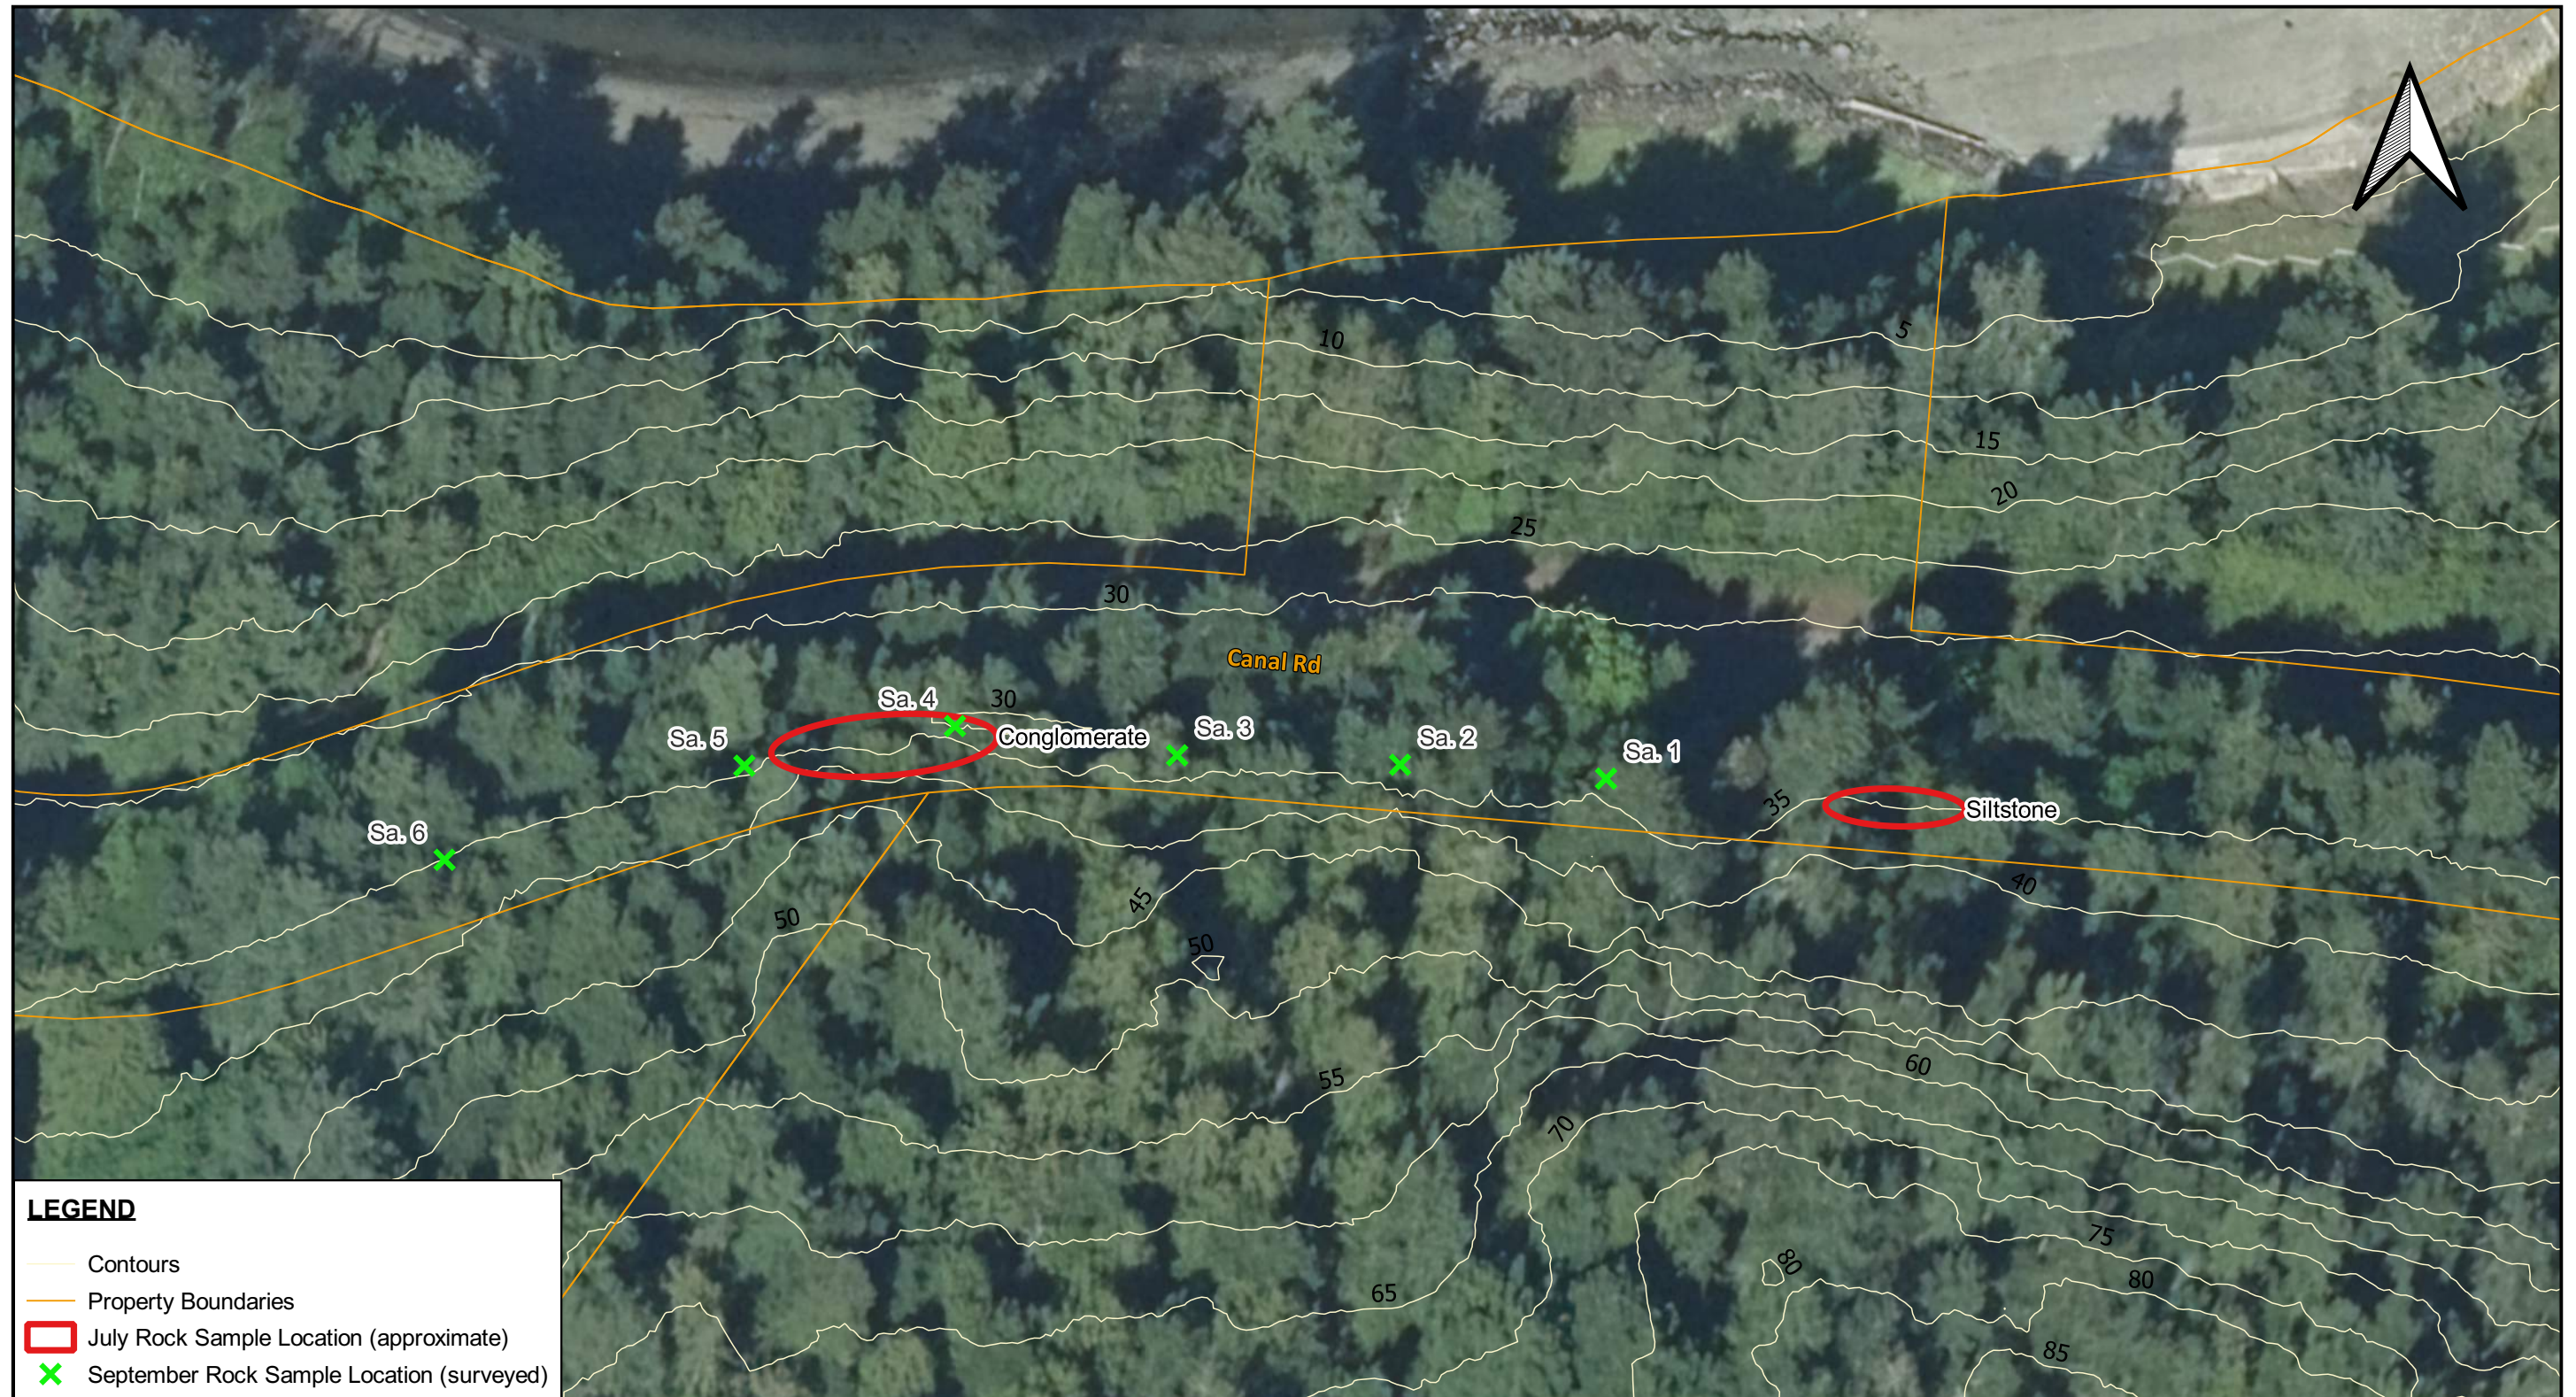
**FIGURE 1**

On July 21, 2022, Maggie Cramb, EIT of Thurber visited the Canal Road site to collect rock samples for durability testing. Samples of both rock types were collected by breaking off outcrop fragments using a rock hammer. Approximate locations of sample collection are shown on Figure 1 (attached).

At request of MoTI, On September 13, 2022, Jessica Dhami, GIT of Thurber returned to the site accompanied by Alex Hutter, GIT of MoTI, to collect additional samples of the conglomerate. A hand operated hammer drill, rock hammer, and mallet were used to collect conglomerate samples at six discrete locations along the outcrop. Each sample was approximately 18 to 19 L in volume (one 5-gallon pail). Sample locations were marked in the field and surveyed by McElhanney Ltd. Locations of each sample are shown on Figure 1 (attached).
